**STORMWATER SYSTEM
ASSET MANAGEMENT PLAN**

**CITY OF KEEGO HARBOR
OAKLAND COUNTY, MICHIGAN**

EGLE SAW GRANT #1220-01

DECEMBER 2019

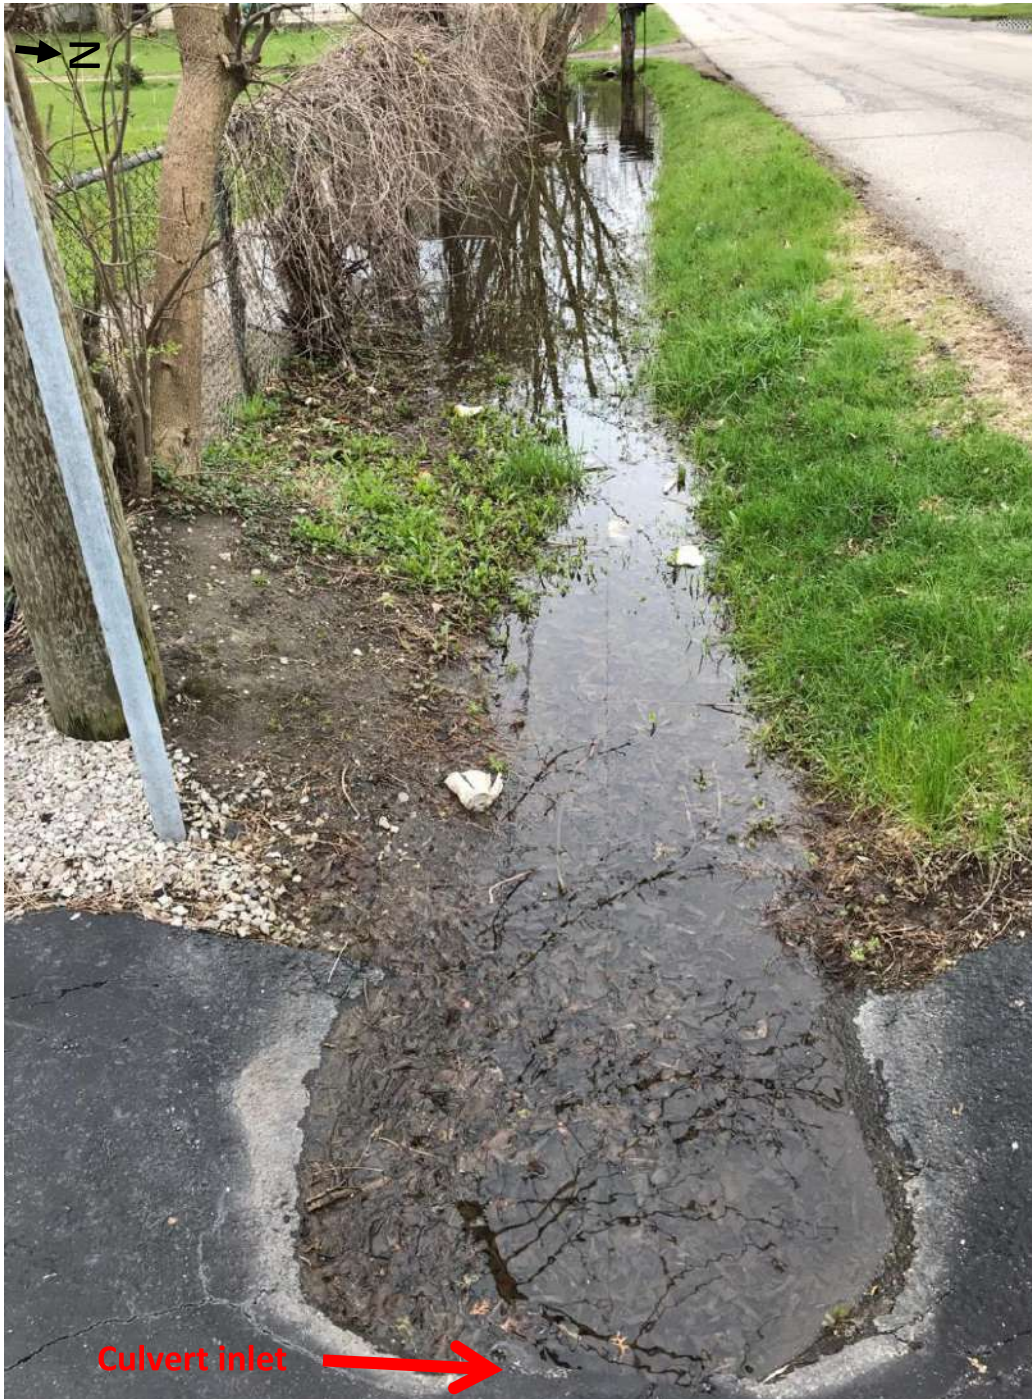
Photo taken by HRC staff on May 3, 2019 of clogged culvert inlet and stagnate water at 3185 Kenrick Street.

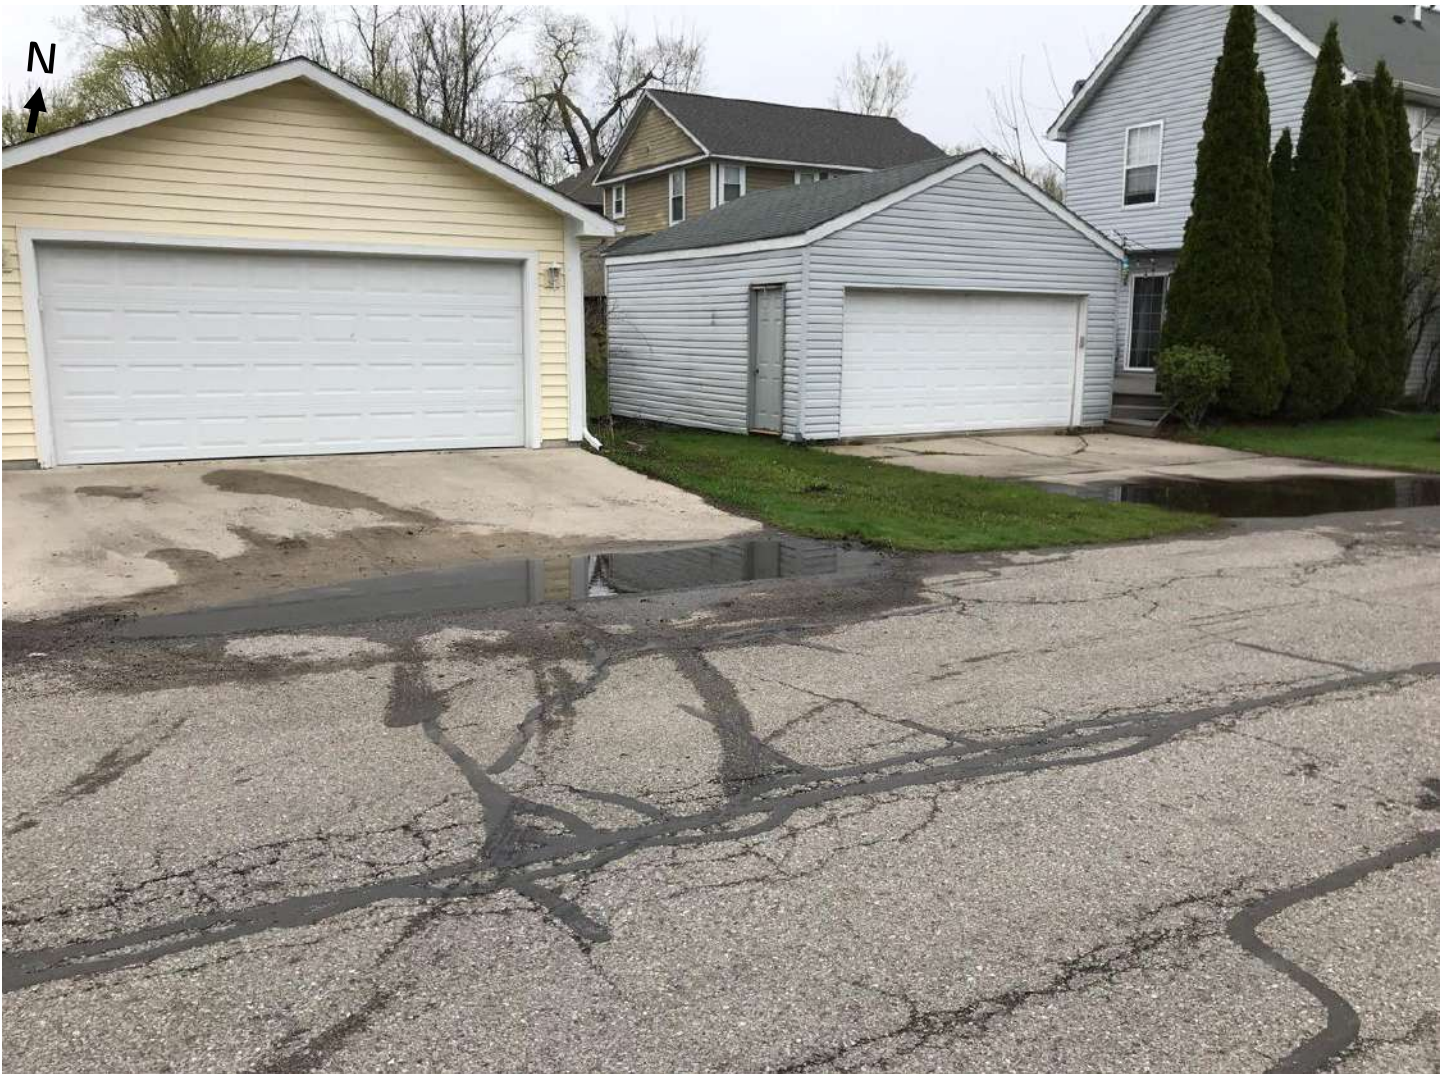
Image taken by HRC staff on May 3, 2019 of standing water at driveways of 2141 Willow Beach Street and 2140 Brock Street.

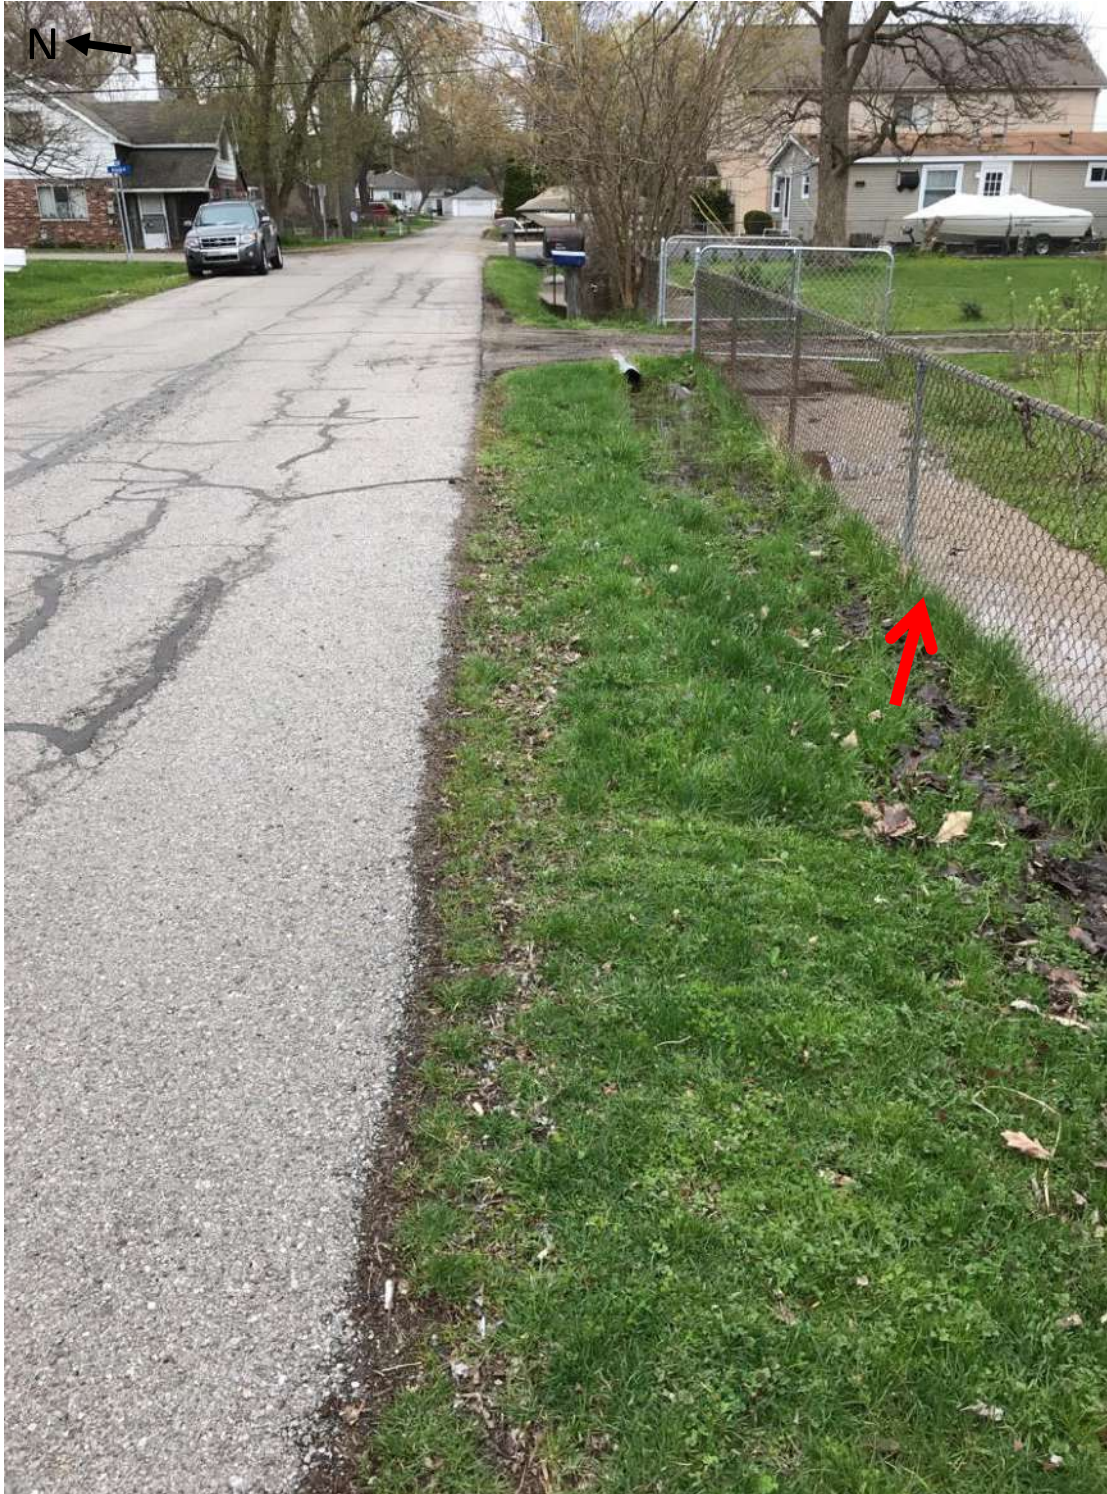
Image taken by HRC staff on May 3, 2019 of the heaved culvert at 3201 Kenrick and the location where the homeowner of 3201 Kenrick placed a sand berm to prevent roadway runoff from draining to their property.

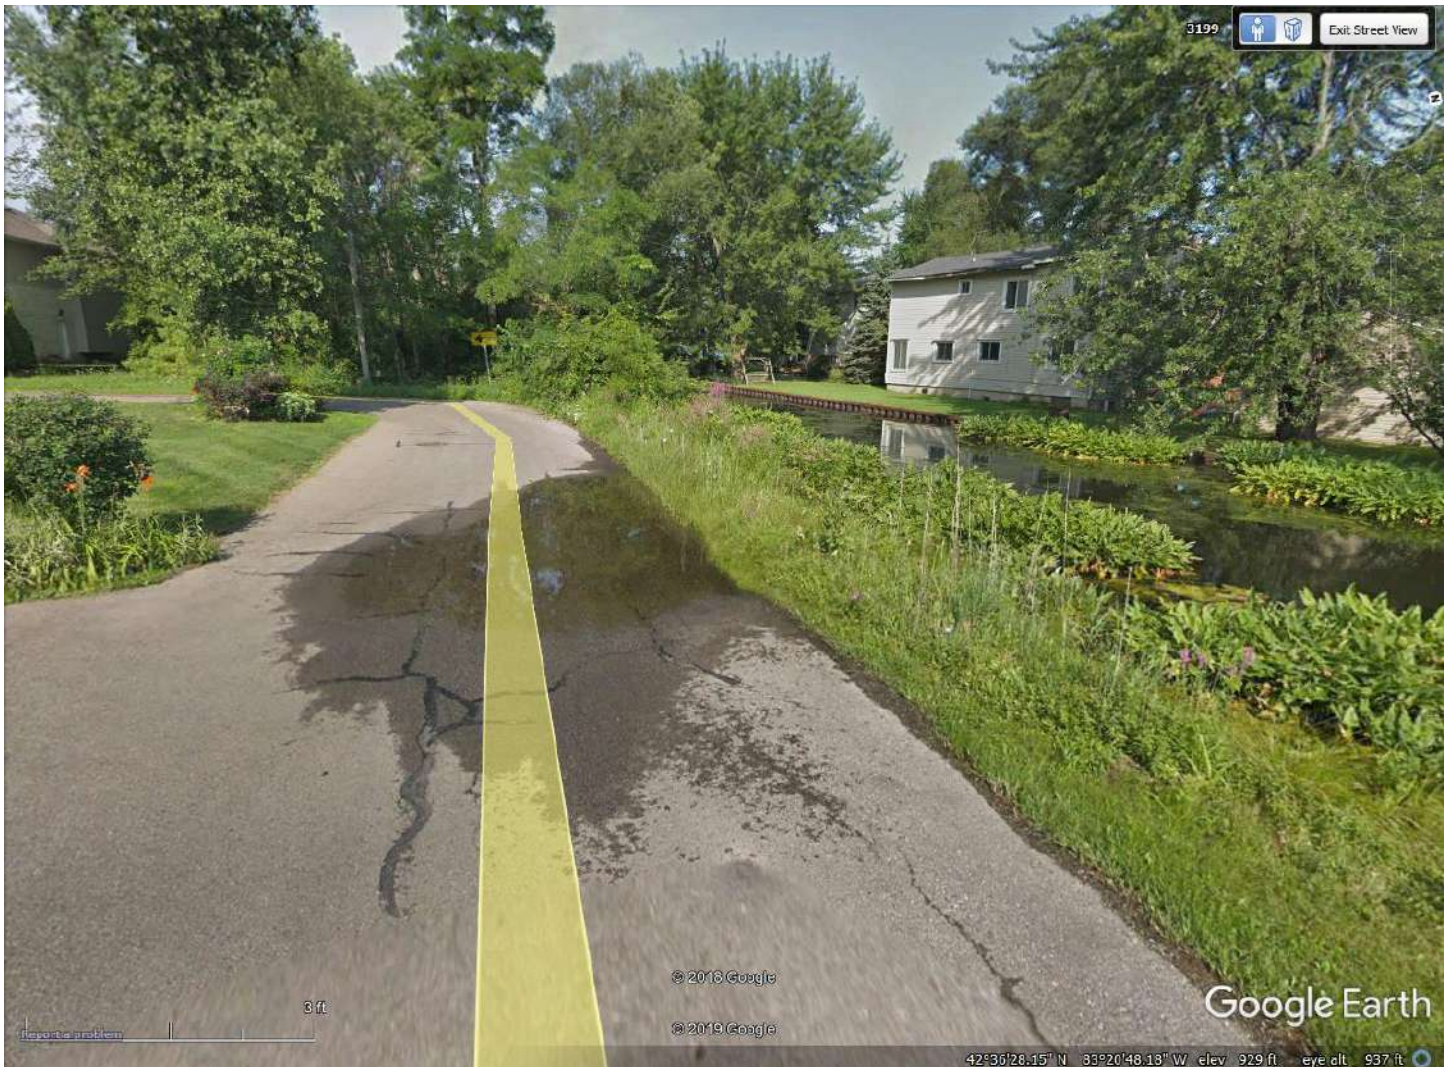
August 2018 Google street view image of low-lying area in front of 3119 Brock Street that experiences frequent water ponding.

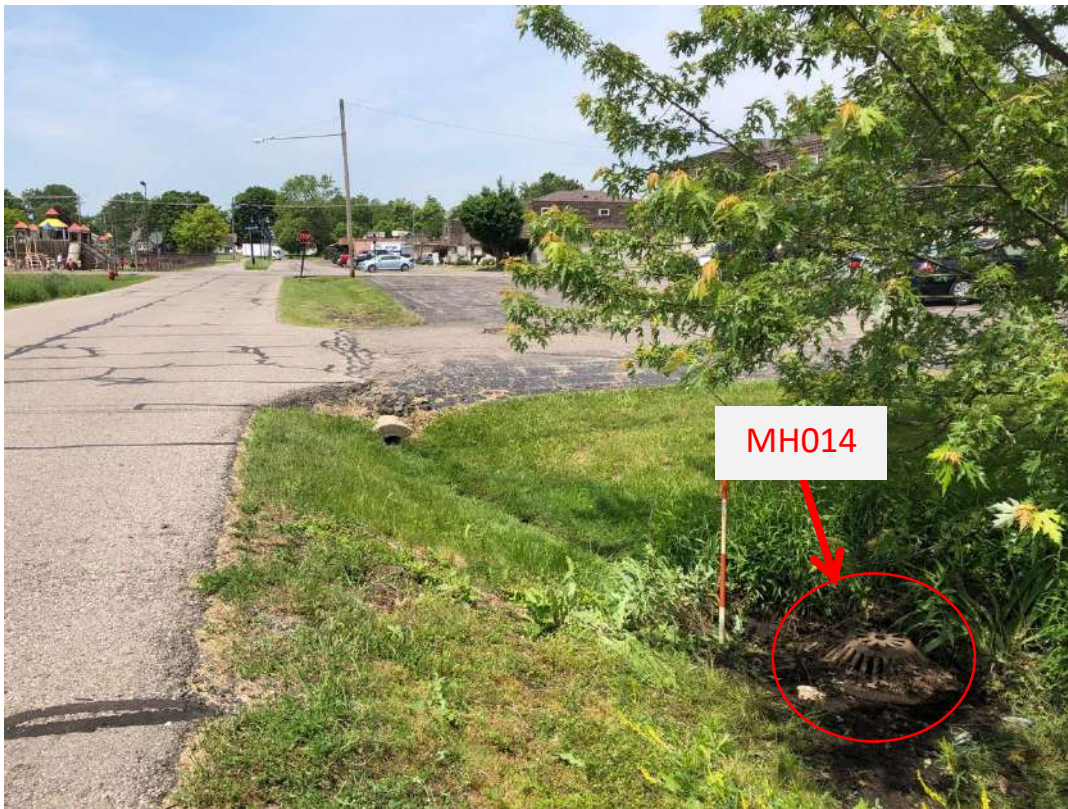
Google street view image taken in August 2018 of Schroeder Blvd., facing west and showing the location of the manhole recommended to repair.

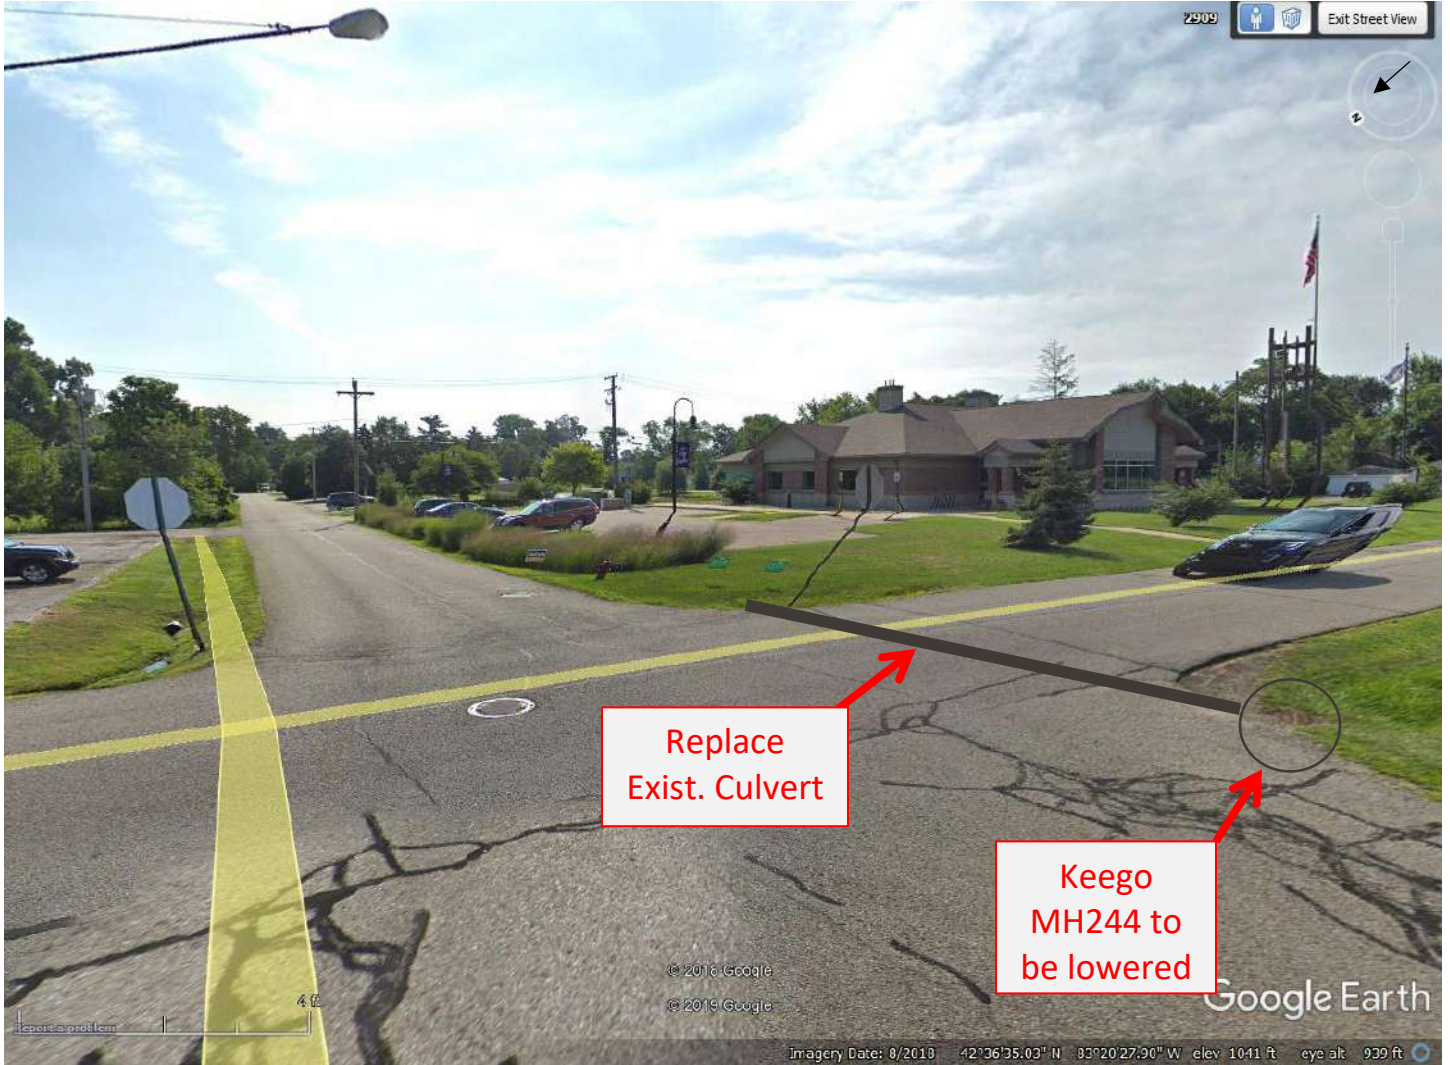
Google street view image taken in August 2018 of Schroeder Blvd., facing east and showing the location of the repair recommendations to existing manhole and culvert.

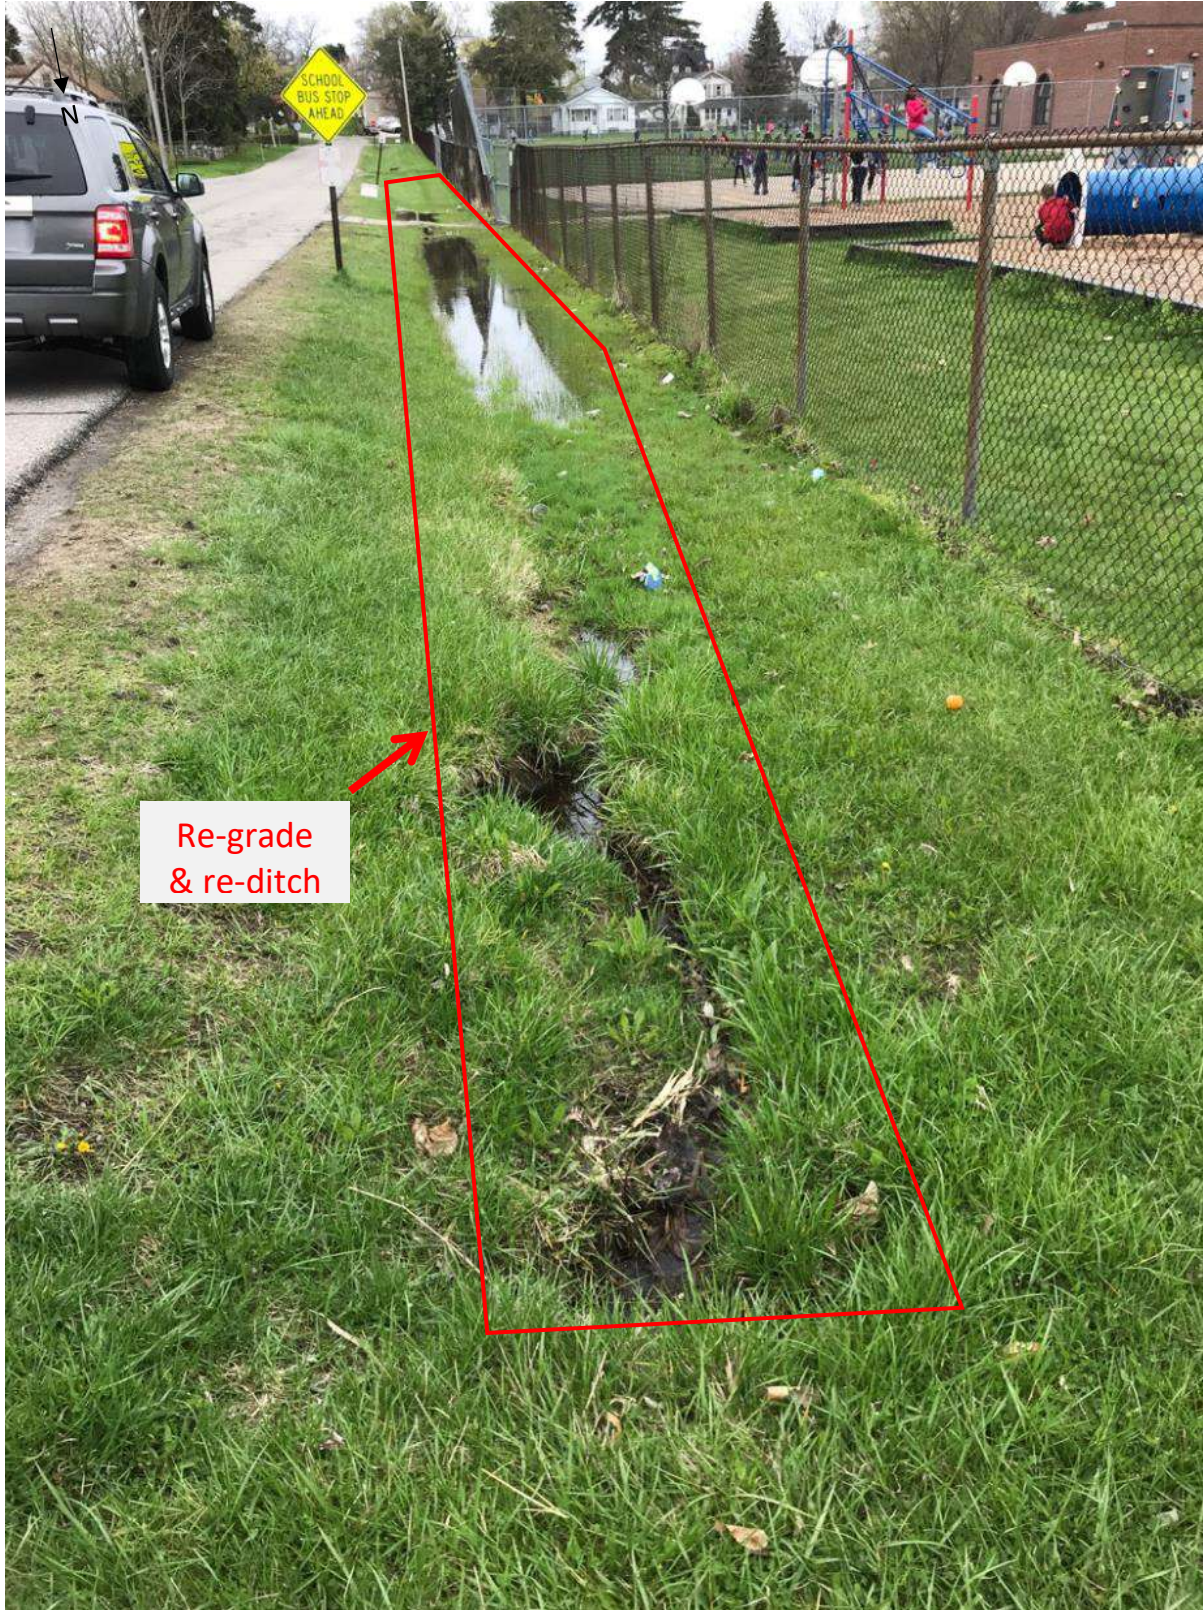
Photo taken by HRC staff on May 3, 2019 of the overgrown ditch along Beechmont Road, south of Schroeder.

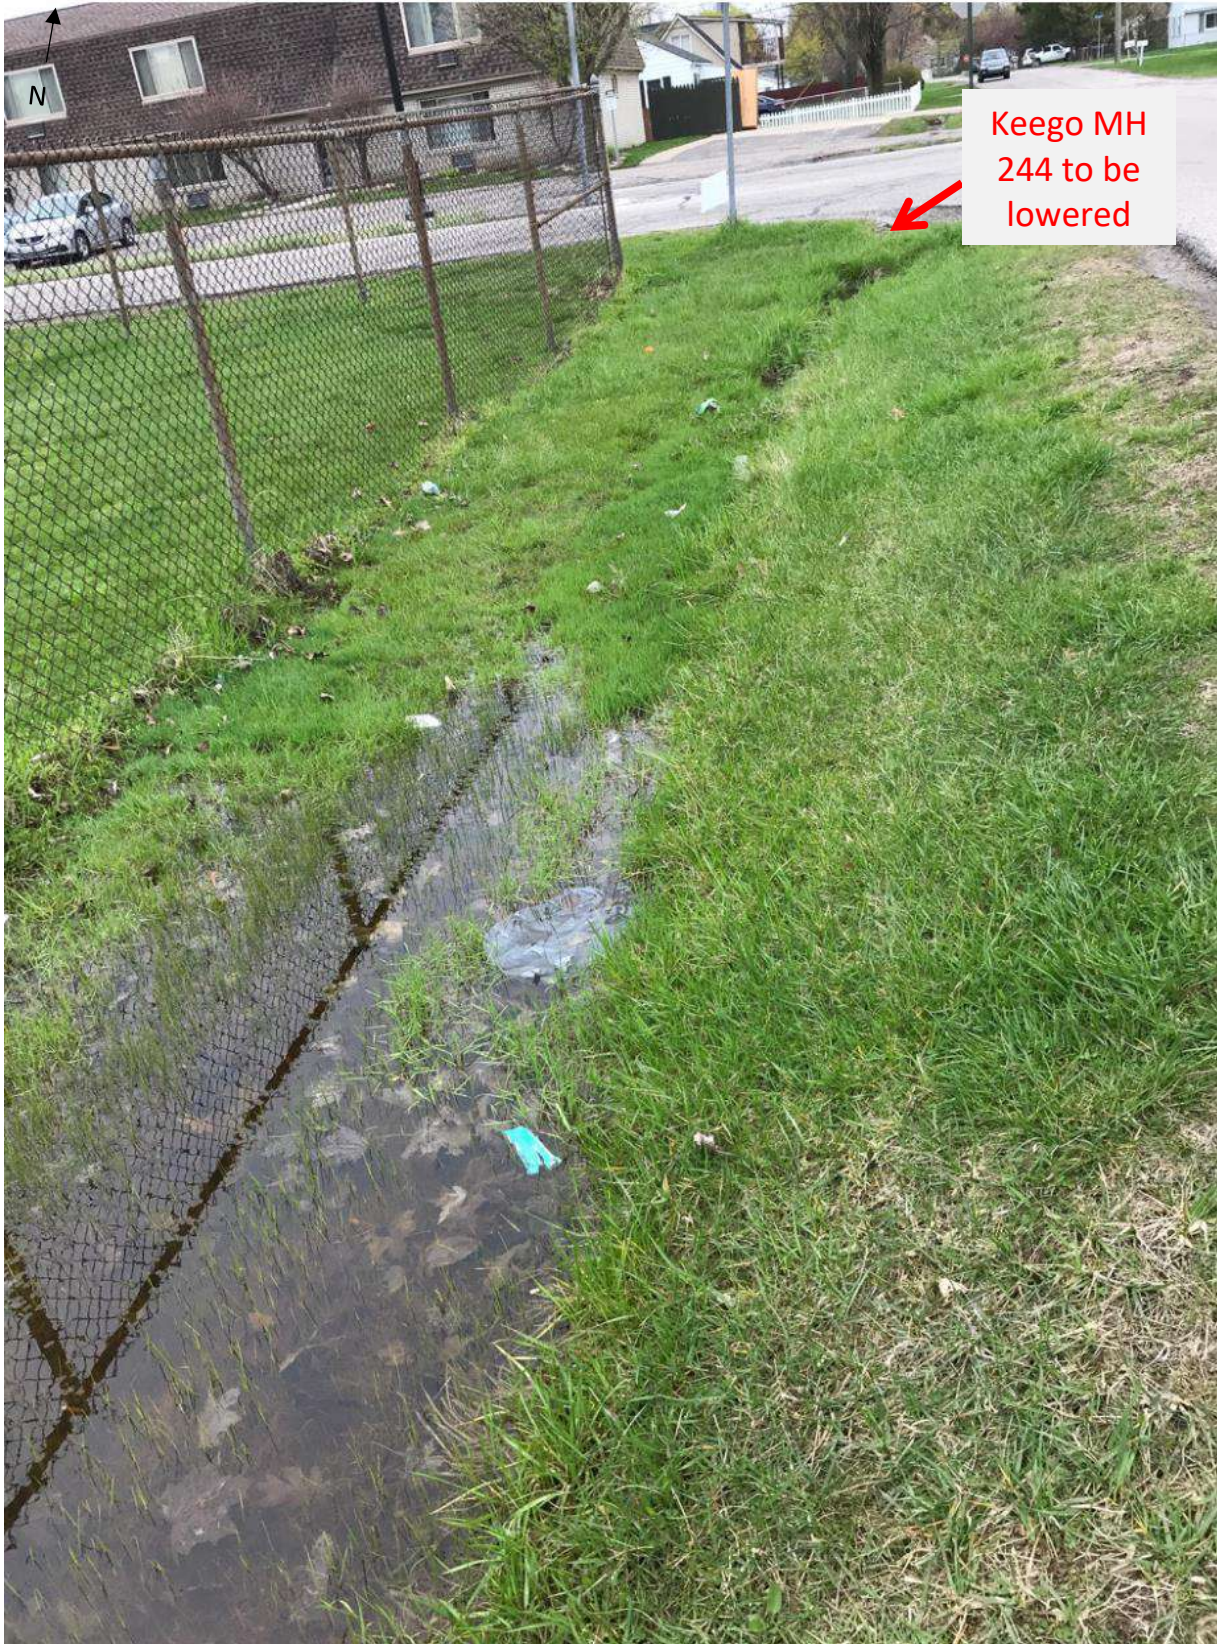
Photo taken by HRC staff on May 3, 2019 of stagnant water in the ditch along Beechmont, south of Schroeder, that's prevent flow from entering the manhole.

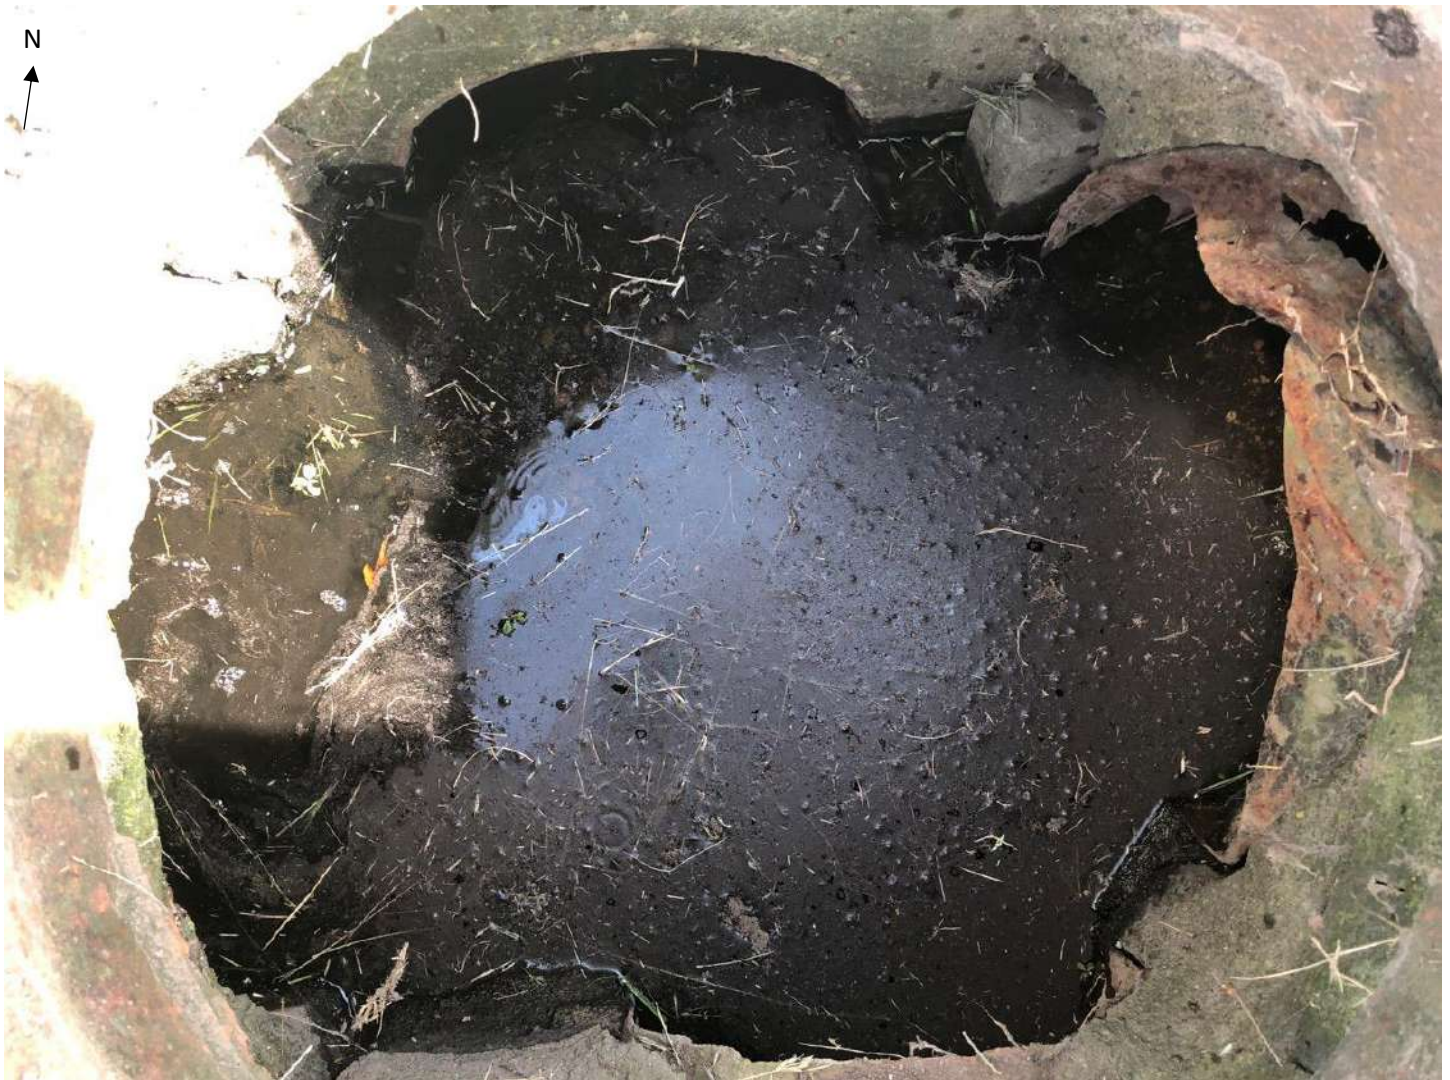
Photo taken by HRC staff on May 3, 2019 showing the inside of the manhole (MH244) at the corner of Beechmont and Schroeder.

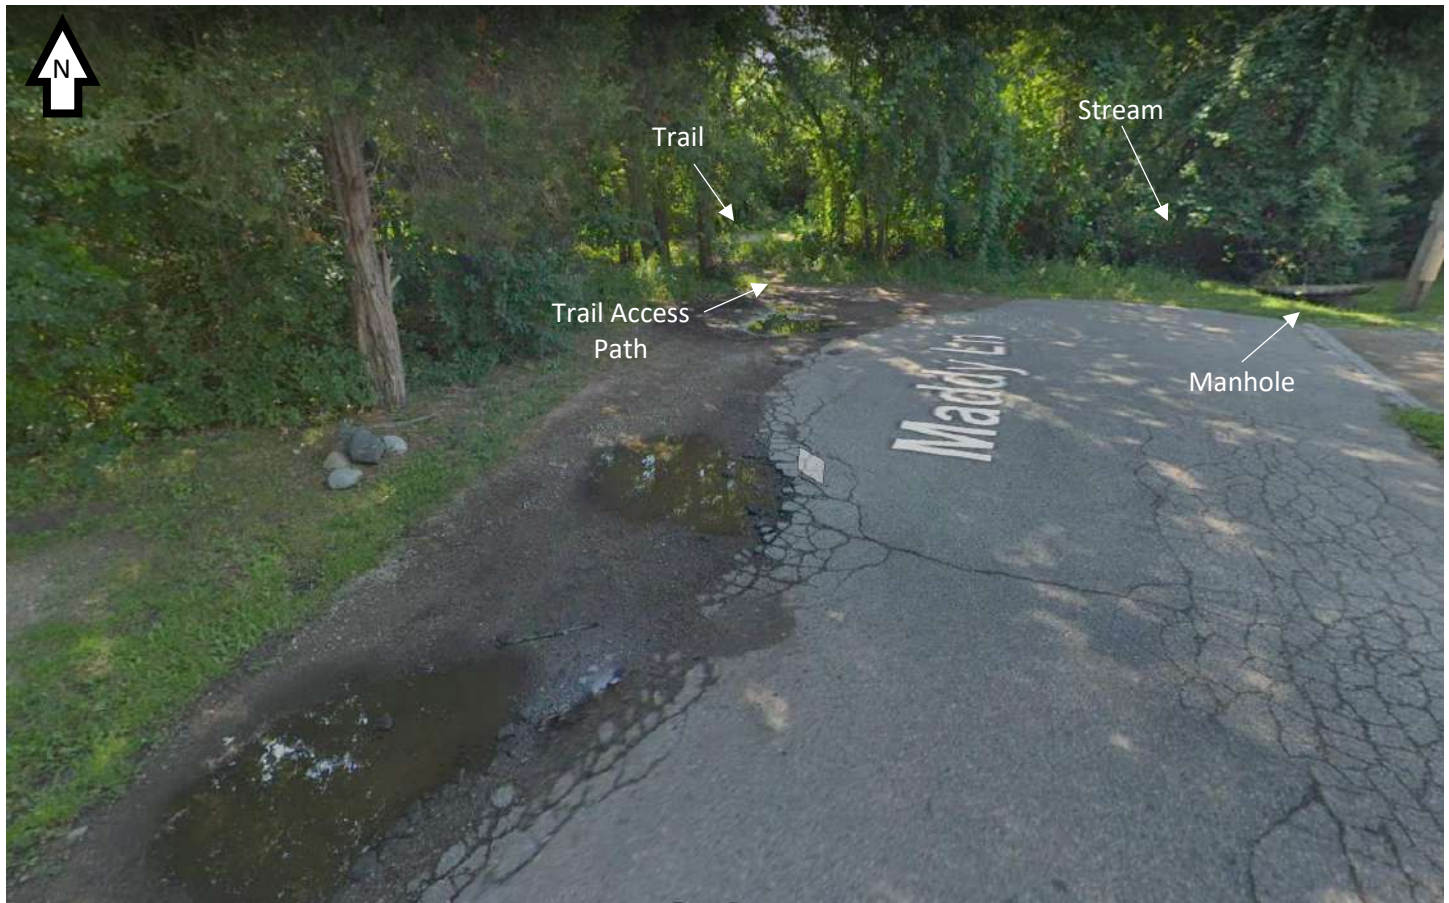
Google Street View of dead-end street where stormwater ponding occurs.

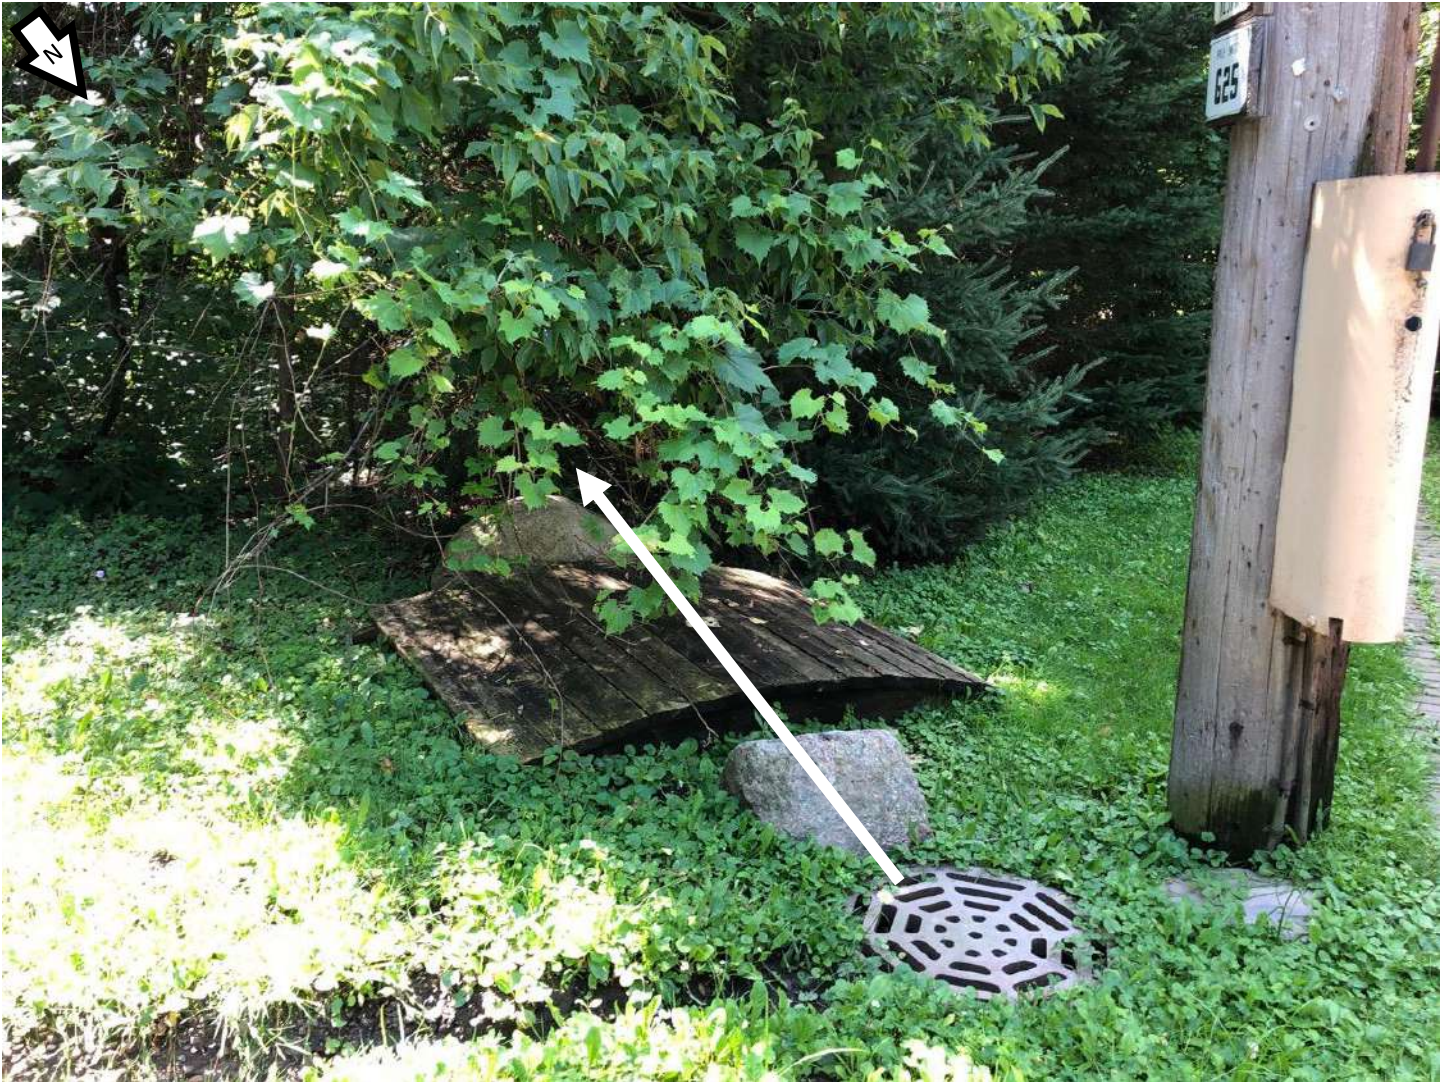
Location of the manhole at the end of Maddy Ln that discharges to the stream.

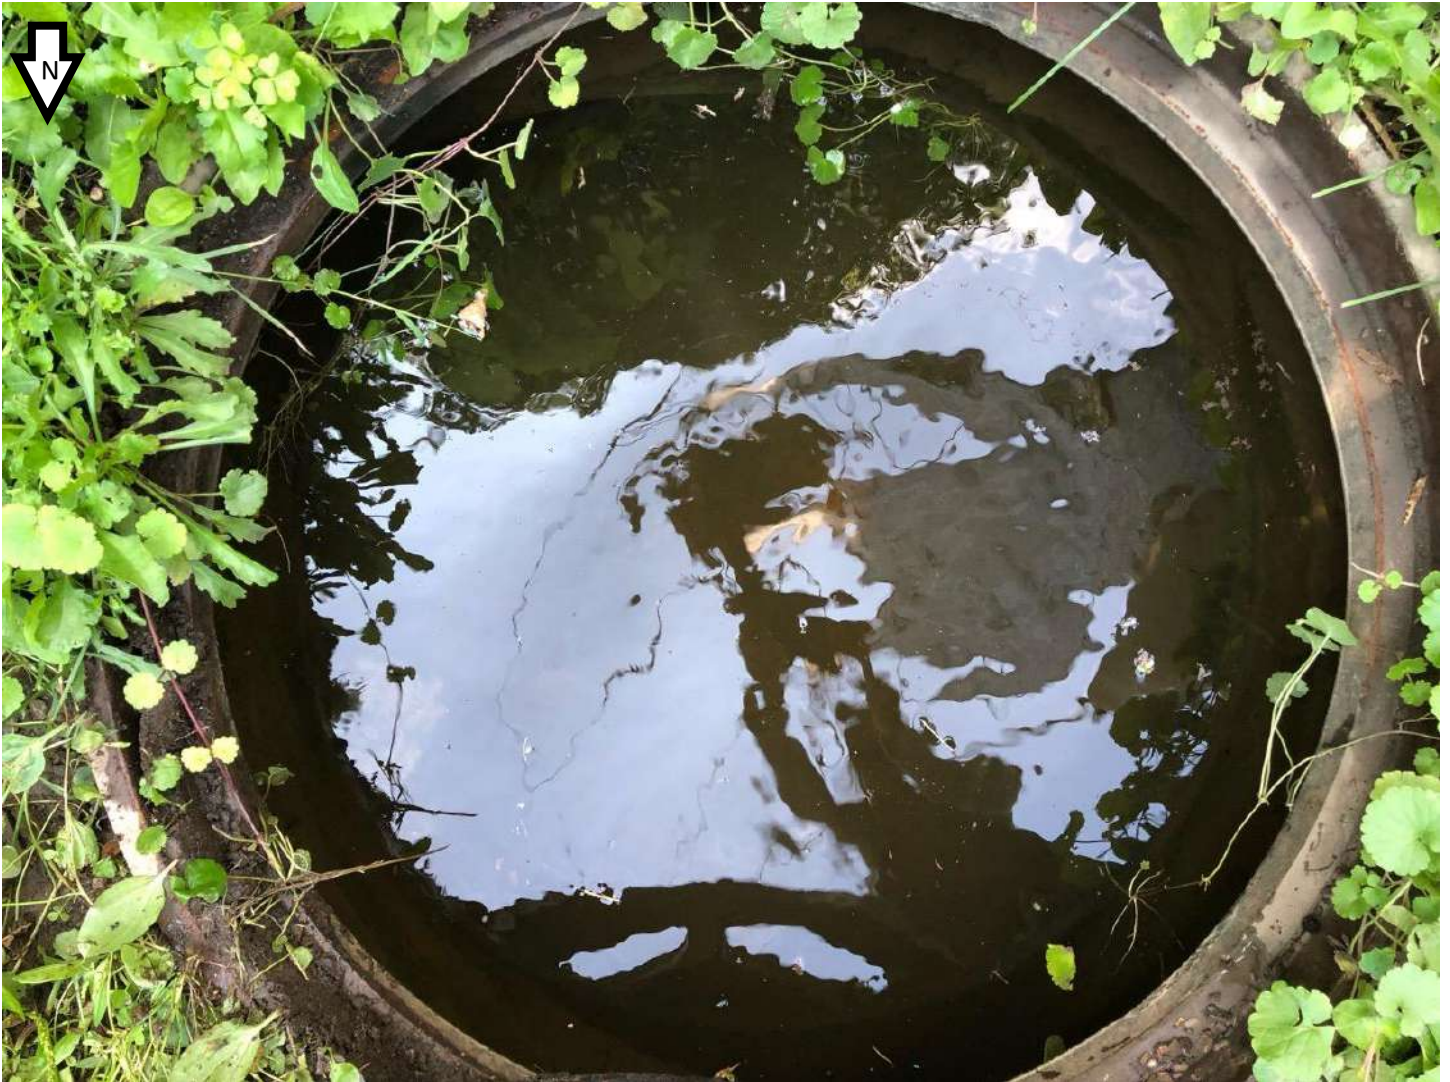
Inside image of the manhole at the end of Maddy Ln that is regularly filled with water as the outgoing pipe is below the water level in the stream.

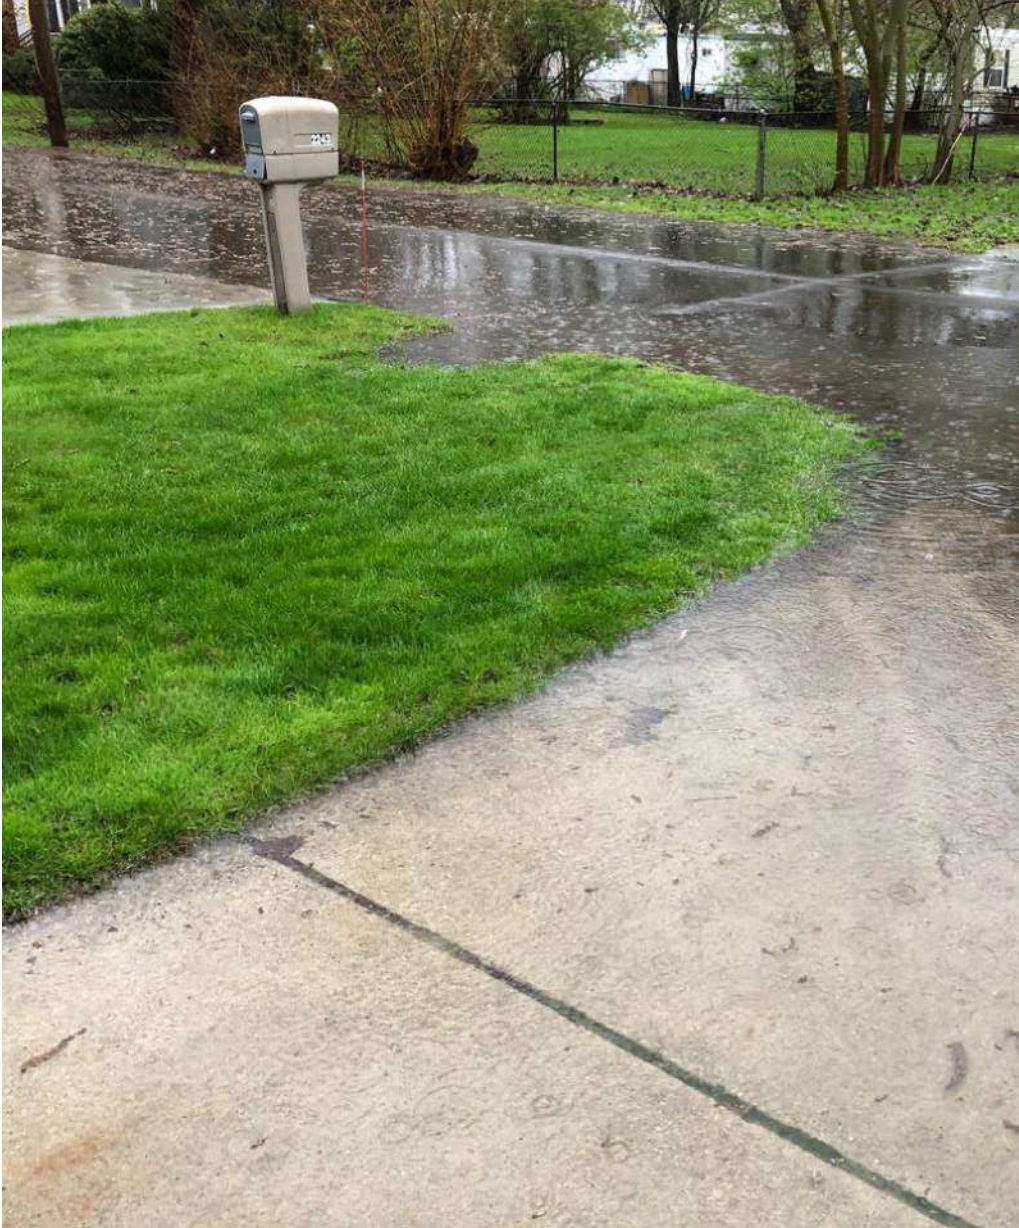
Photo from homeowner at 2229 Willow Beach St from May, 2019 of the flooded driveway and street.

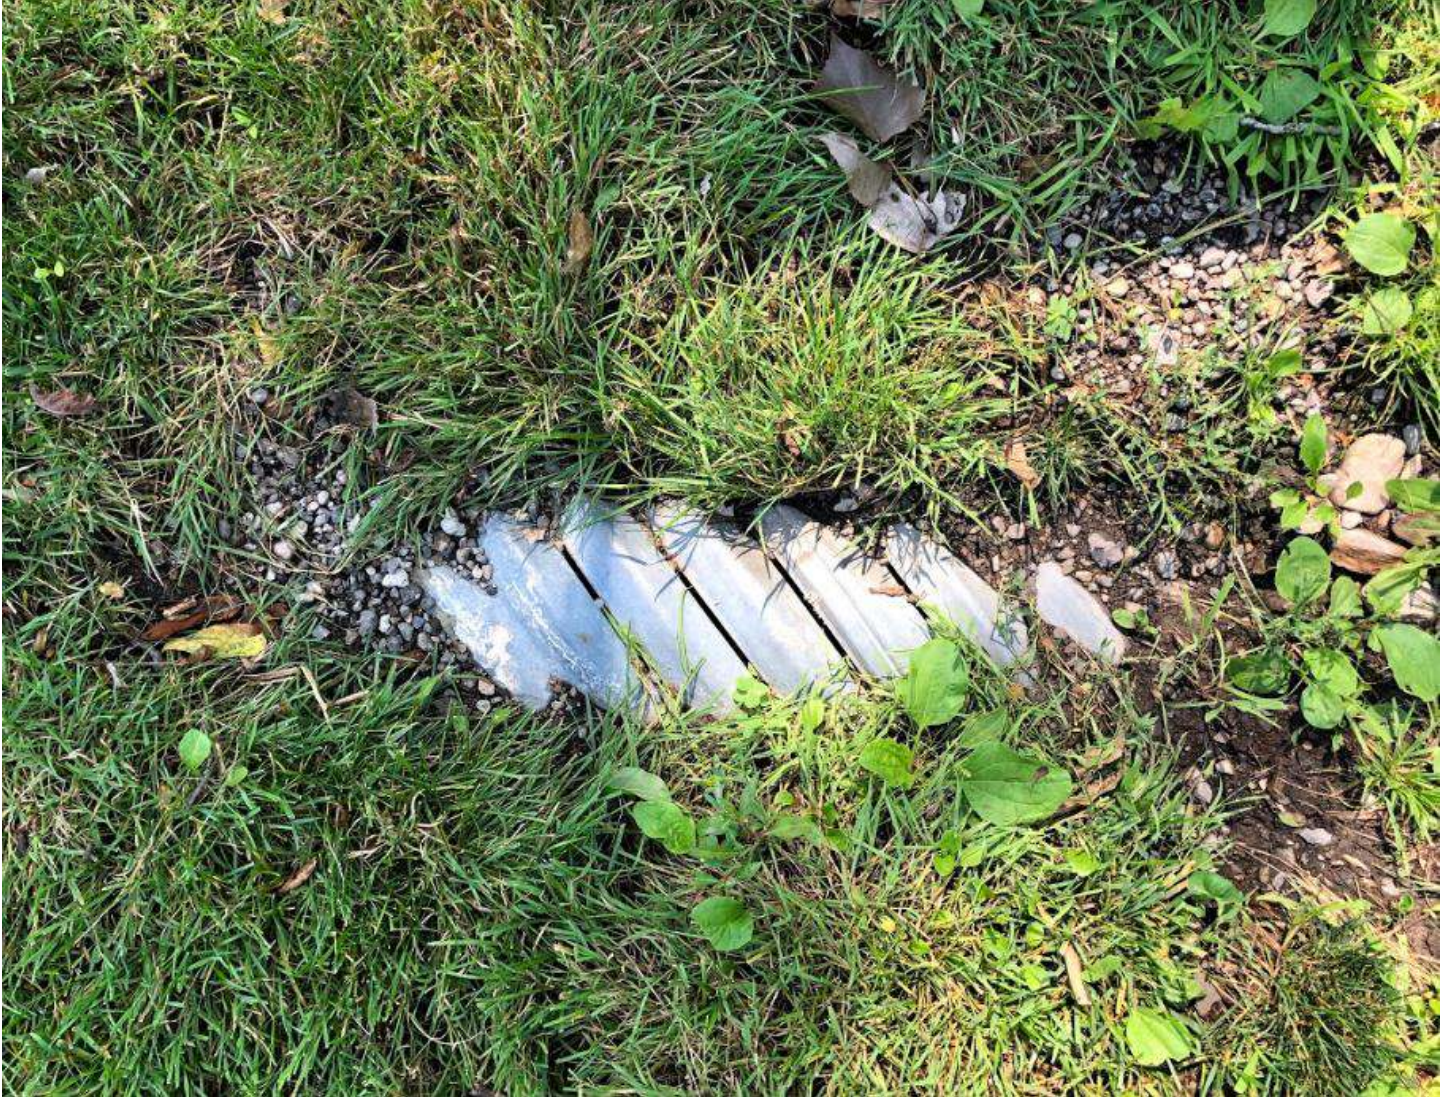
Photo taken by HRC staff the exposed drain and slit created to allow flow into the pipe from July 30, 2019. Location where field catch basin is recommended to be installed.
