**STORMWATER SYSTEM
ASSET MANAGEMENT PLAN**

**CITY OF KEEGO HARBOR
OAKLAND COUNTY, MICHIGAN**

EGLE SAW GRANT #1220-01

DECEMBER 2019

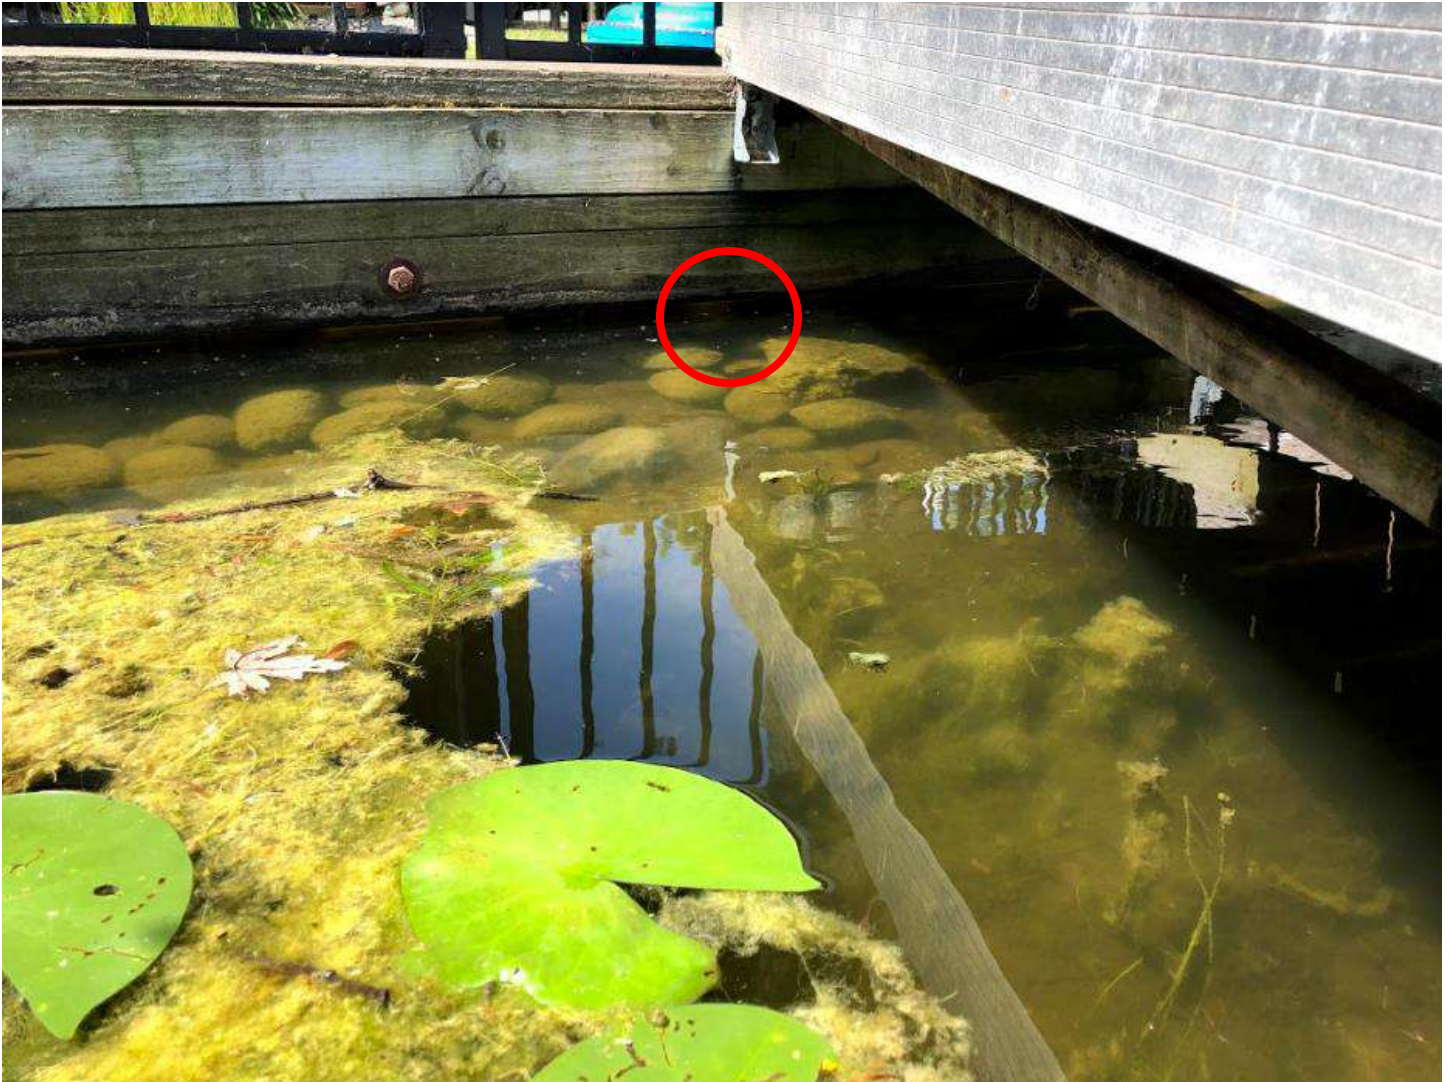
Photo taken by HRC staff of culvert outlet through the seawall into Sylvan Lake.
