**STORMWATER SYSTEM
ASSET MANAGEMENT PLAN**

**CITY OF KEEGO HARBOR
OAKLAND COUNTY, MICHIGAN**

DECEMBER 2019

HRC JOB NO. 20130735

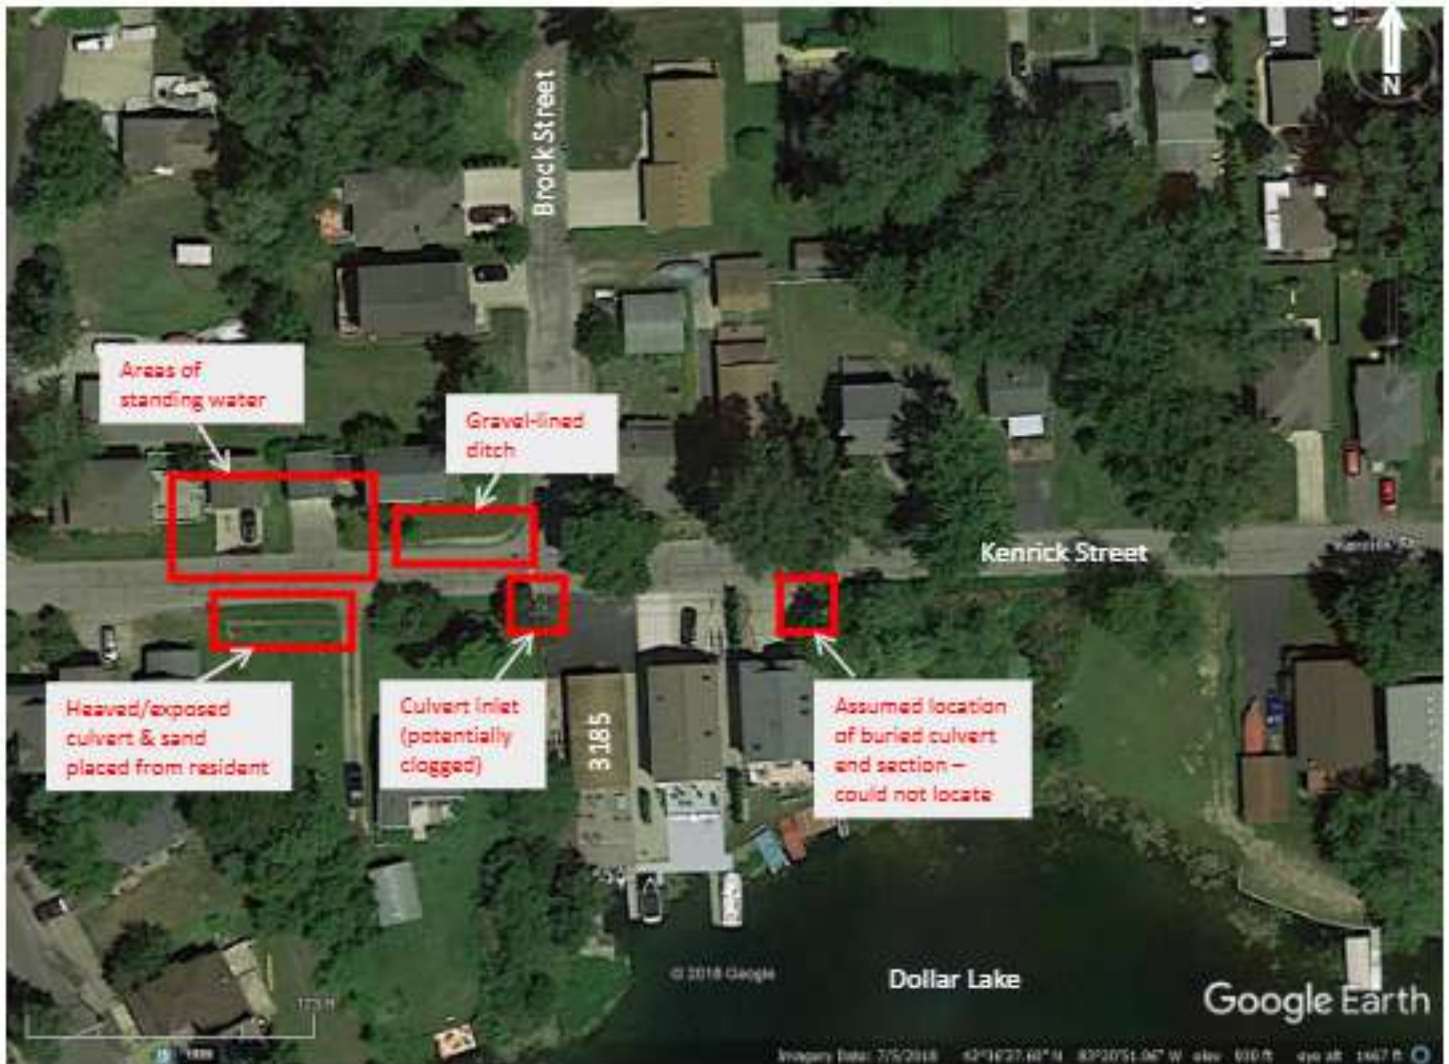
Google aerial view of Kenrick Street with markups of where complaints and drainage issues were passed along to the City.

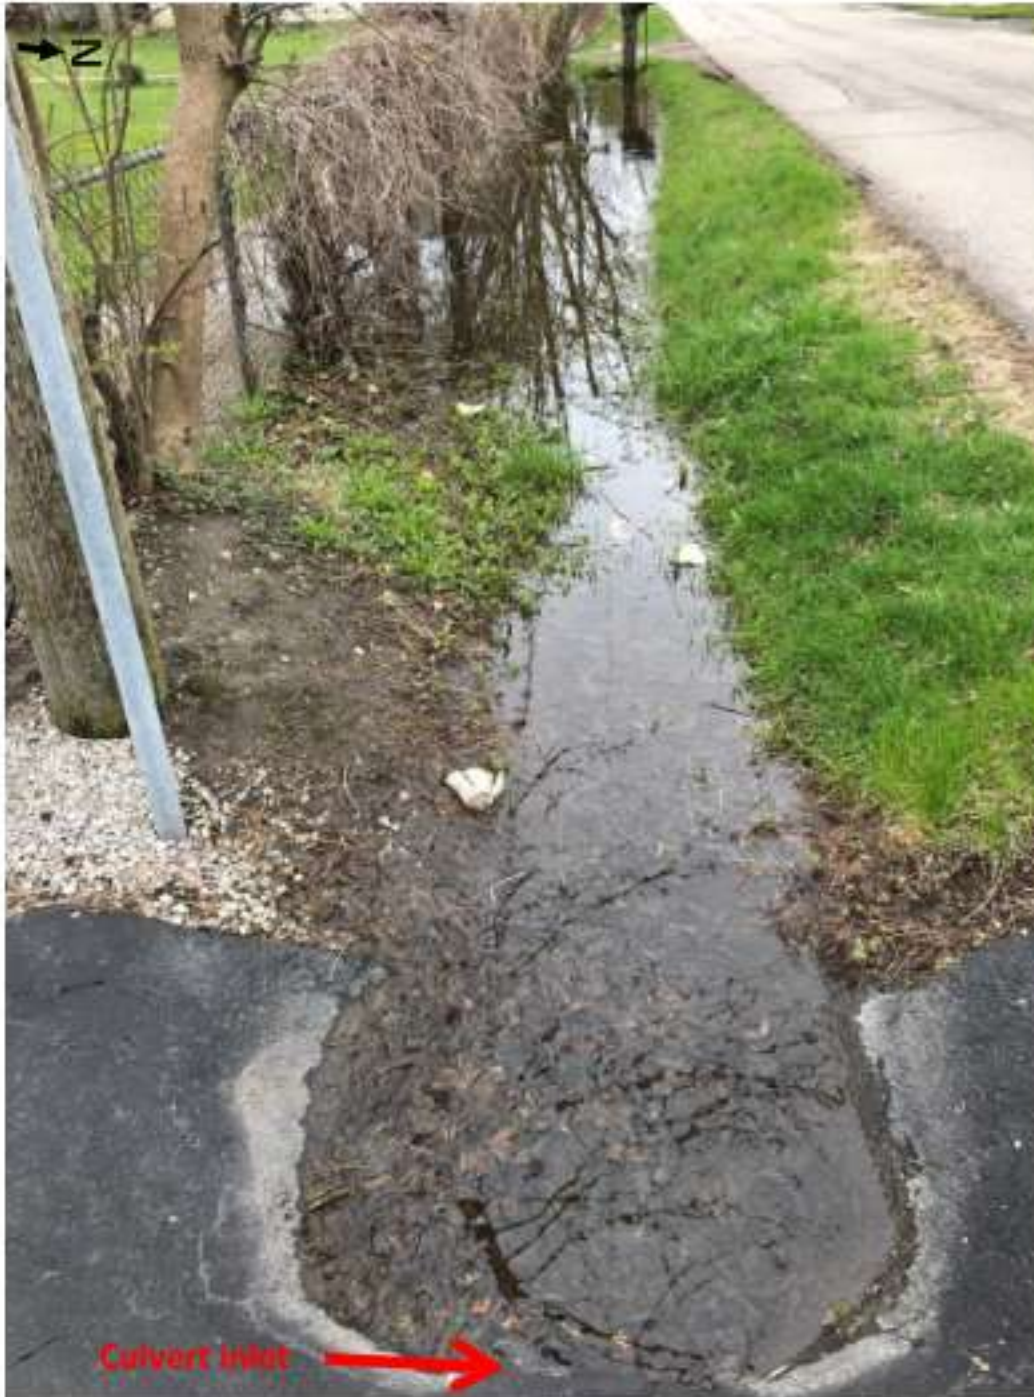
Photo taken by HRC staff on May 3, 2019 of clogged culvert inlet and stagnate water at 3185 Kenrick Street.

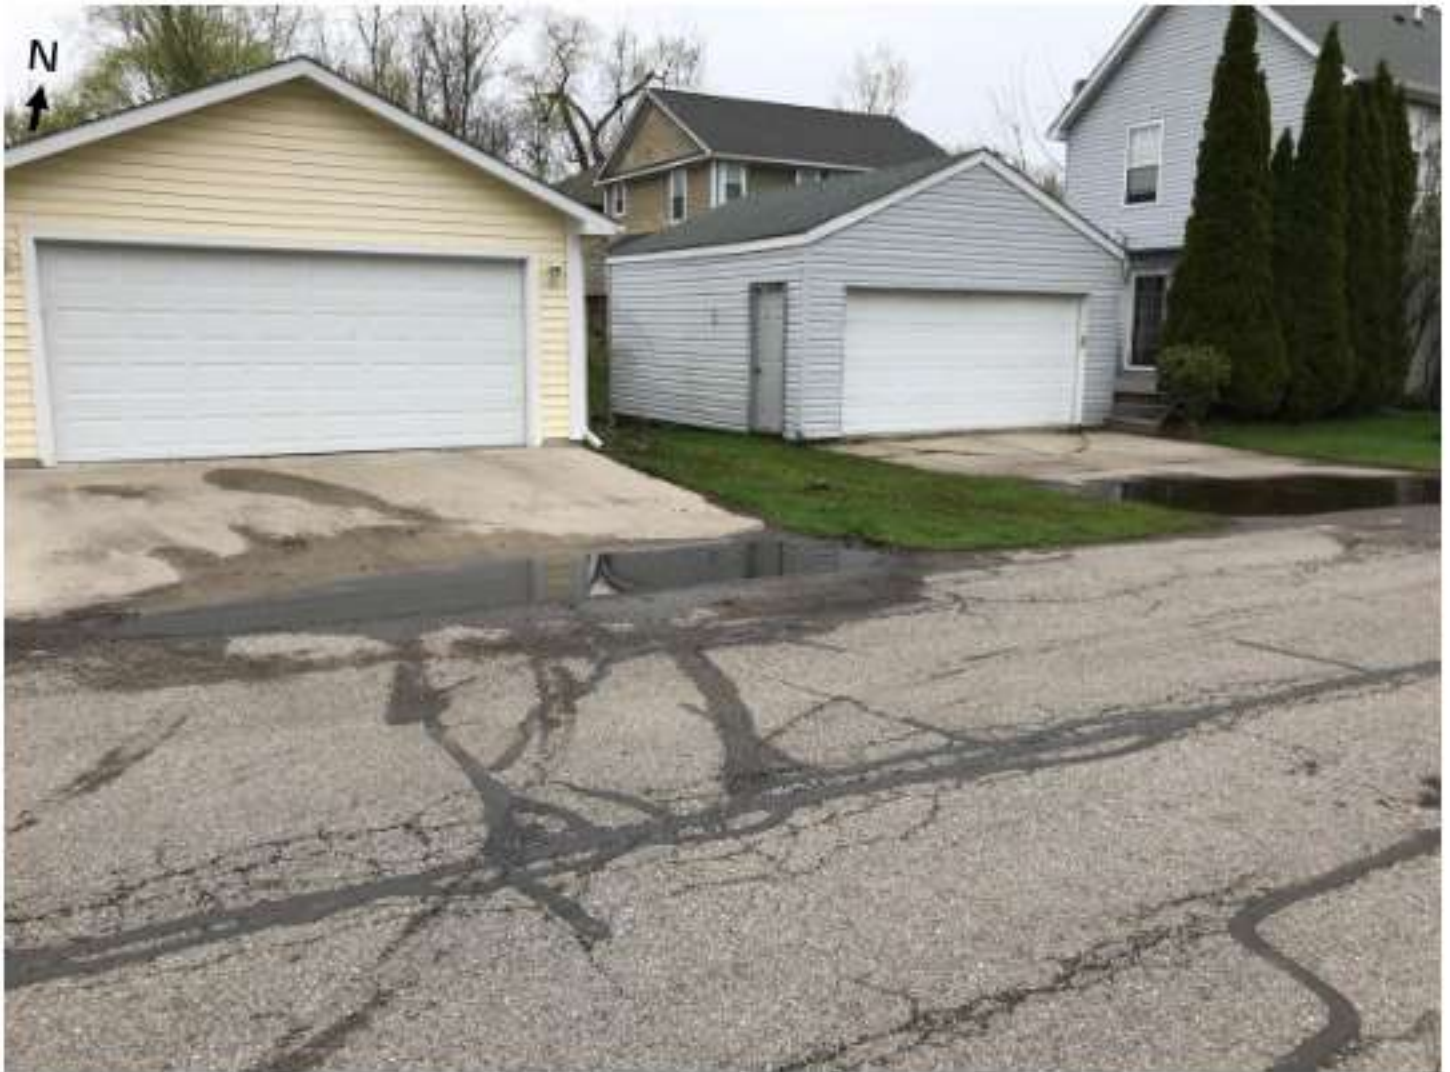
Image taken by HRC staff on May 3, 2019 of standing water at driveways of 2141 Willow Beach Street and 2140 Brock Street.

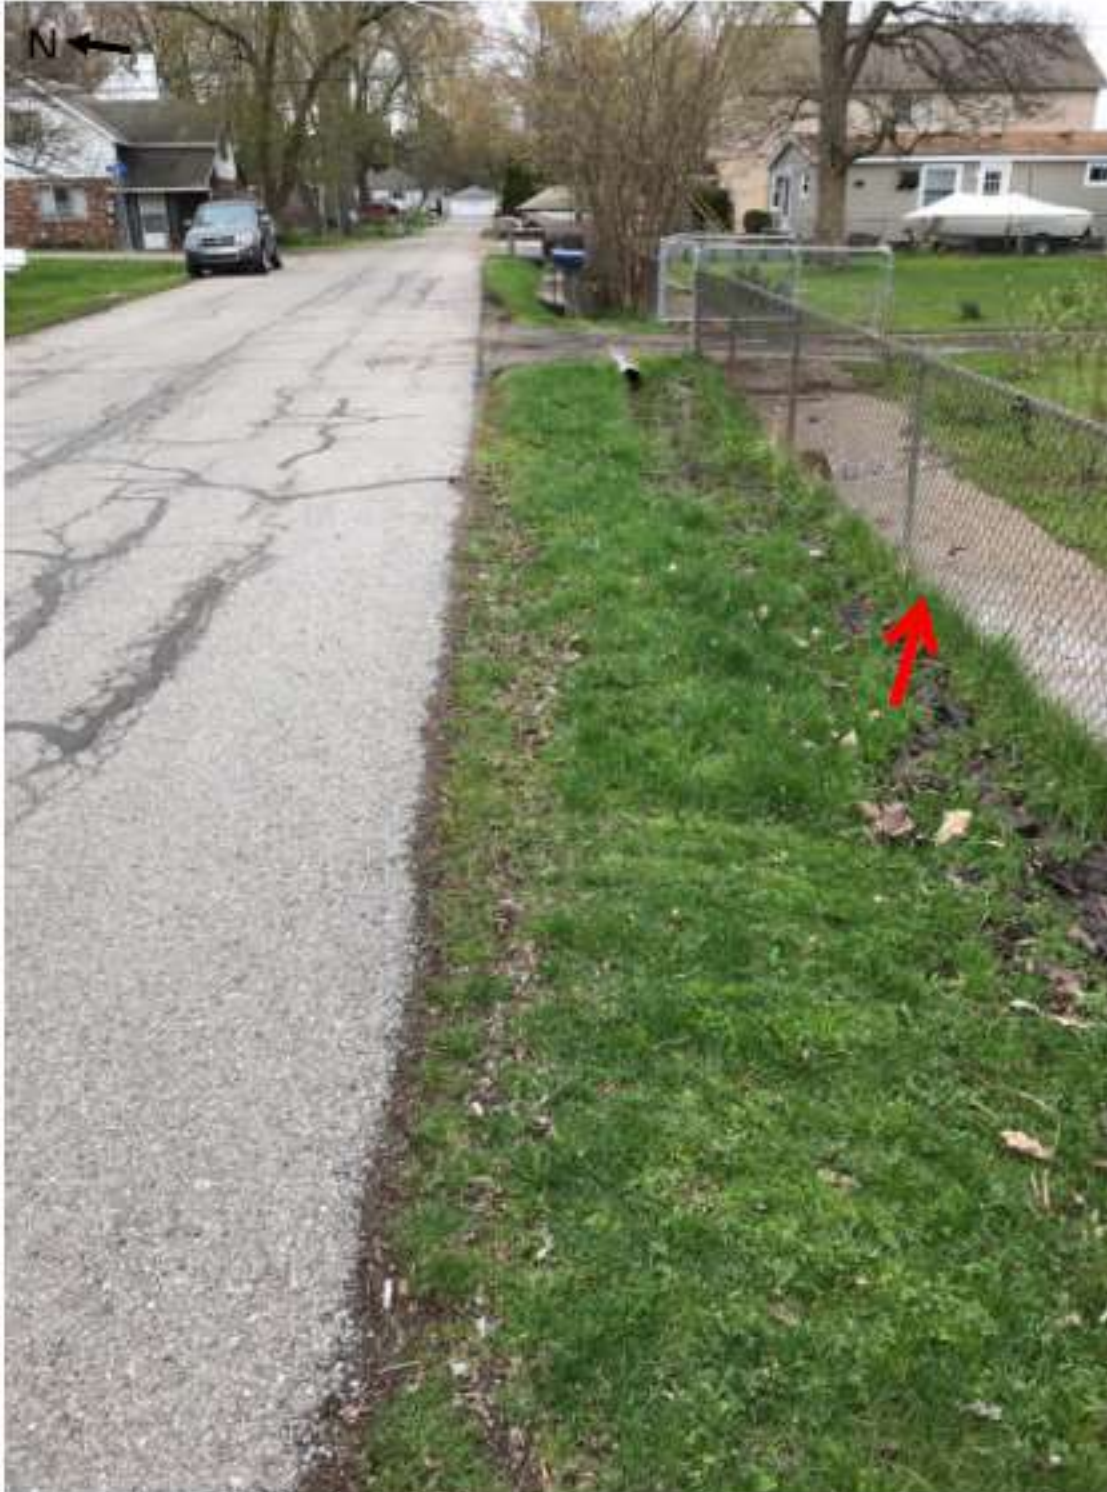
Image taken by HRC staff on May 3, 2019 of the heaved culvert at 3201 Kenrick and the location where the homeowner of 3201 Kenrick placed a sand berm to prevent roadway runoff from draining to their property.

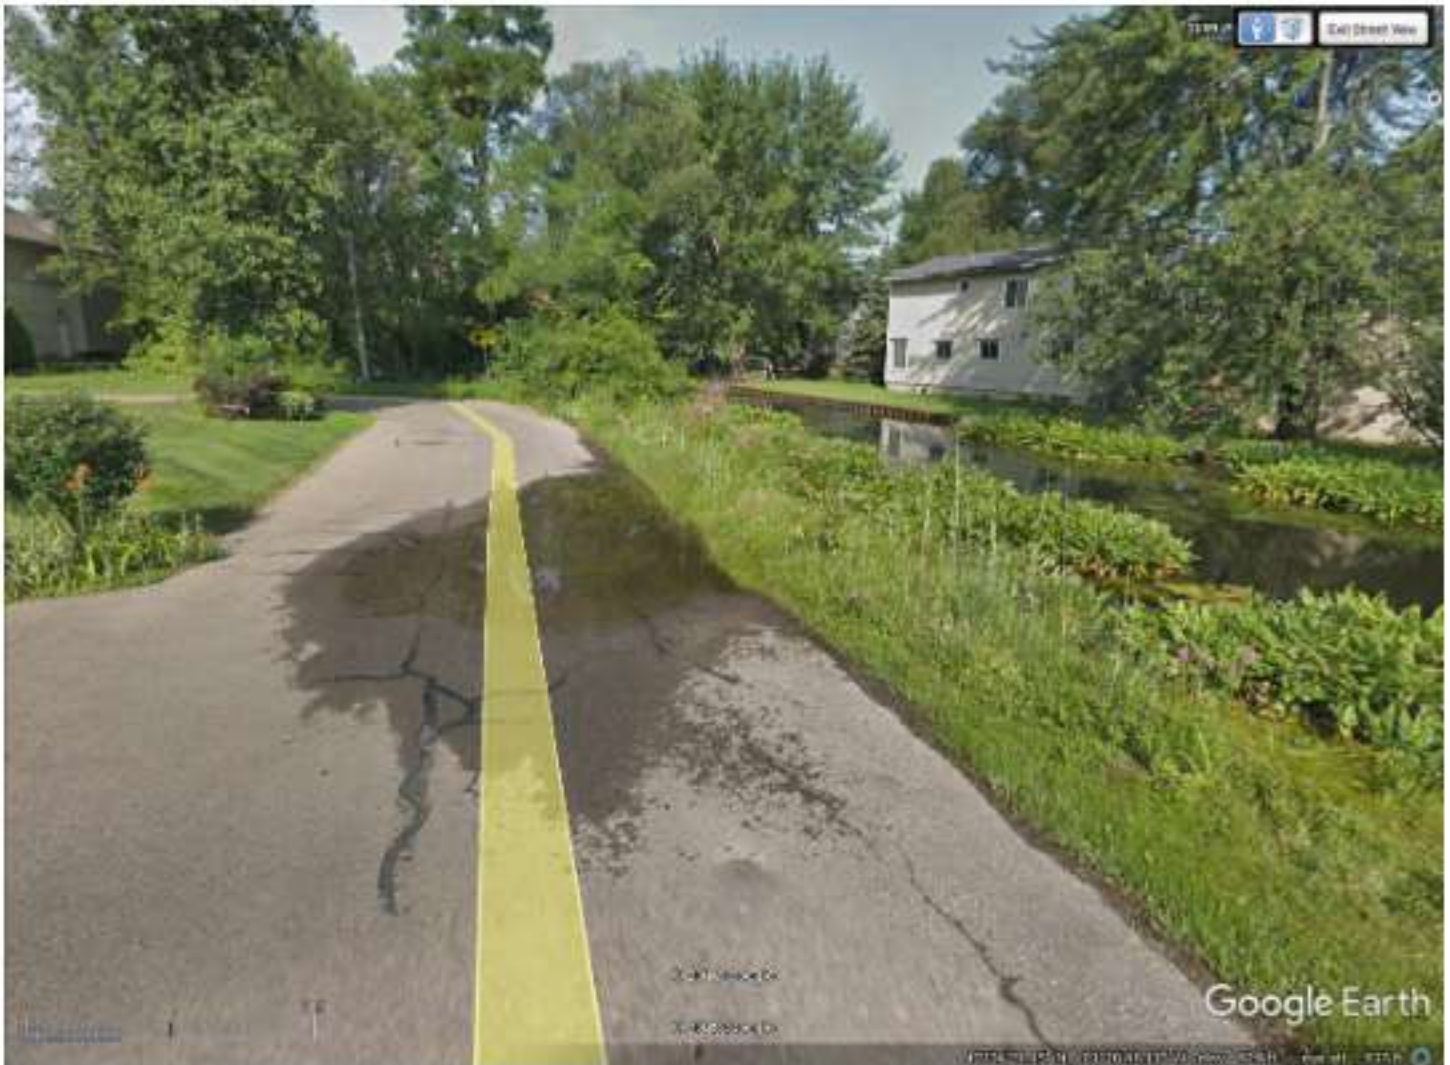
August 2018 Google street view image of low-lying area in front of 3119 Brock Street that experiences frequent water ponding.

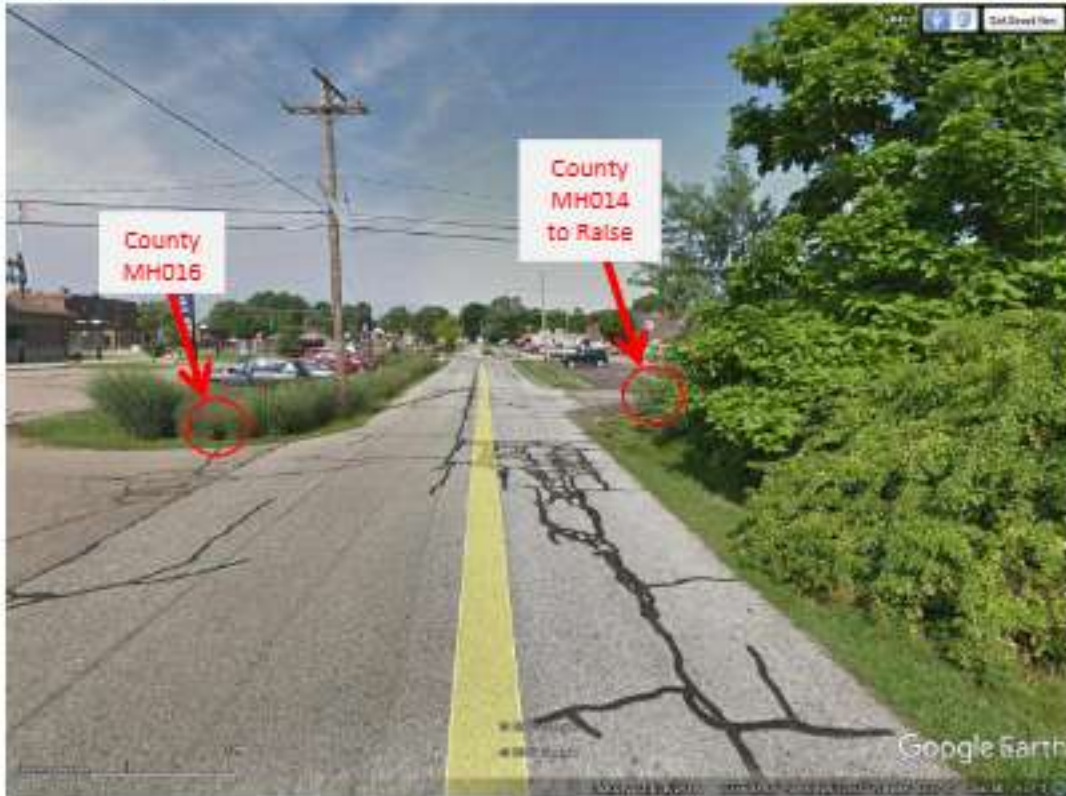
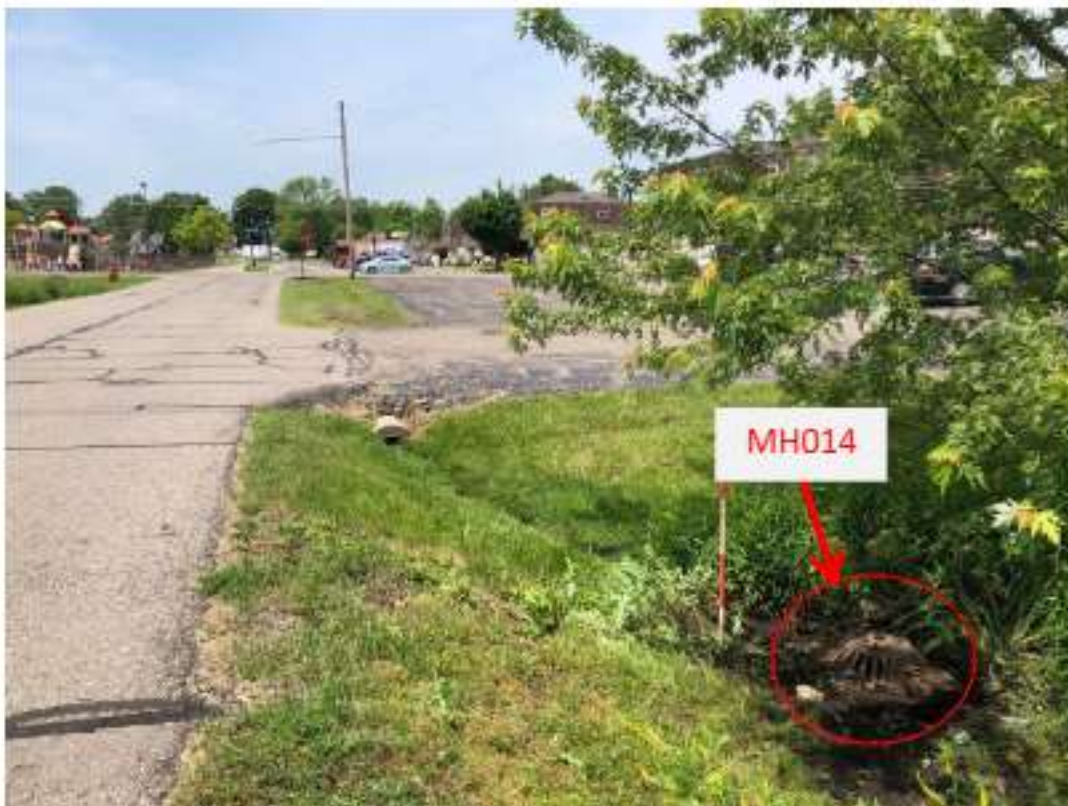
Google street view image taken in August 2018 of Schroeder Blvd., facing west and showing the location of the manhole recommended to repair.

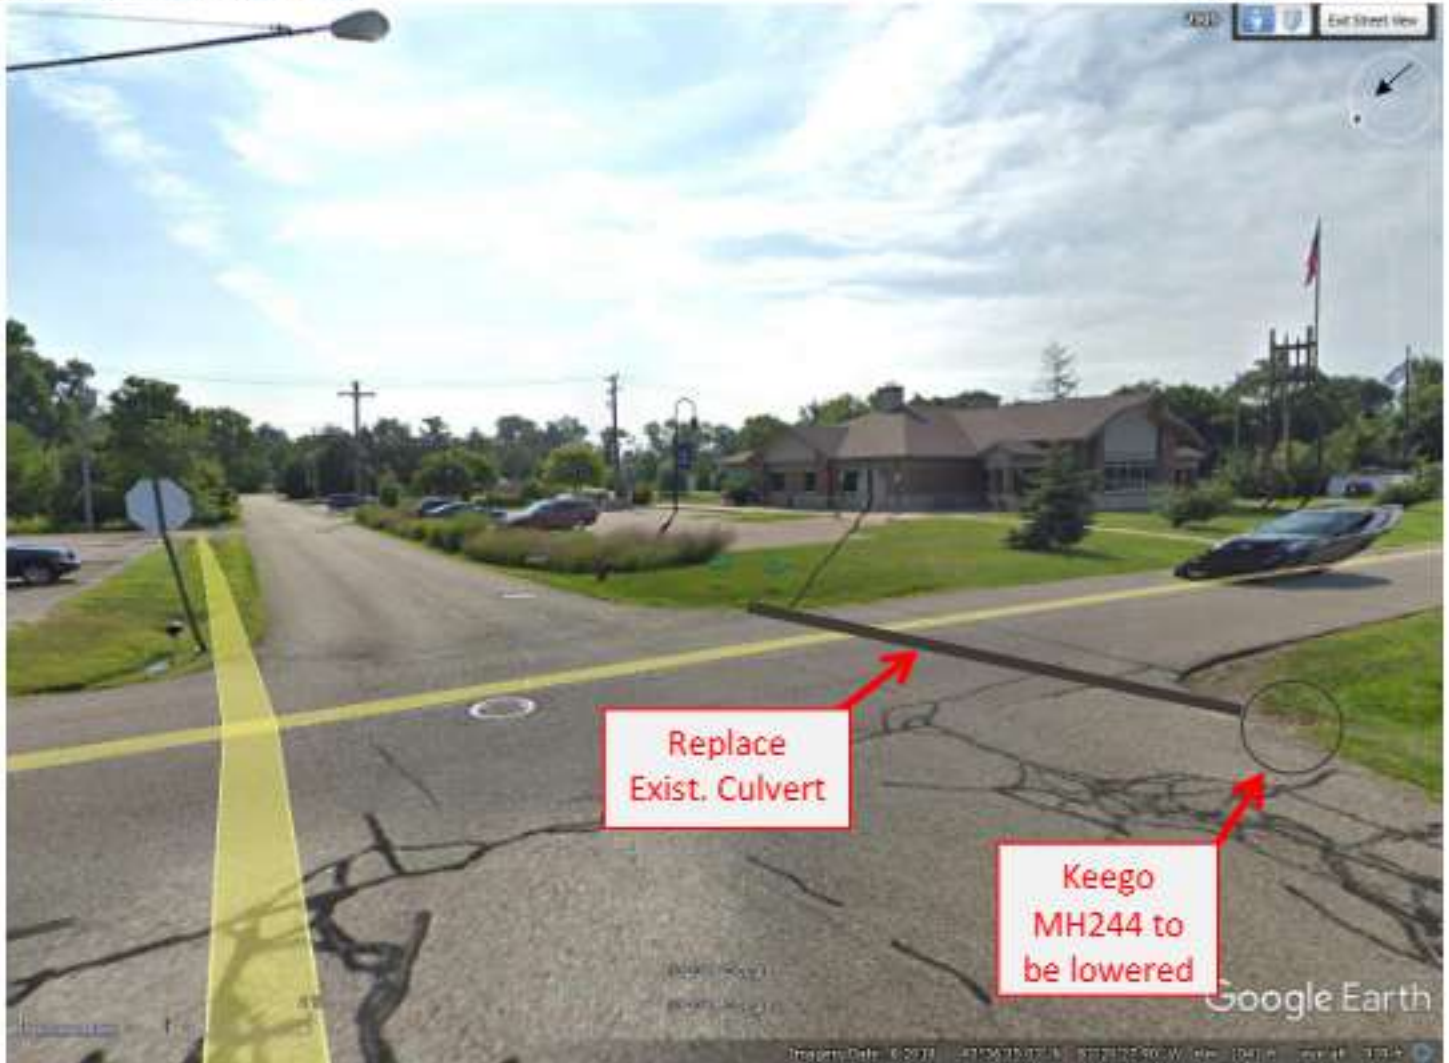
Google street view image taken in August 2018 of Schroeder Blvd., facing east and showing the location of the repair recommendations to existing manhole and culvert.

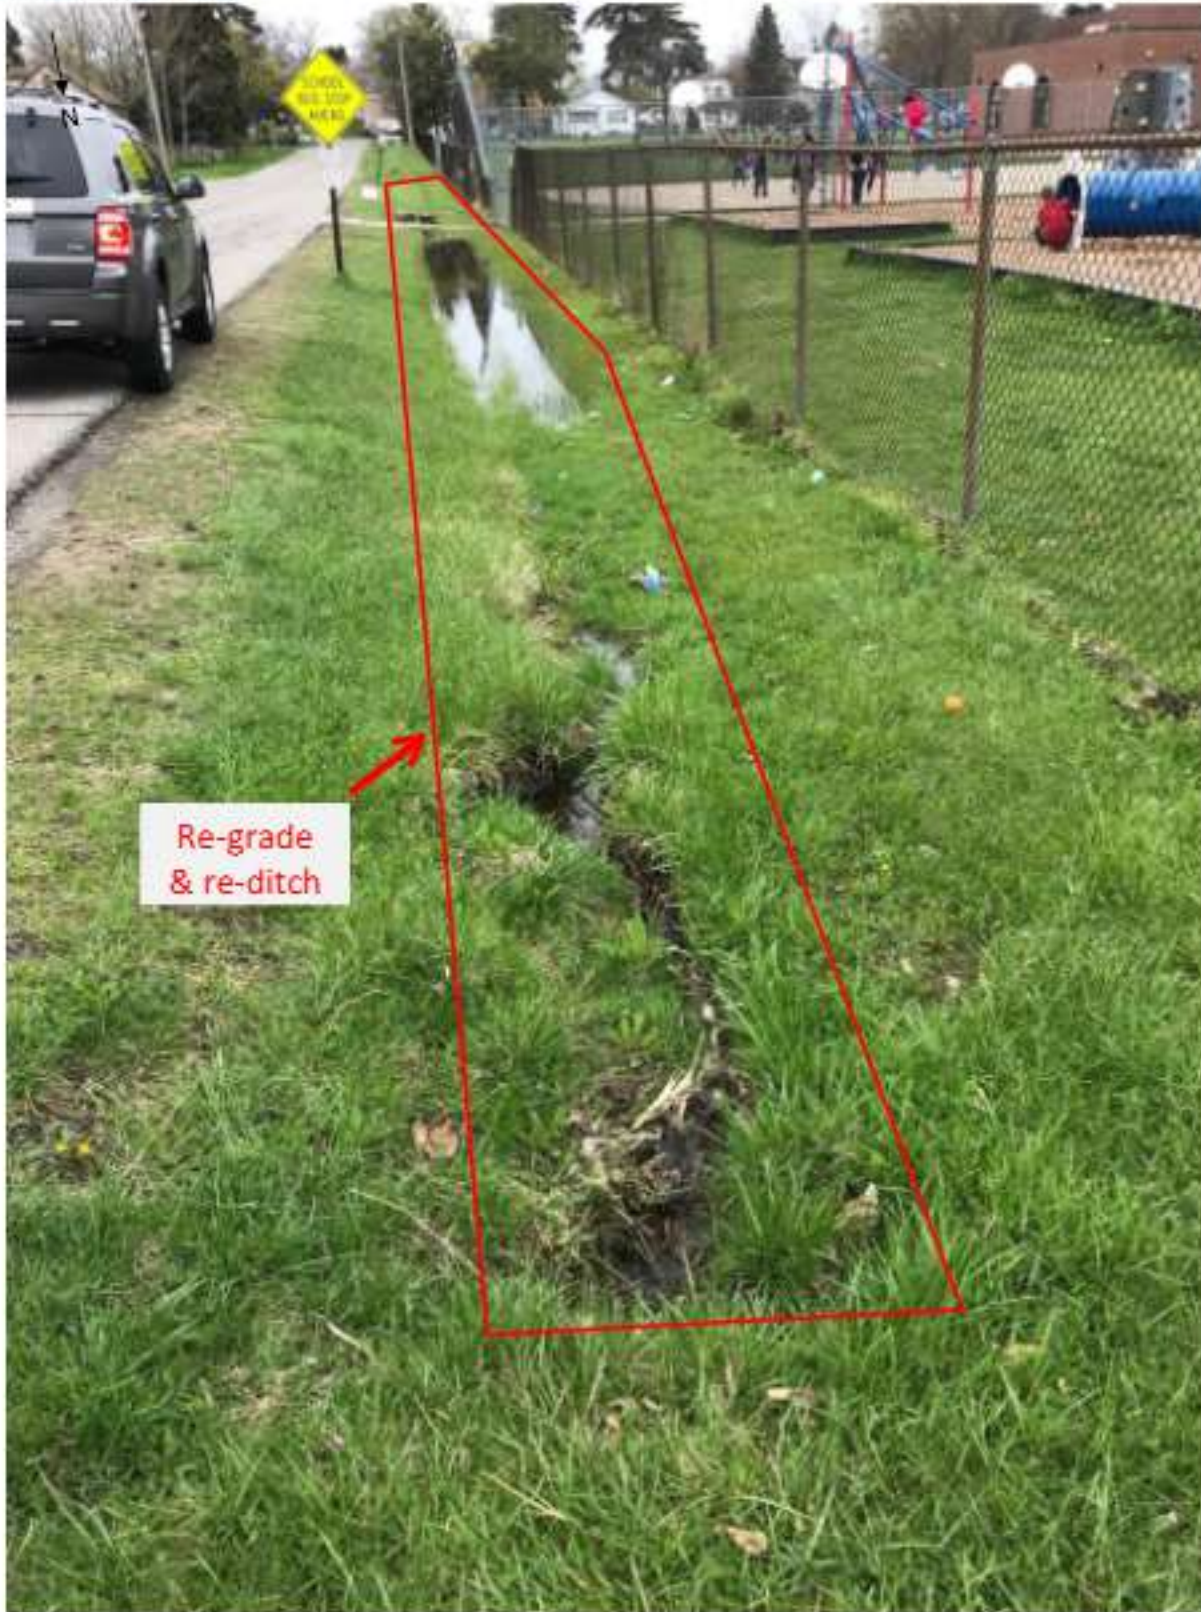
Photo taken by HRC staff on May 3, 2019 of the overgrown ditch along Beechmont Road, south of Schroeder.

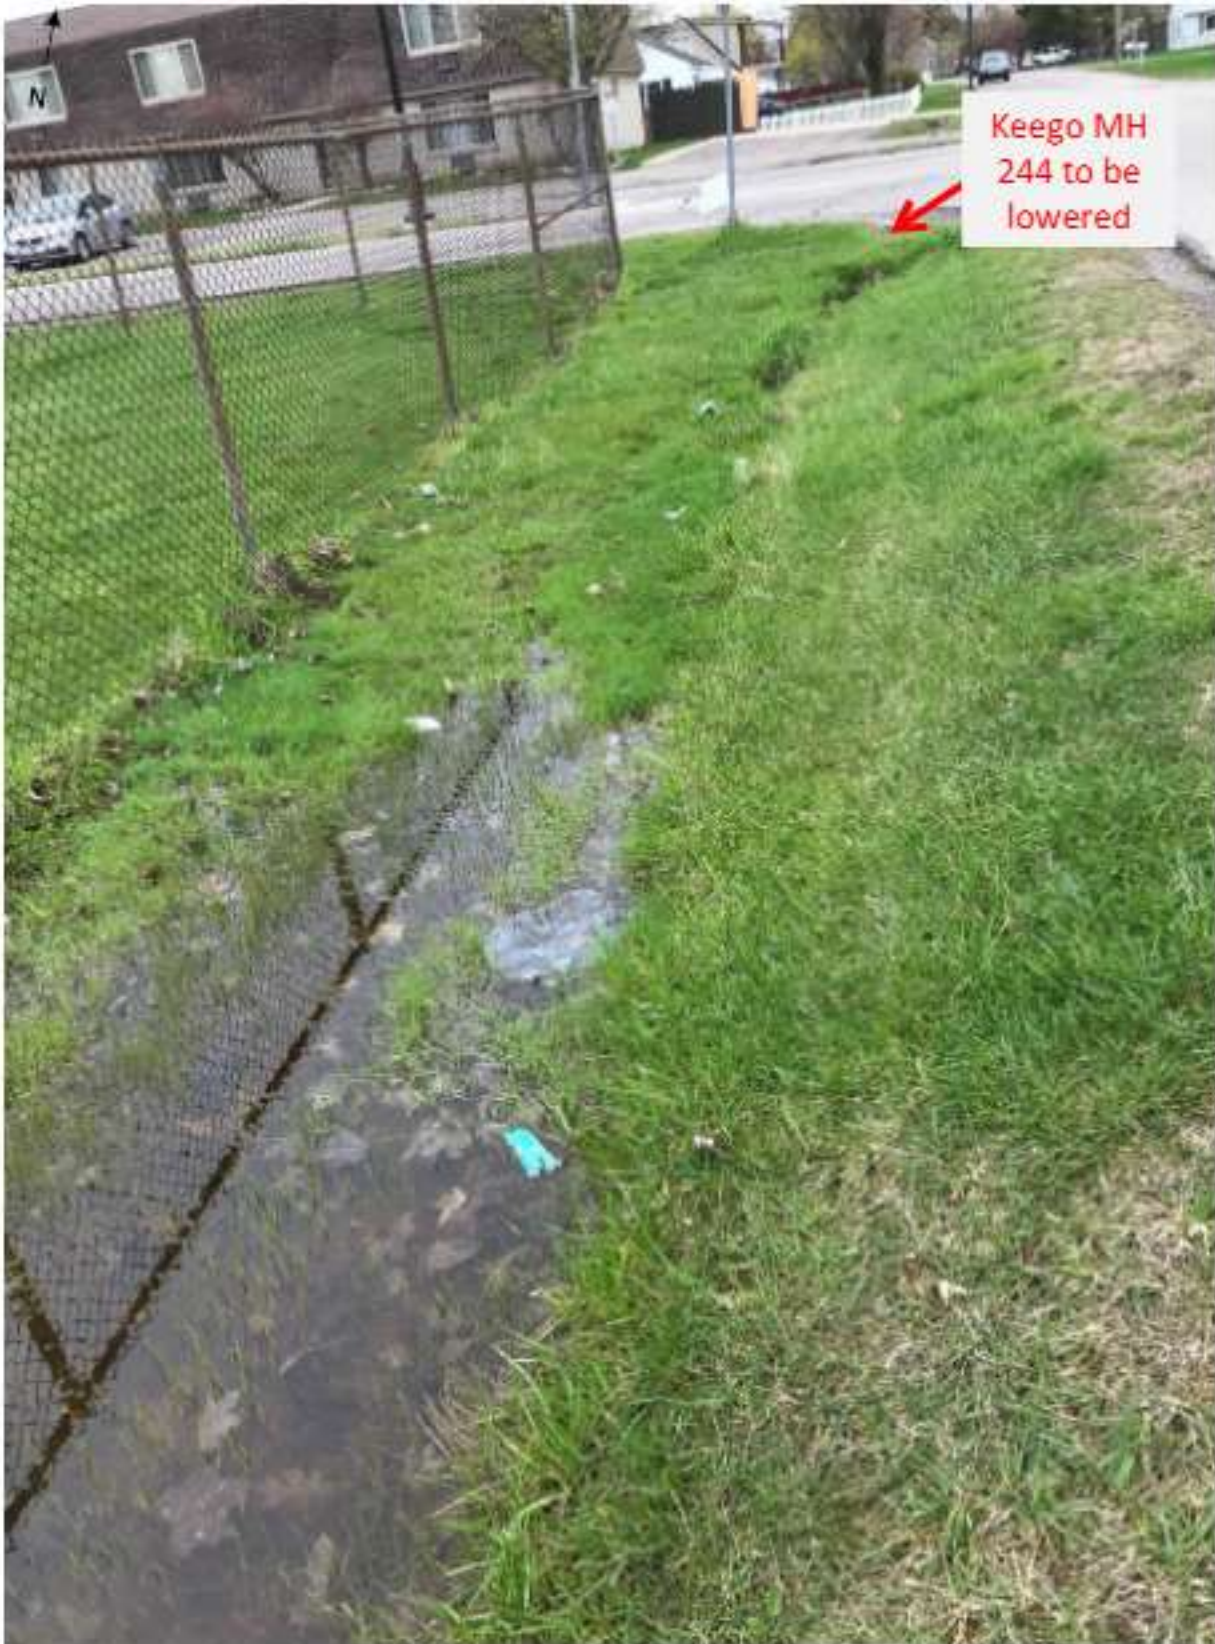
Photo taken by HRC staff on May 3, 2019 of stagnant water in the ditch along Beechmont, south of Schroeder, that's prevent flow from entering the manhole.

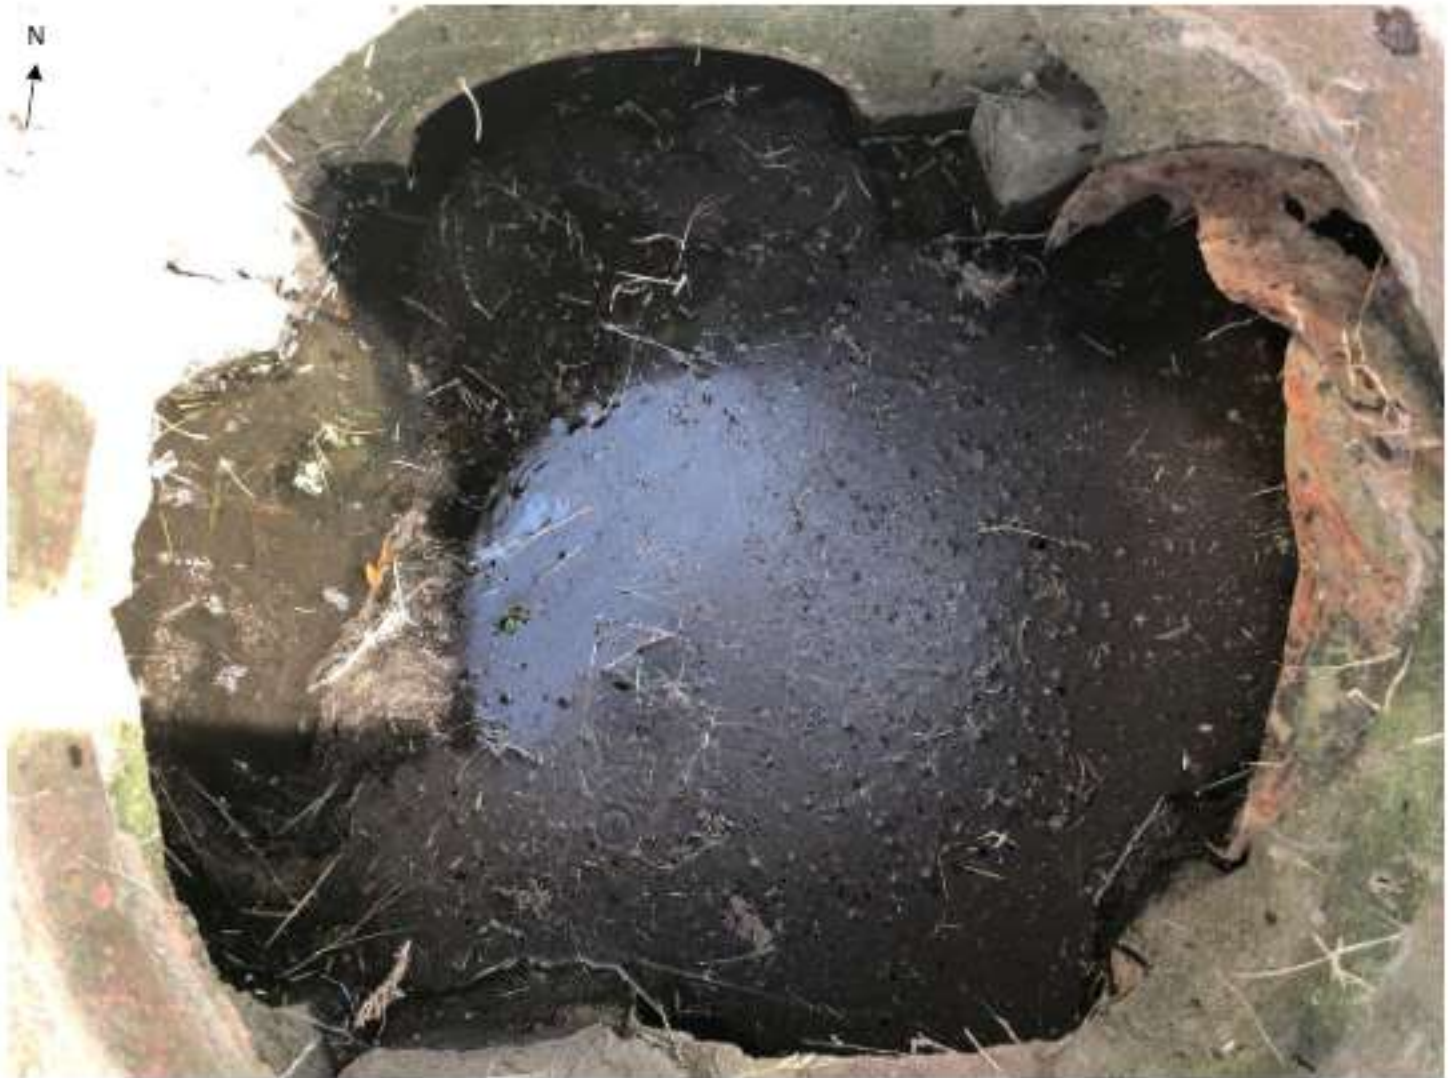
Photo taken by HRC staff on May 3, 2019 showing the inside of the manhole (MH244) at the corner of Beechmont and Schroeder.

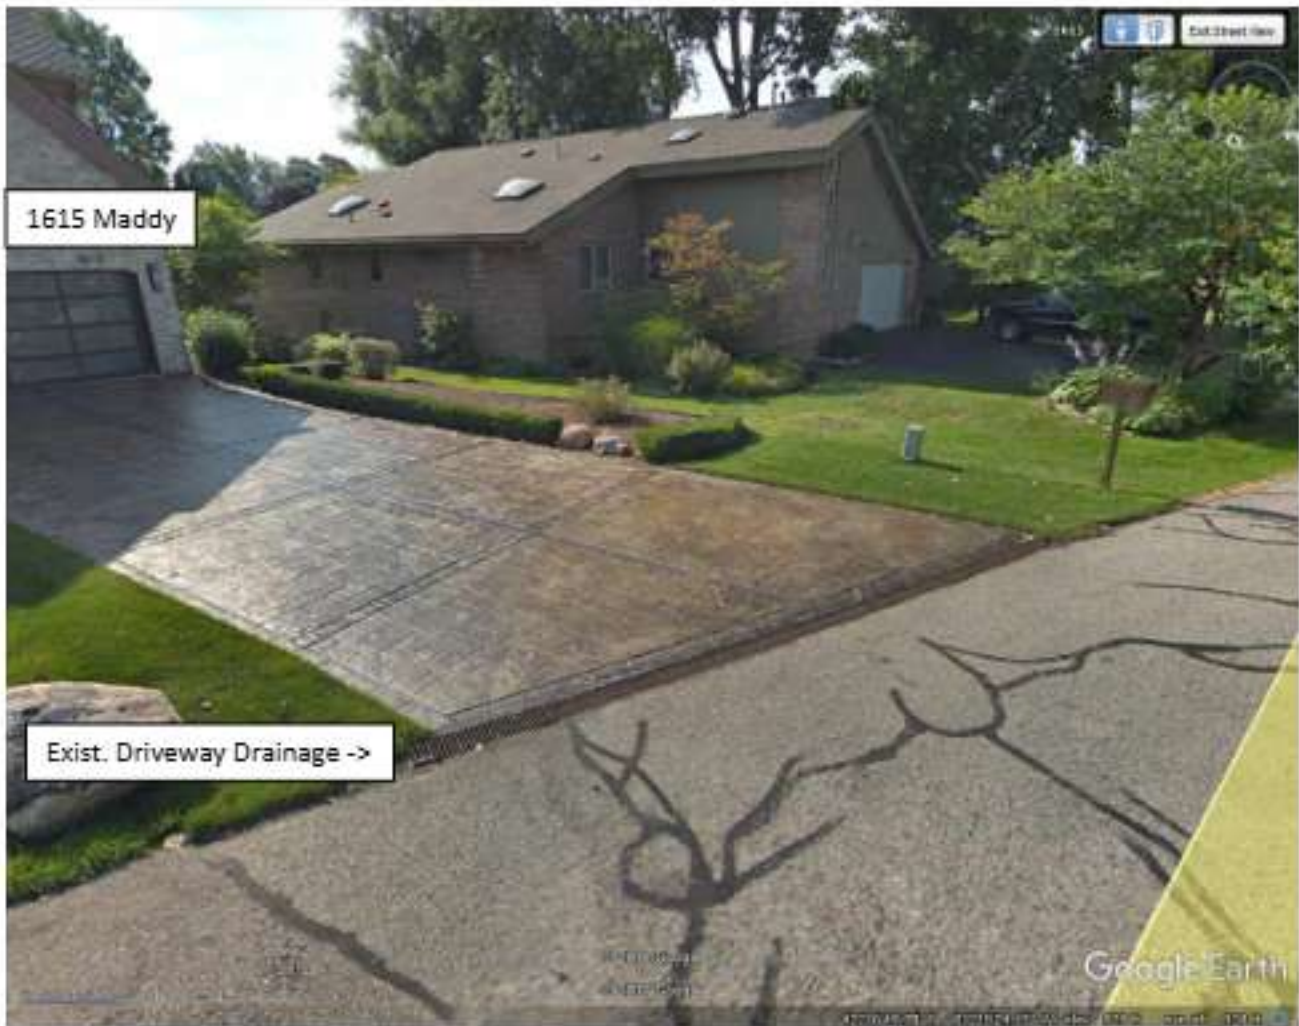
Google Earth Image from August 2018 of homeowner's house and driveway drainage.

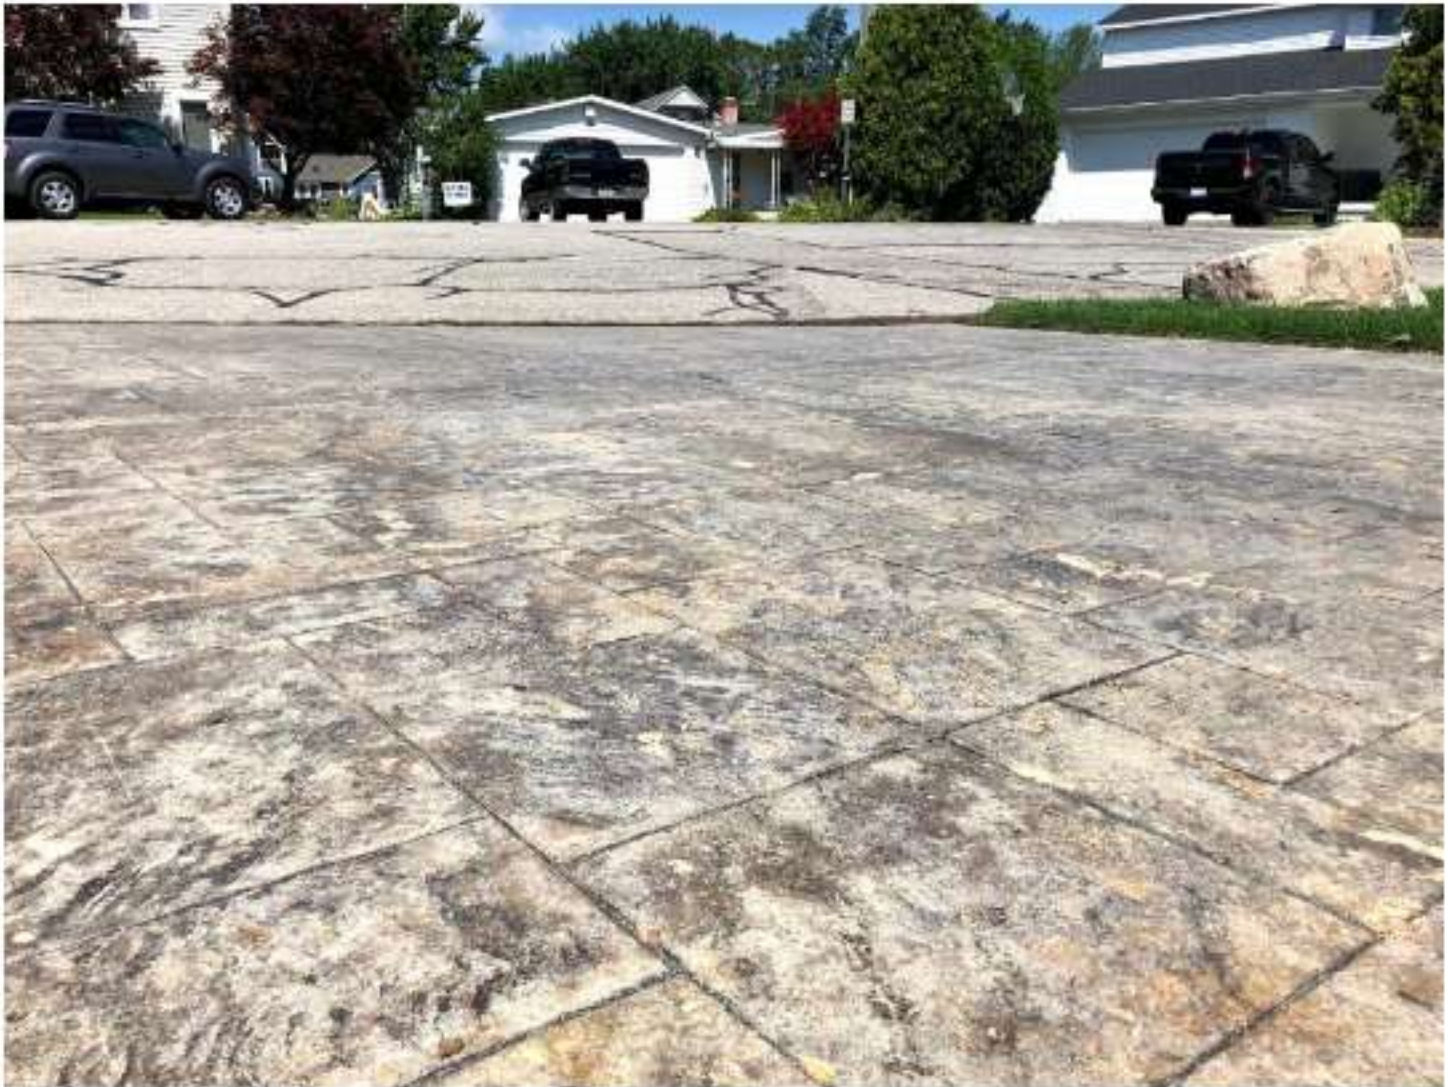
Elevation comparison of driveway compared to the road from July 30, 2019, taken by HRC staff.

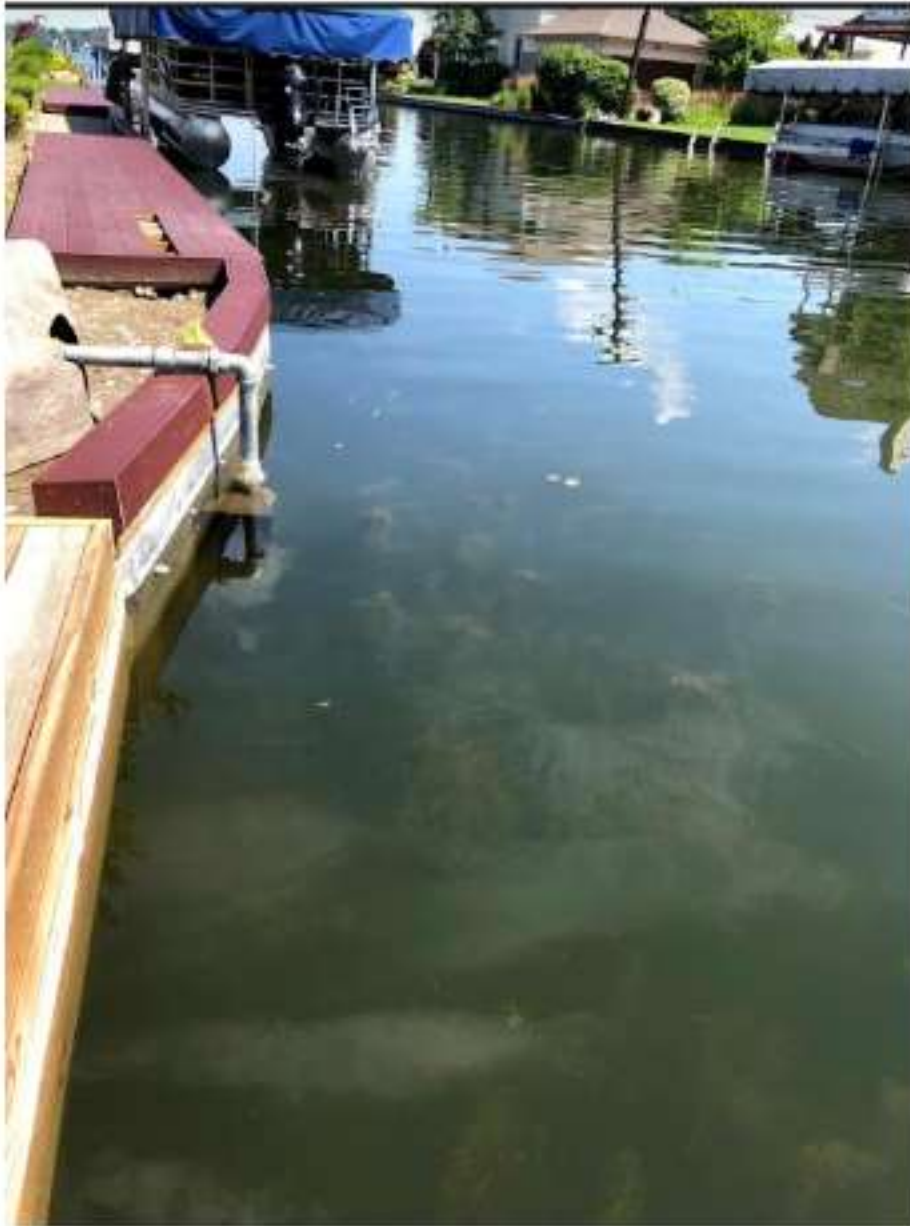
Sylvan Lake water-level at the seawall on July 30, 2019, taken by HRC staff.

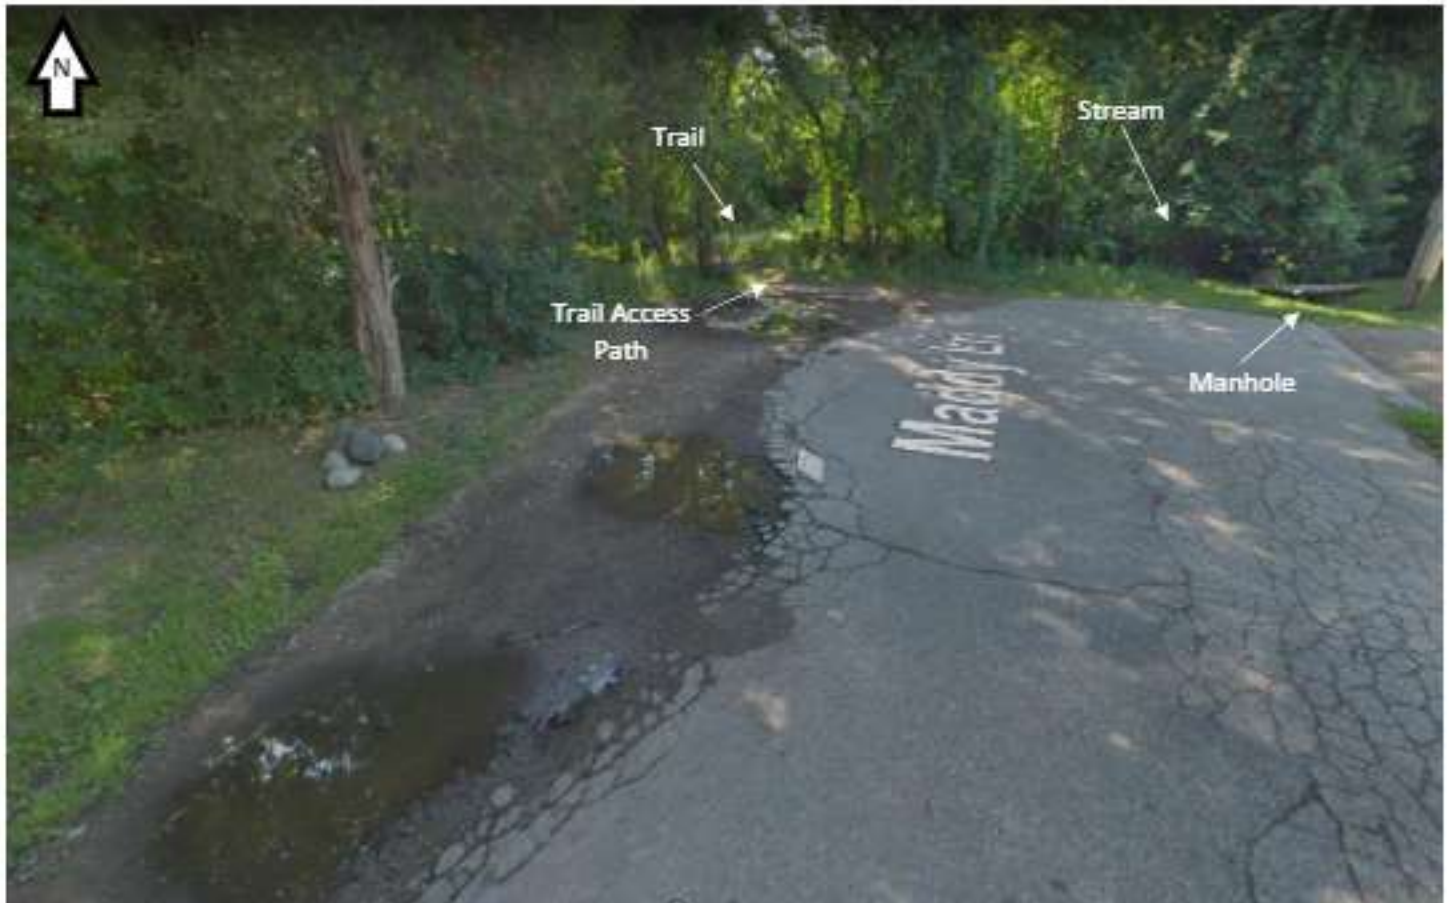
Google Street View of dead-end street where stormwater ponding occurs.
