**STORMWATER SYSTEM
ASSET MANAGEMENT PLAN**

**CITY OF KEEGO HARBOR
OAKLAND COUNTY, MICHIGAN**

DECEMBER 2019

HRC JOB NO. 20130735

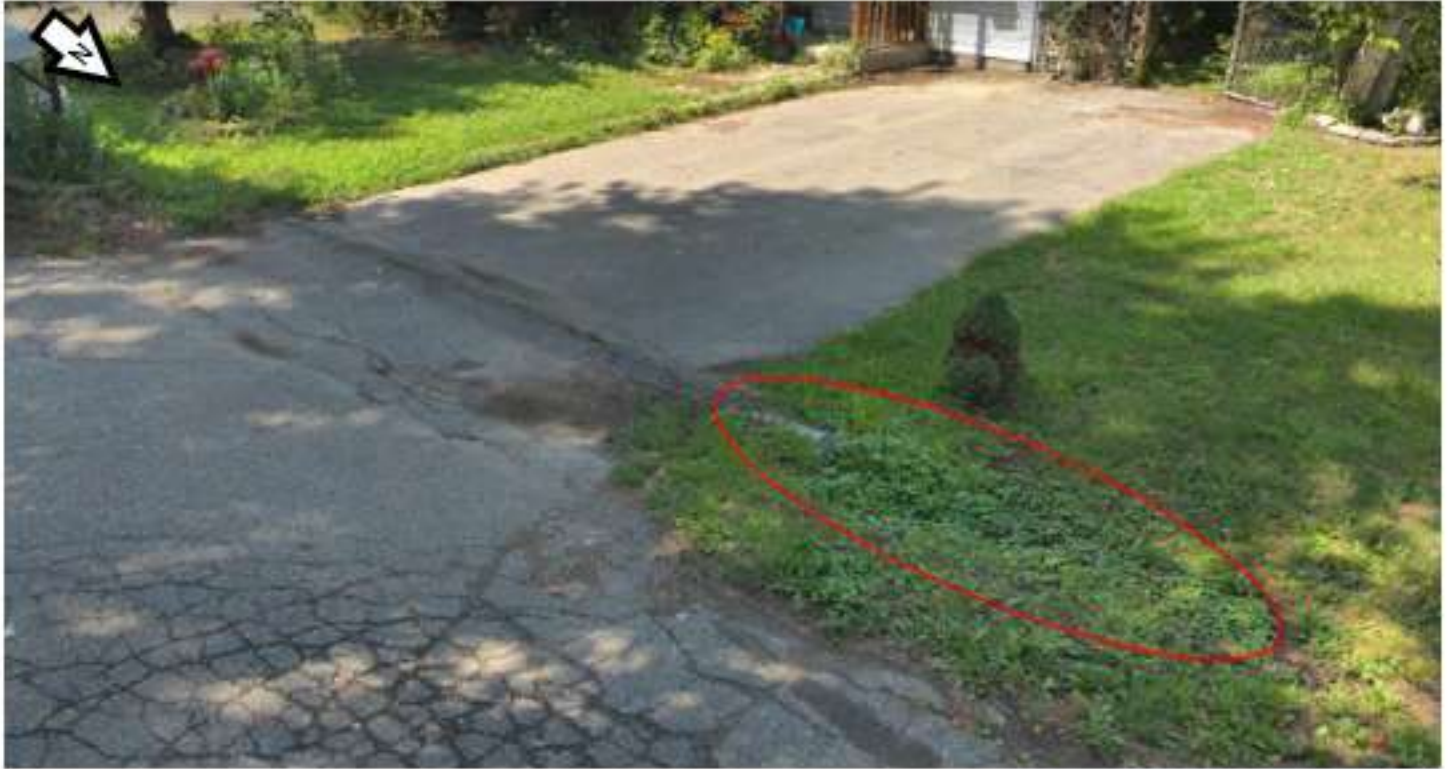
Buried culvert and ditches.

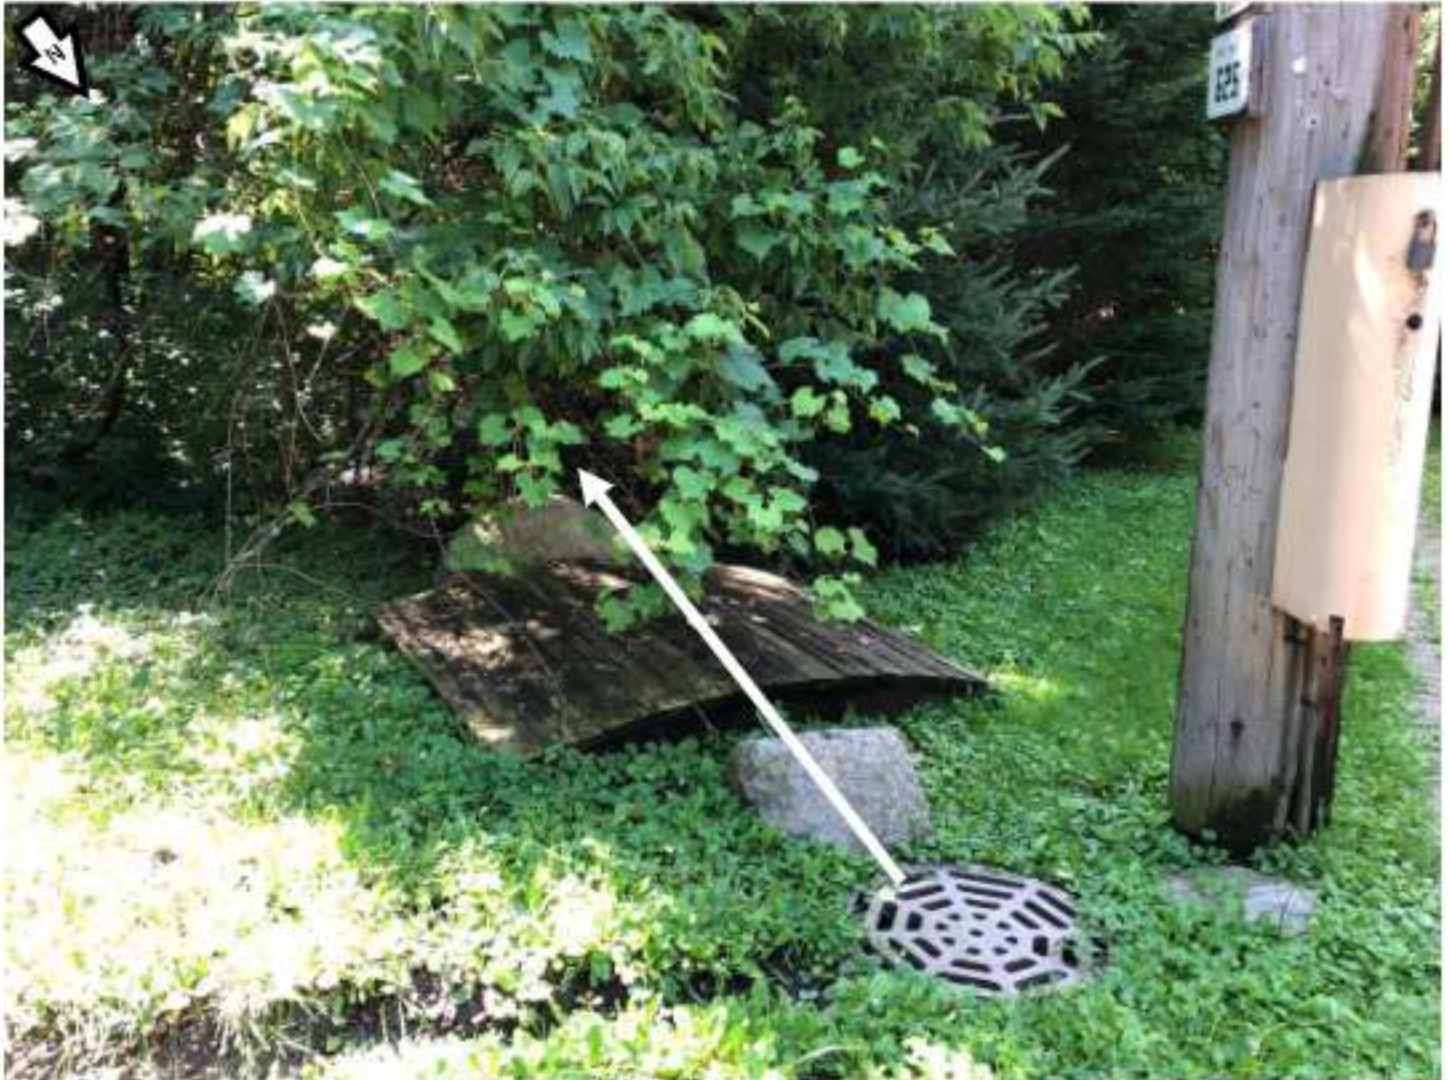
Location of the manhole at the end of Maddy Ln that discharges to the stream.

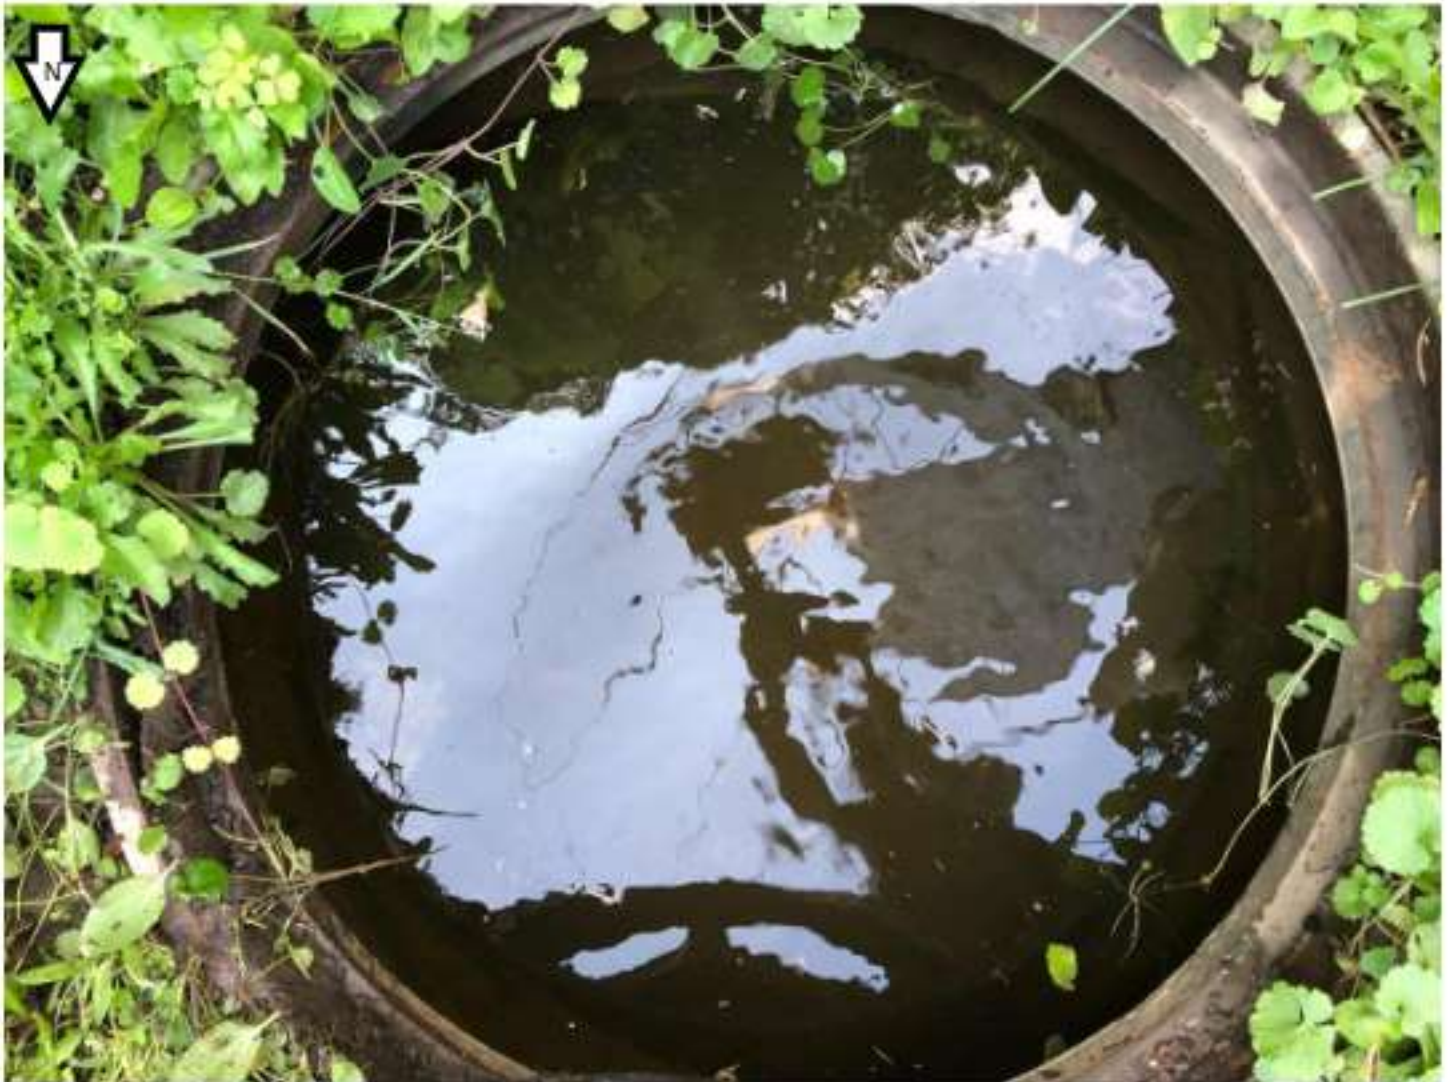
Inside image of the manhole at the end of Maddy Ln that is regularly filled with water as the outgoing pipe is below the water level in the stream.

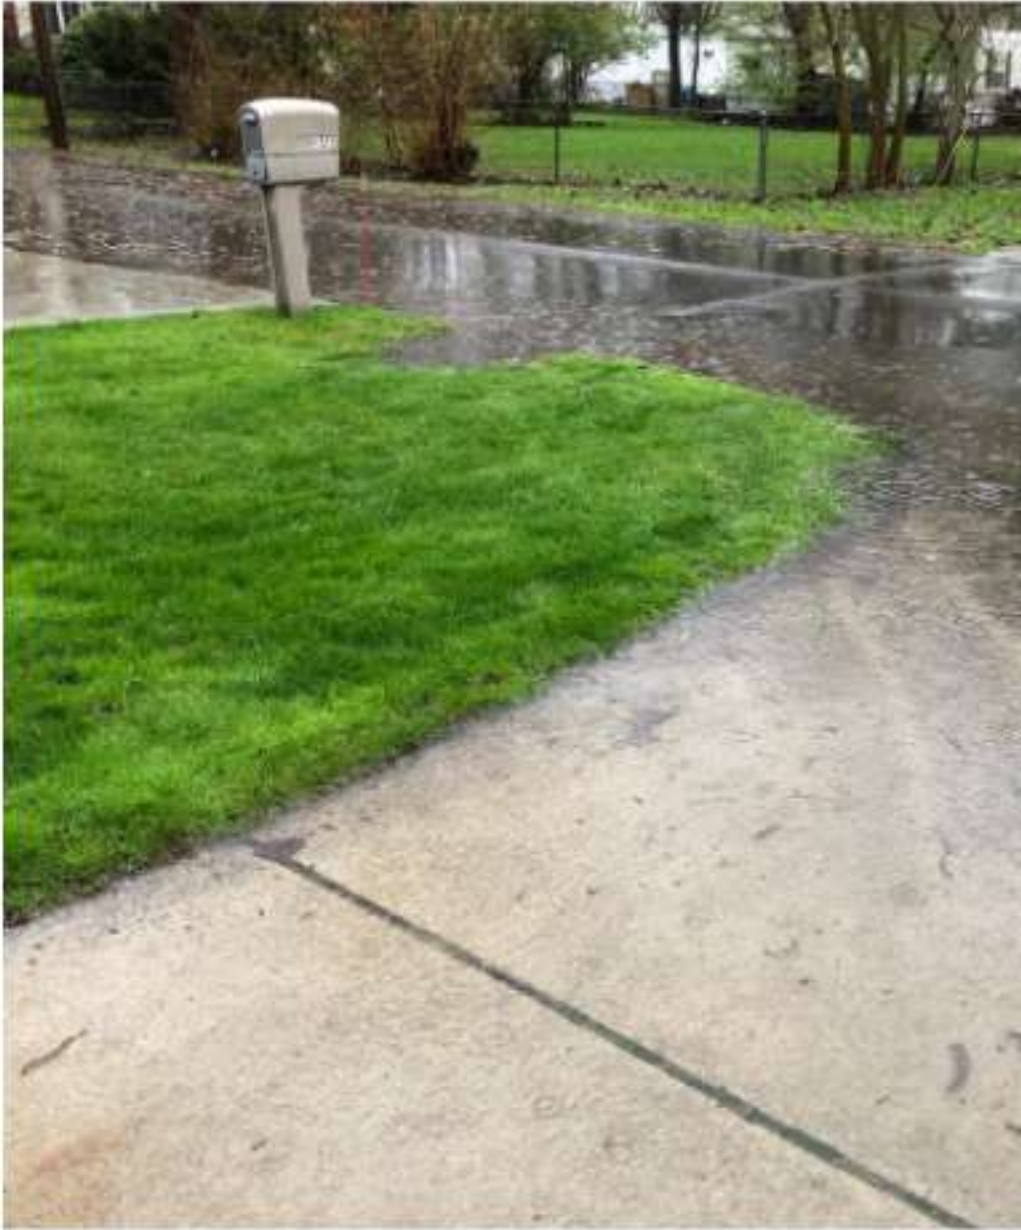
Photo from homeowner at 2229 Willow Beach St from May, 2019 of the flooded driveway and street.

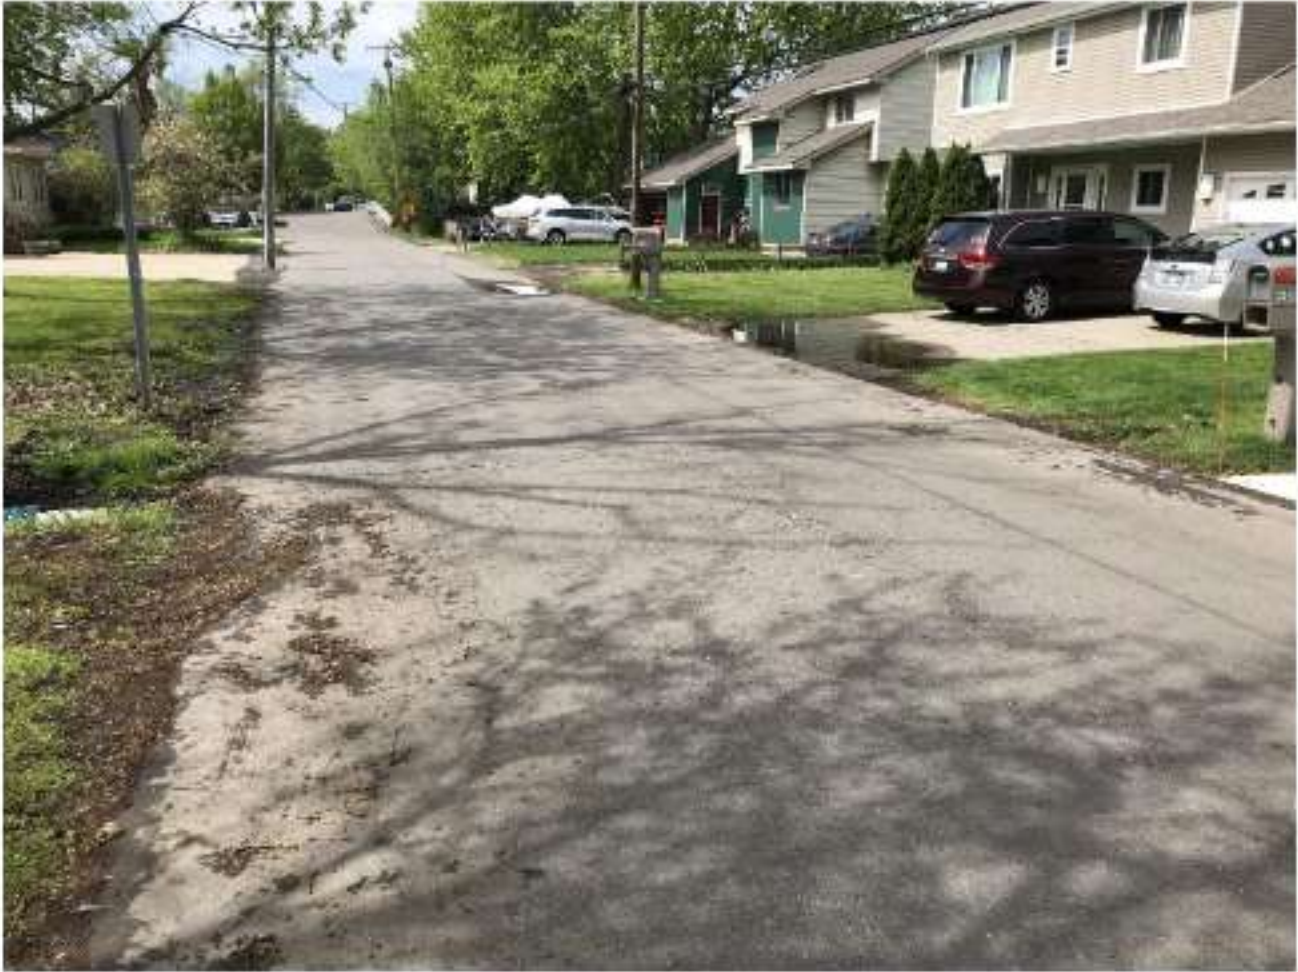
Taken by HRC staff on May 22, 2019 facing north showing Willow Beach with less flooding after rain event

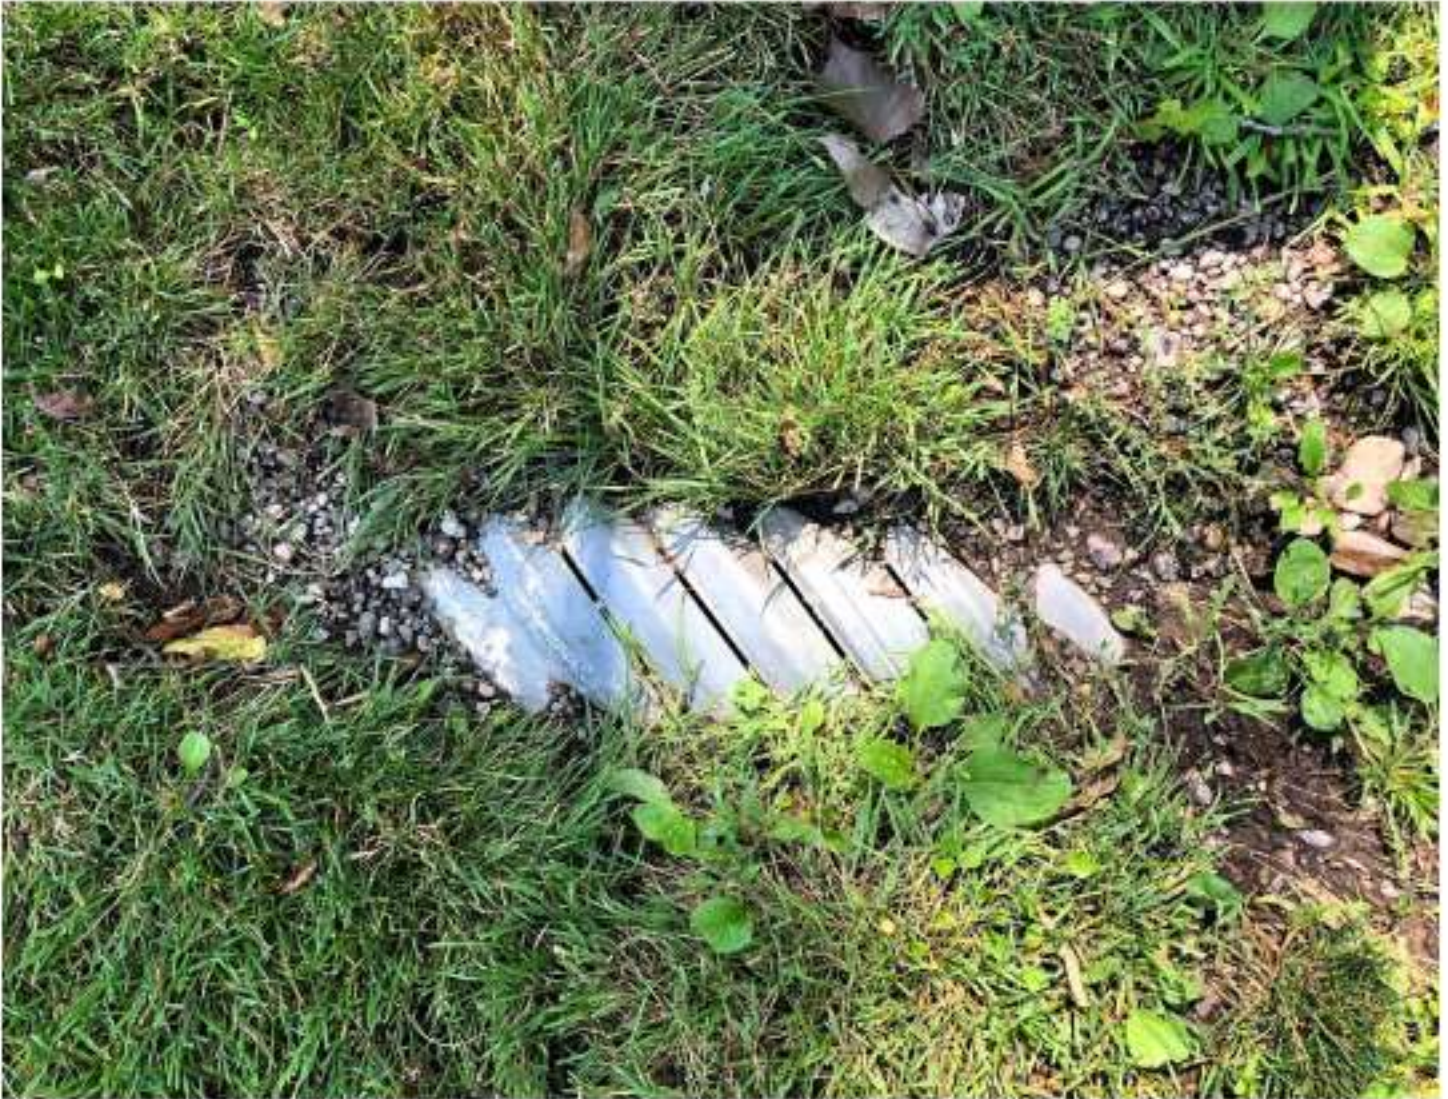
Photo taken by HRC staff the exposed drain and slit created to allow flow into the pipe from July 30, 2019. Location where field catch basin is recommended to be installed.

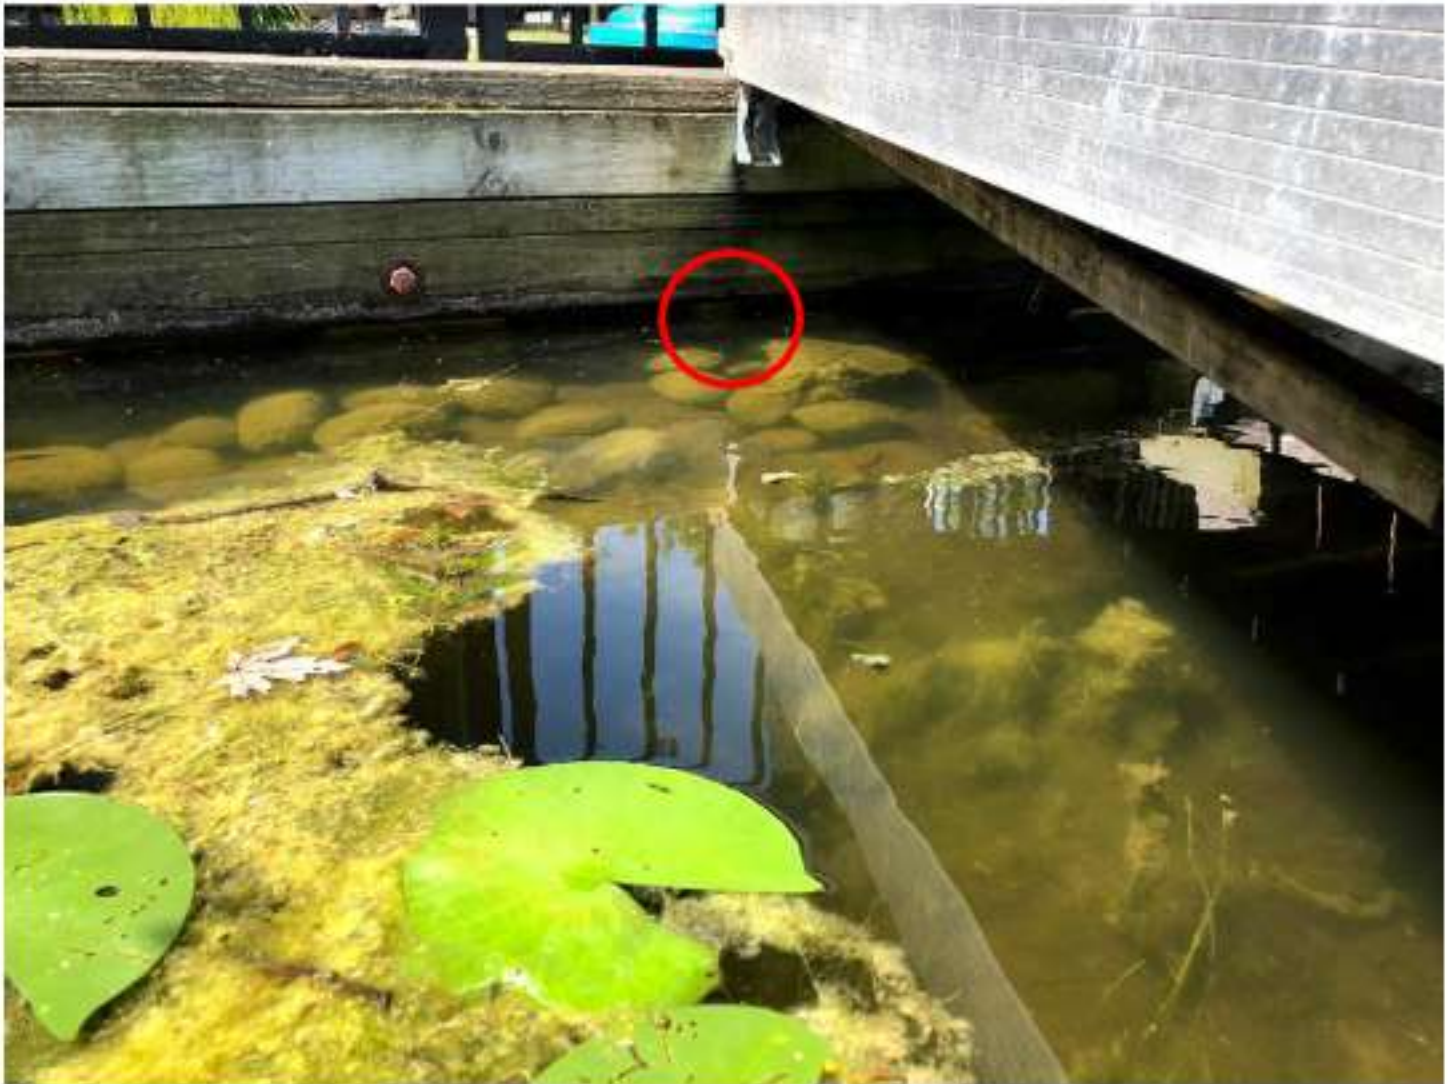
Photo taken by HRC staff of culvert outlet through the seawall into Sylvan Lake.
