STORMWATER SYSTEM ASSET MANAGEMENT PLAN

CITY OF KEEGO HARBOR OAKLAND COUNTY, MICHIGAN

EGLE SAW GRANT #1220-01

DECEMBER 2019

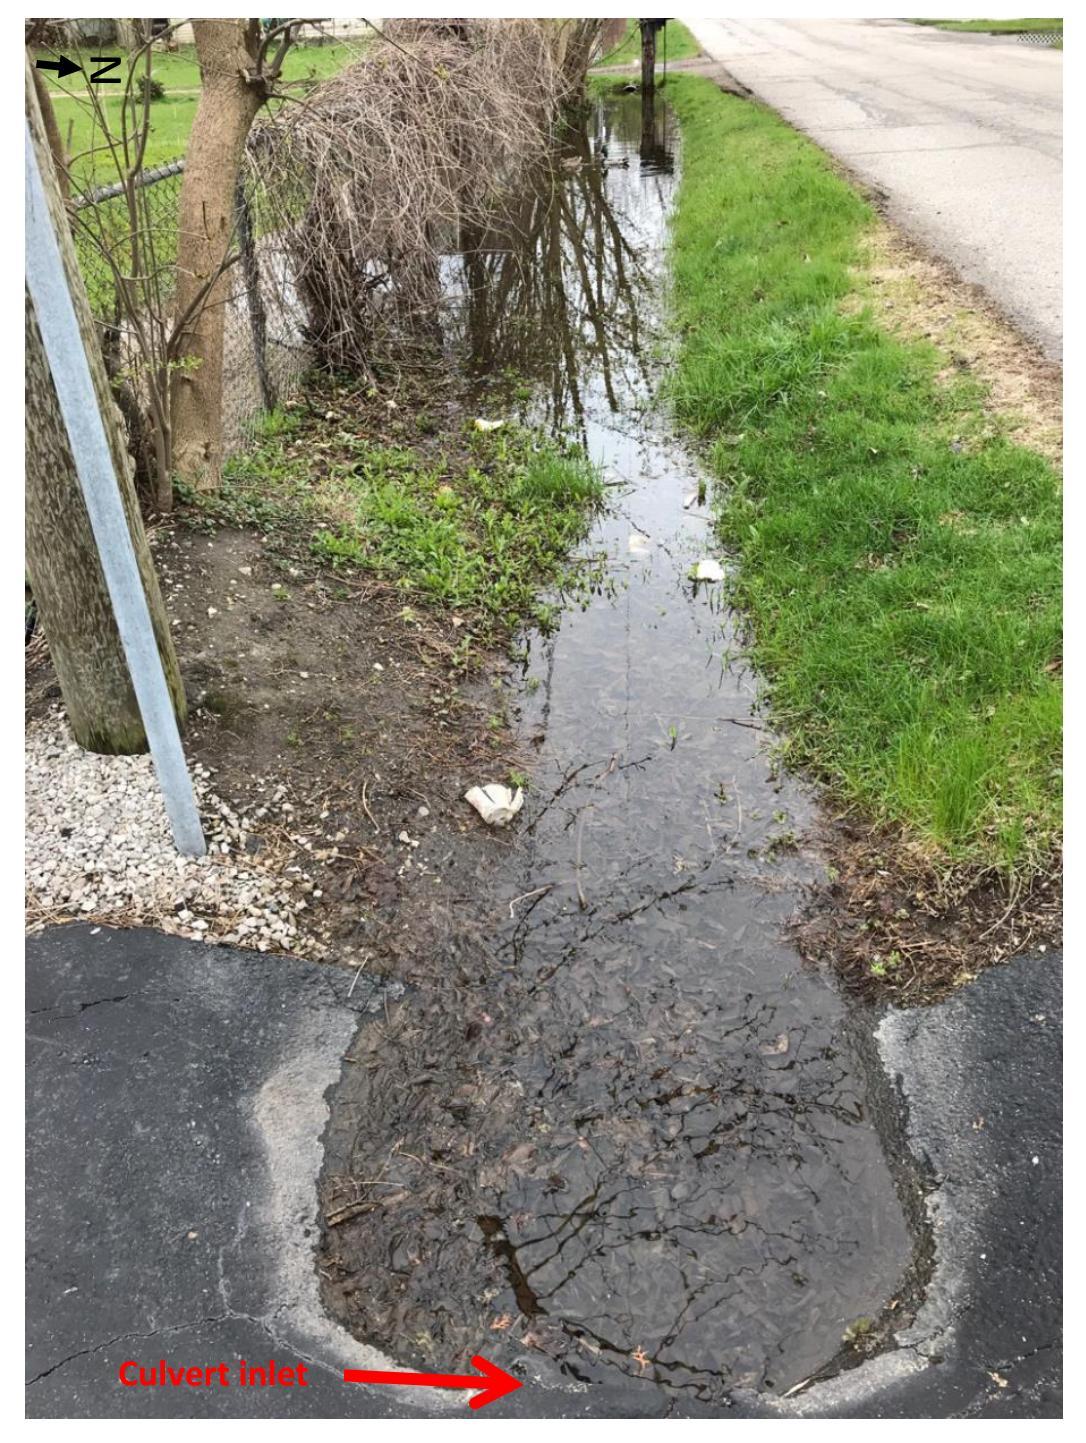
Photo taken by HRC staff on May 3, 2019 of clogged culvert inlet and stagnate water at 3185 Kenrick Street.

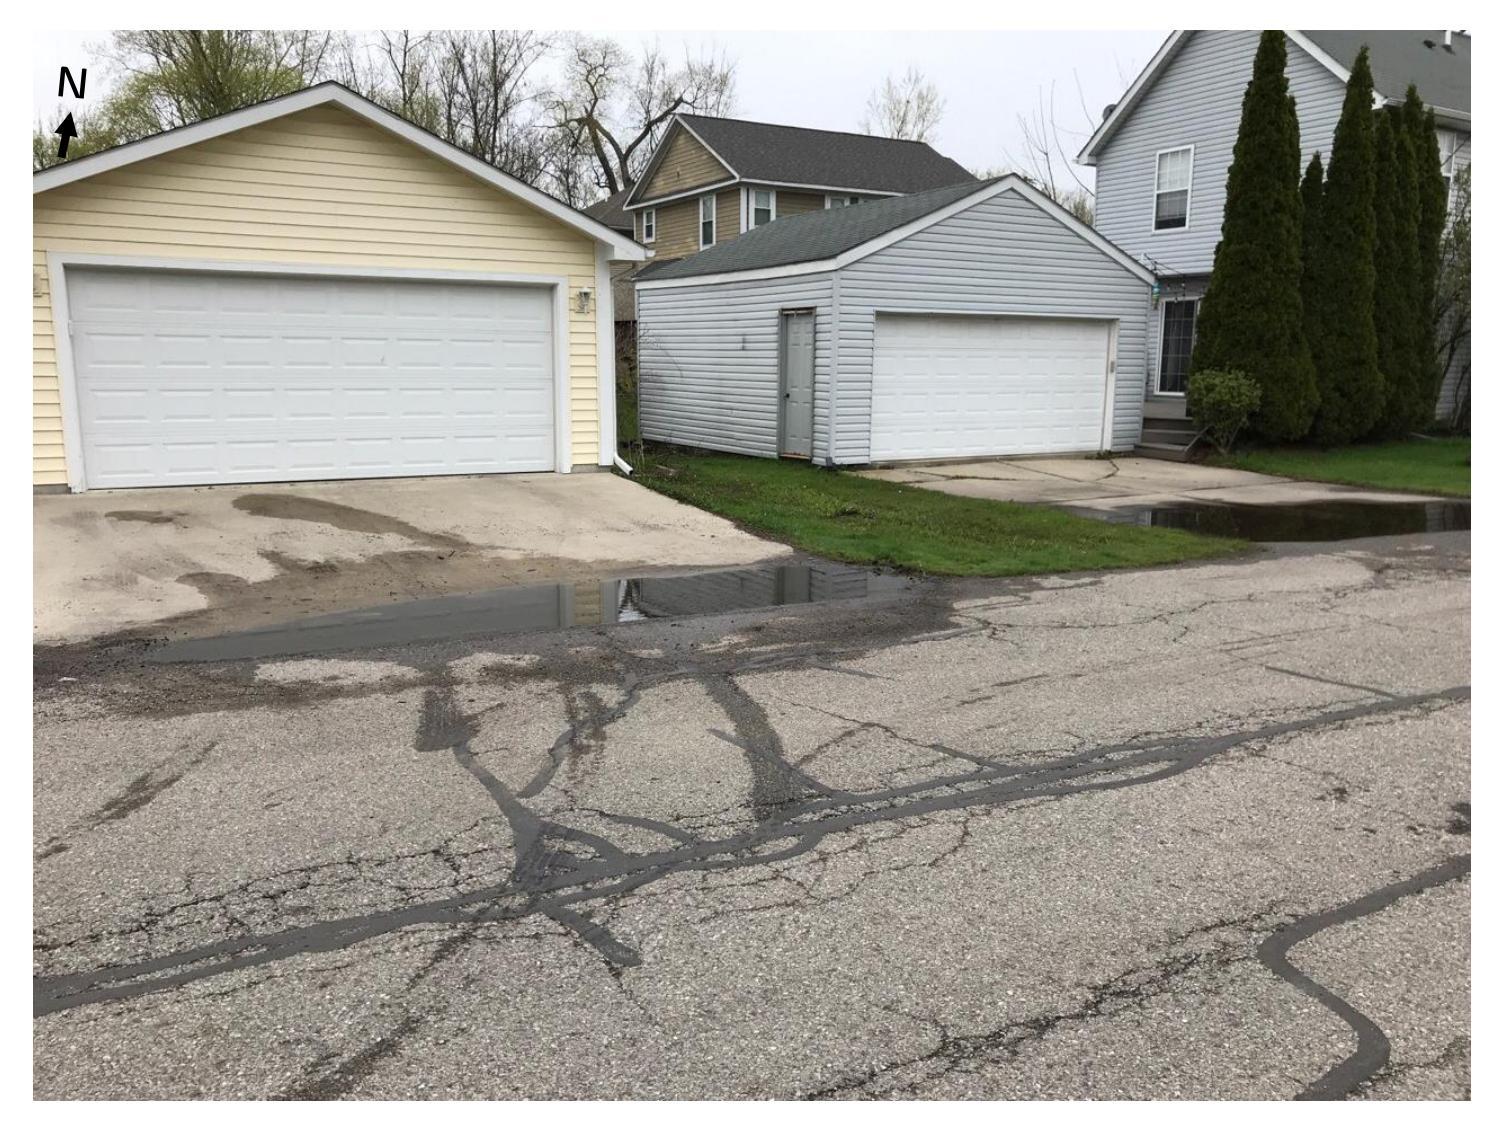
Image taken by HRC staff on May 3, 2019 of standing water at driveways of 2141 Willow Beach Street and 2140 Brock Street.

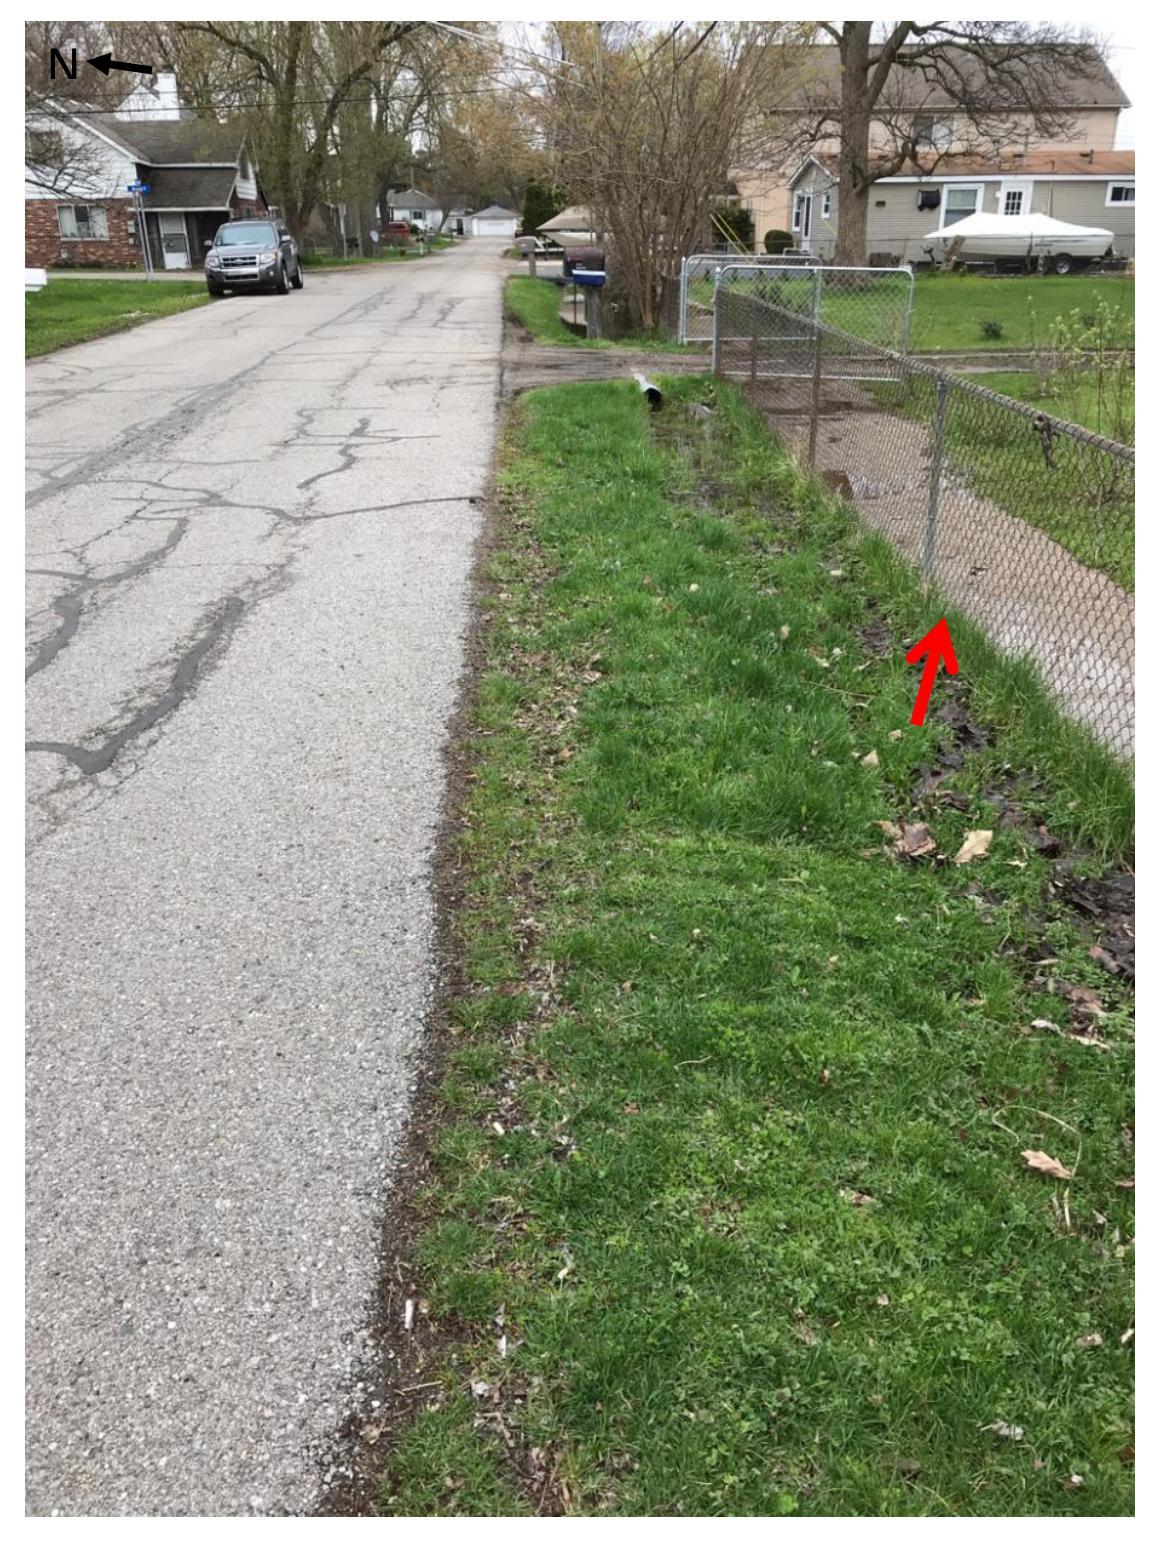
Image taken by HRC staff on May 3, 2019 of the heaved culvert at 3201 Kenrick and the location where the homeowner of 3201 Kenrick placed a sand berm to prevent roadway runoff from draining to their property.

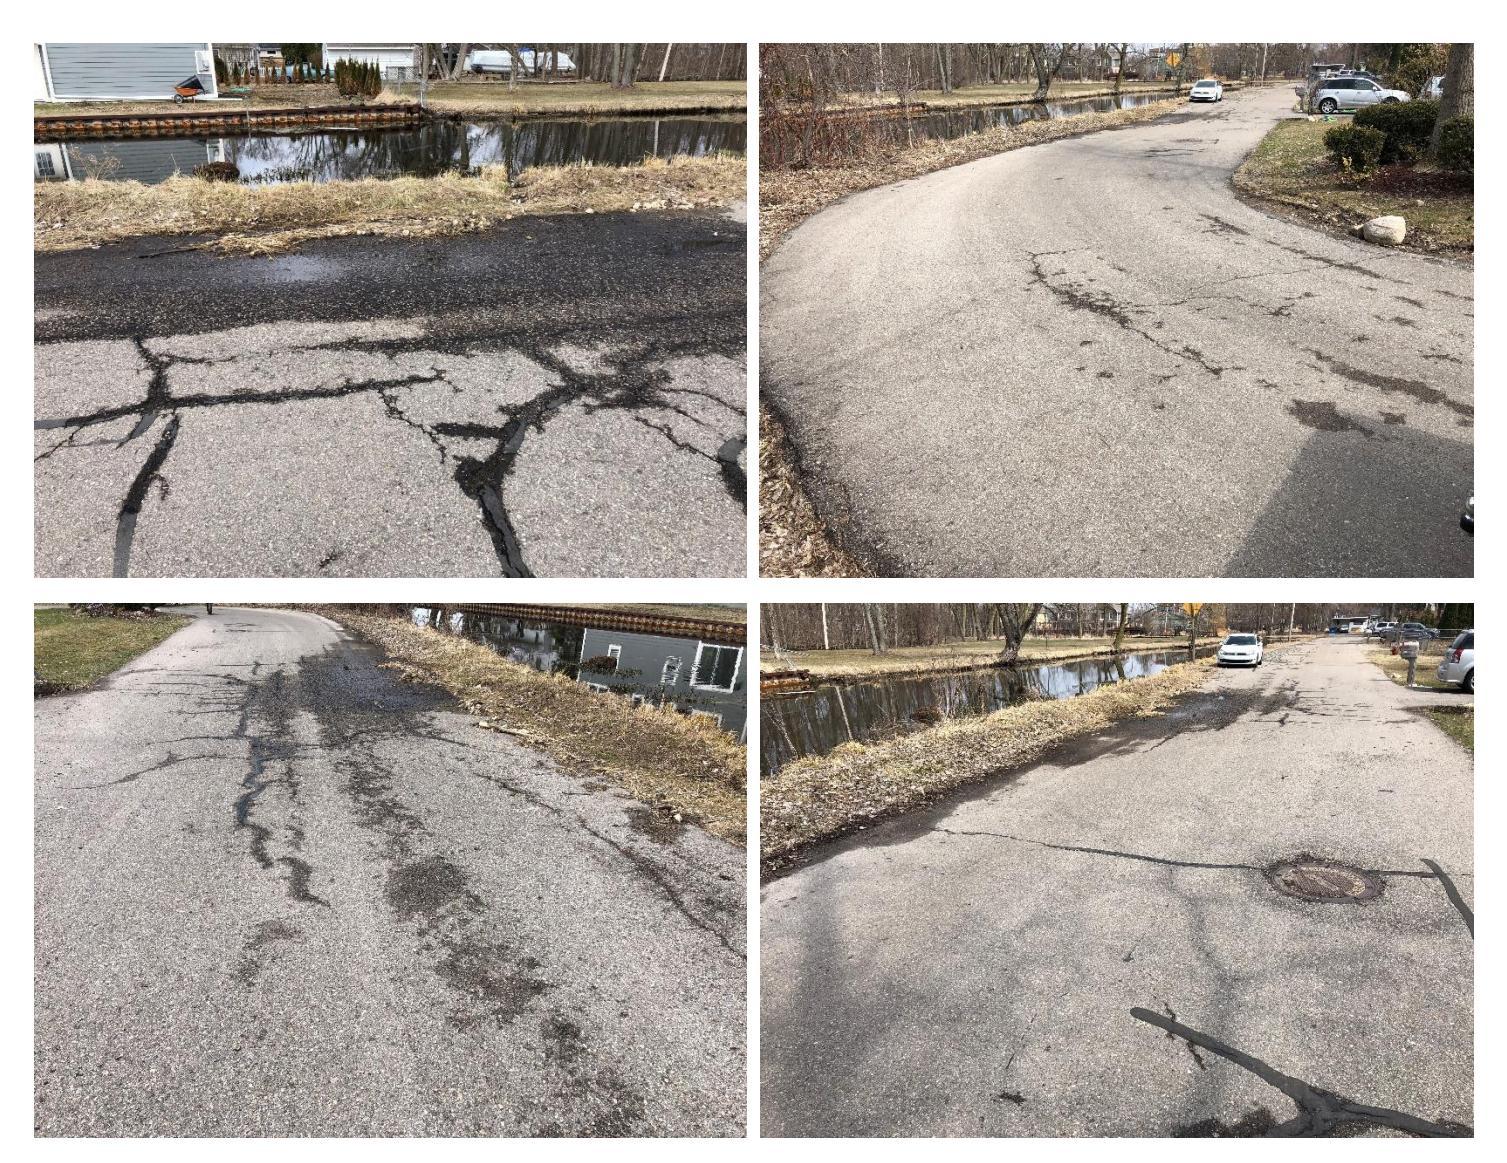
Site photos taken by HRC staff on April 5, 2019 of the wet road and shoreline erosion along Brock Street.

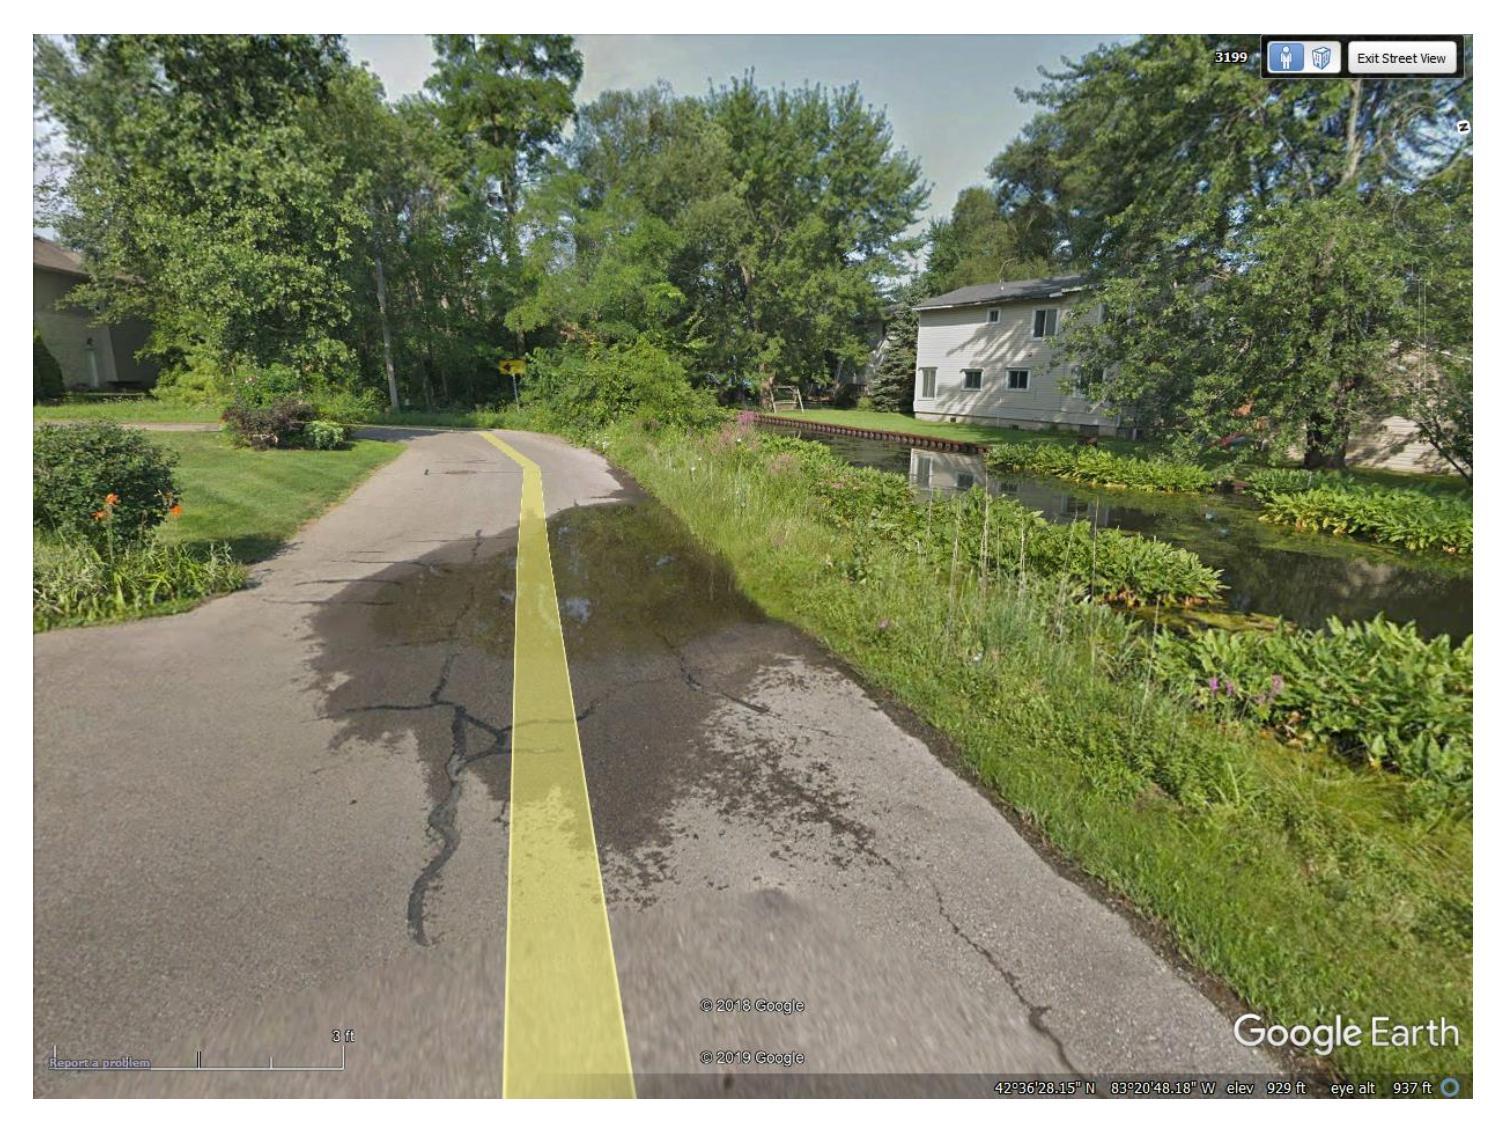
August 2018 Google street view image of low-lying area in front of 3119 Brock Street that experiences frequent water ponding.

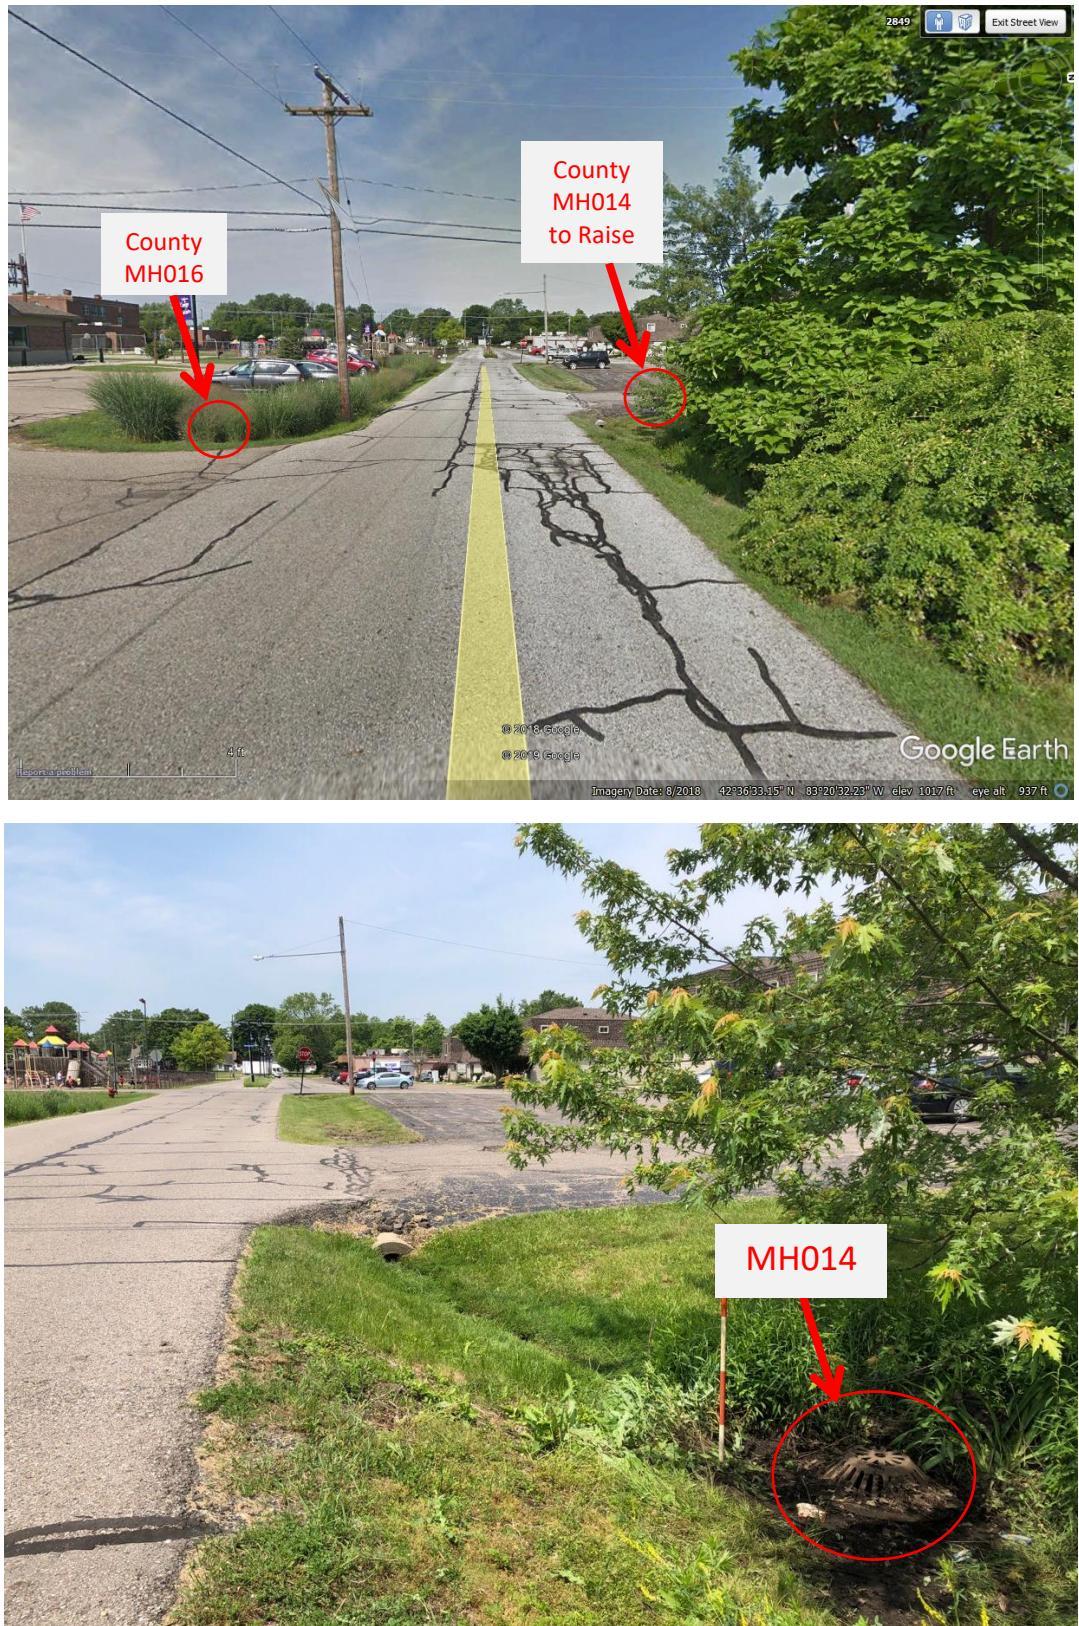
Google street view image taken in August 2018 of Schroeder Blvd., facing west and showing the location of the manhole recommended to repair.

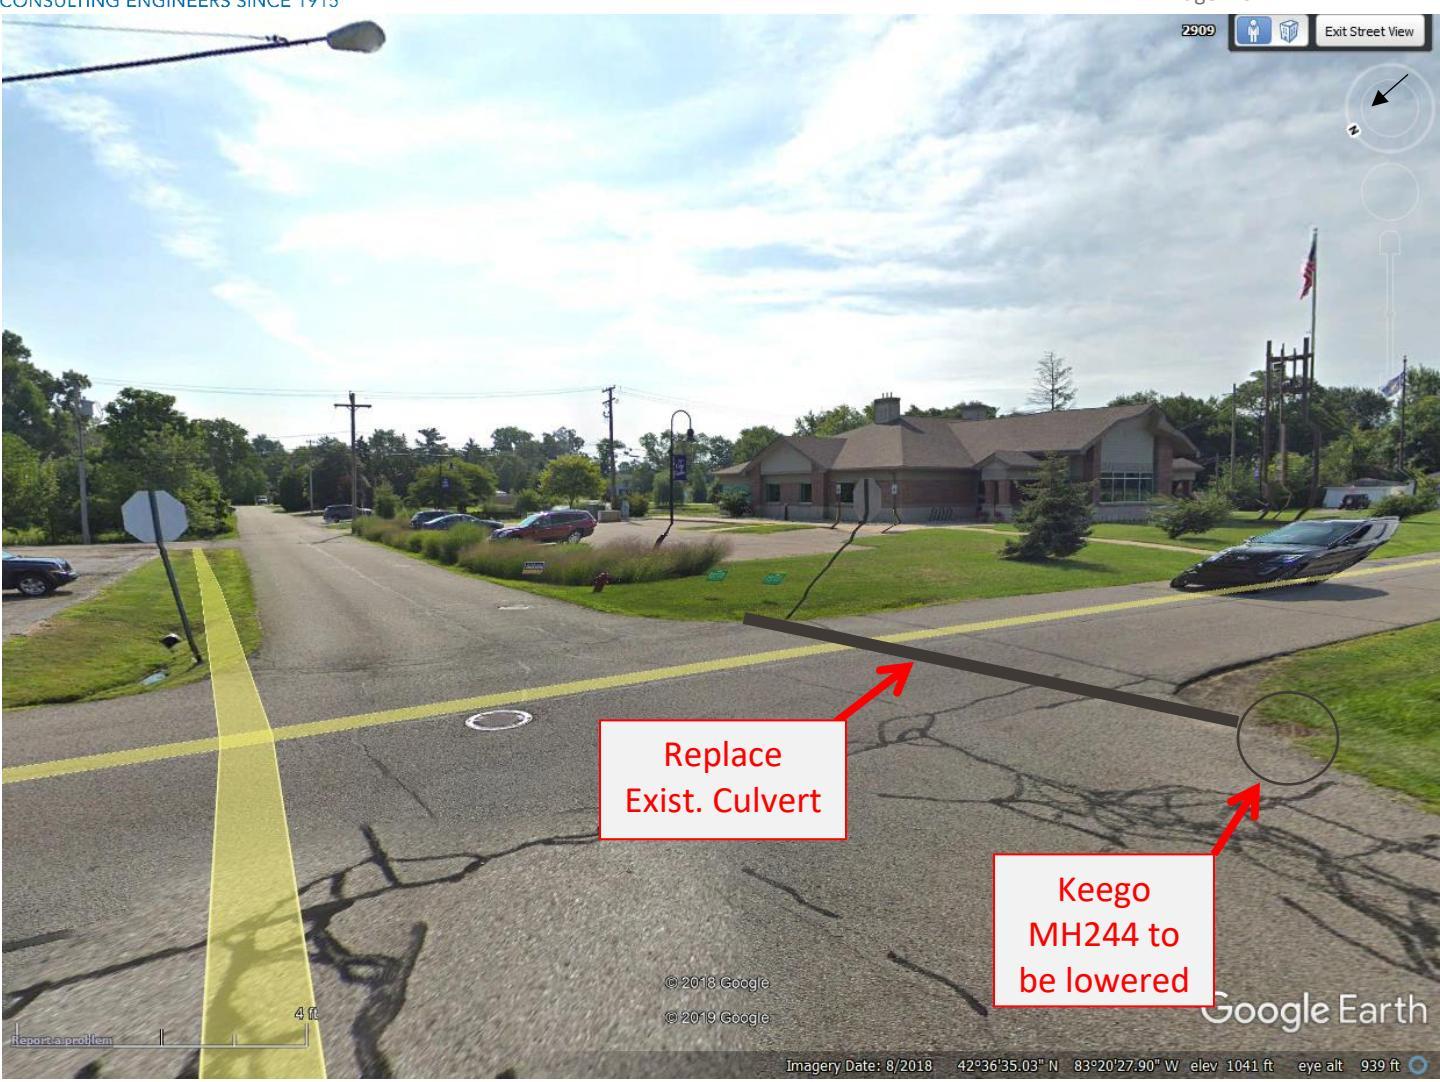
Google street view image taken in August 2018 of Schroeder Blvd., facing east and showing the location of the repair recommendations to existing manhole and culvert.

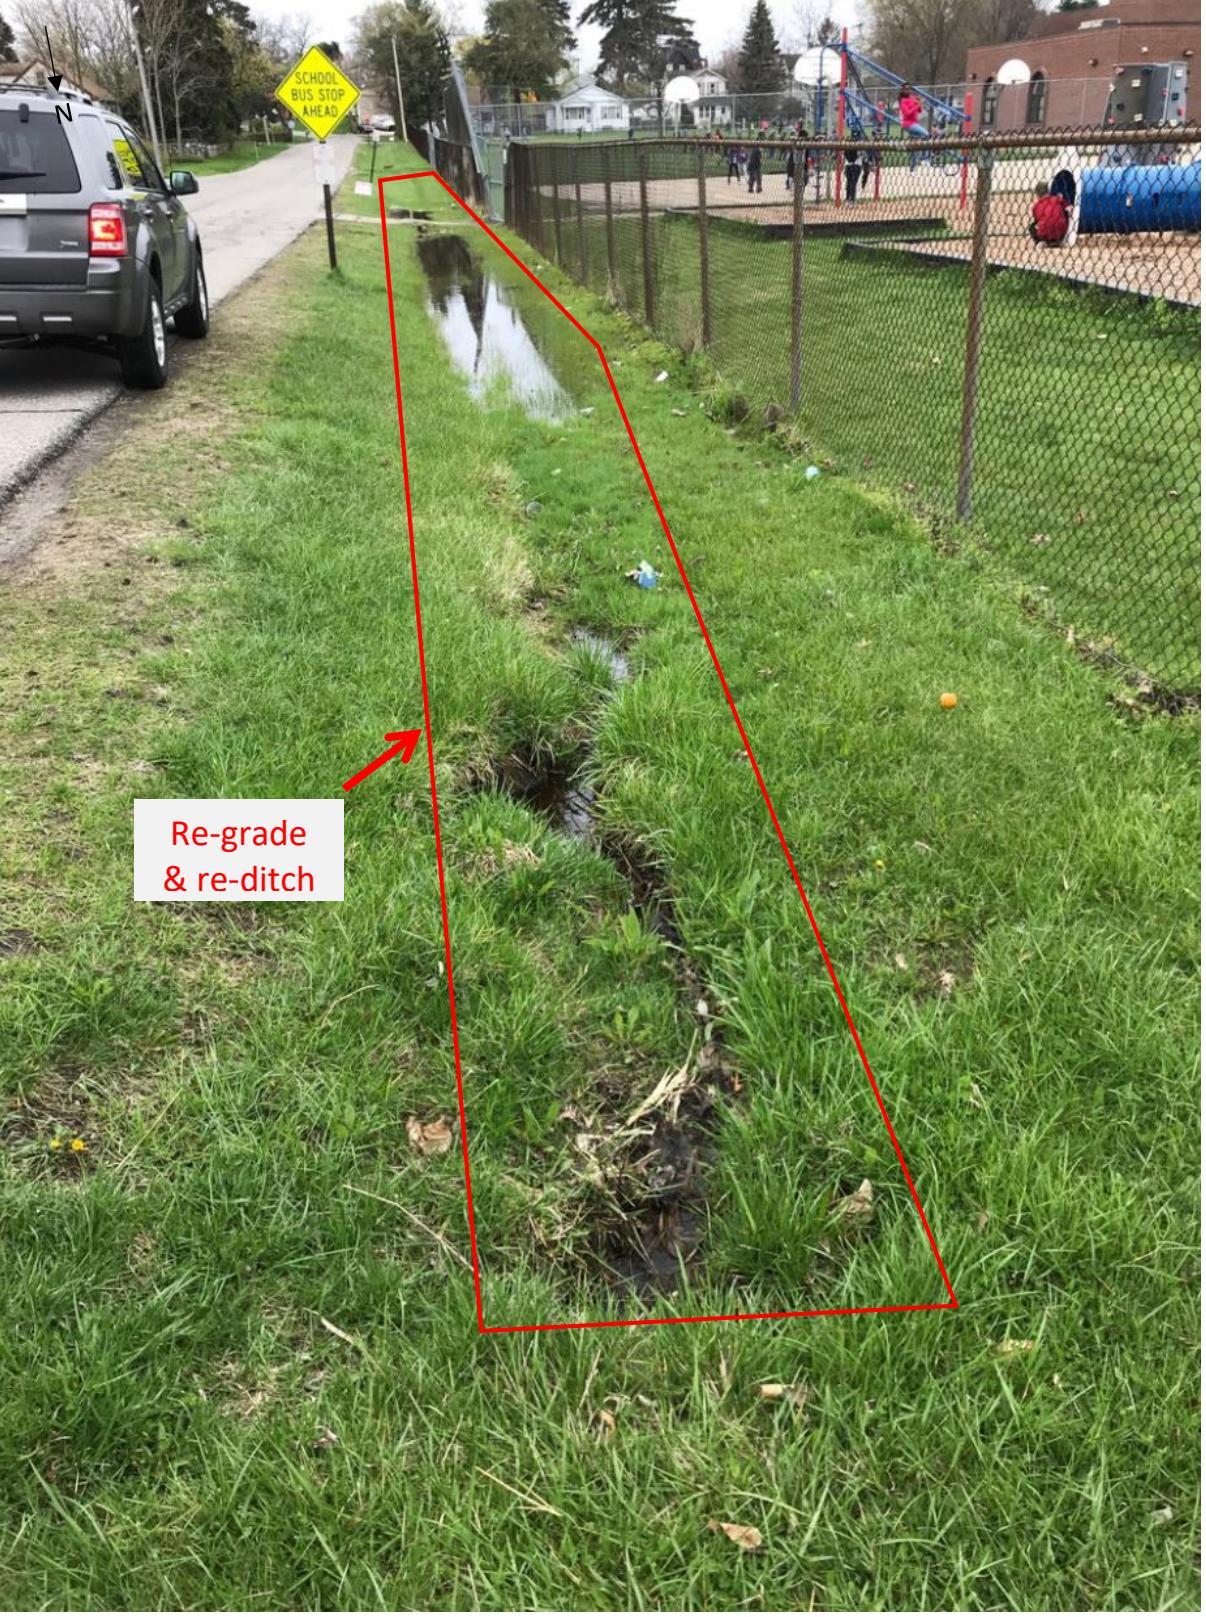
Photo taken by HRC staff on May 3, 2019 of the overgrown ditch along Beechmont Road, south of Schroeder.

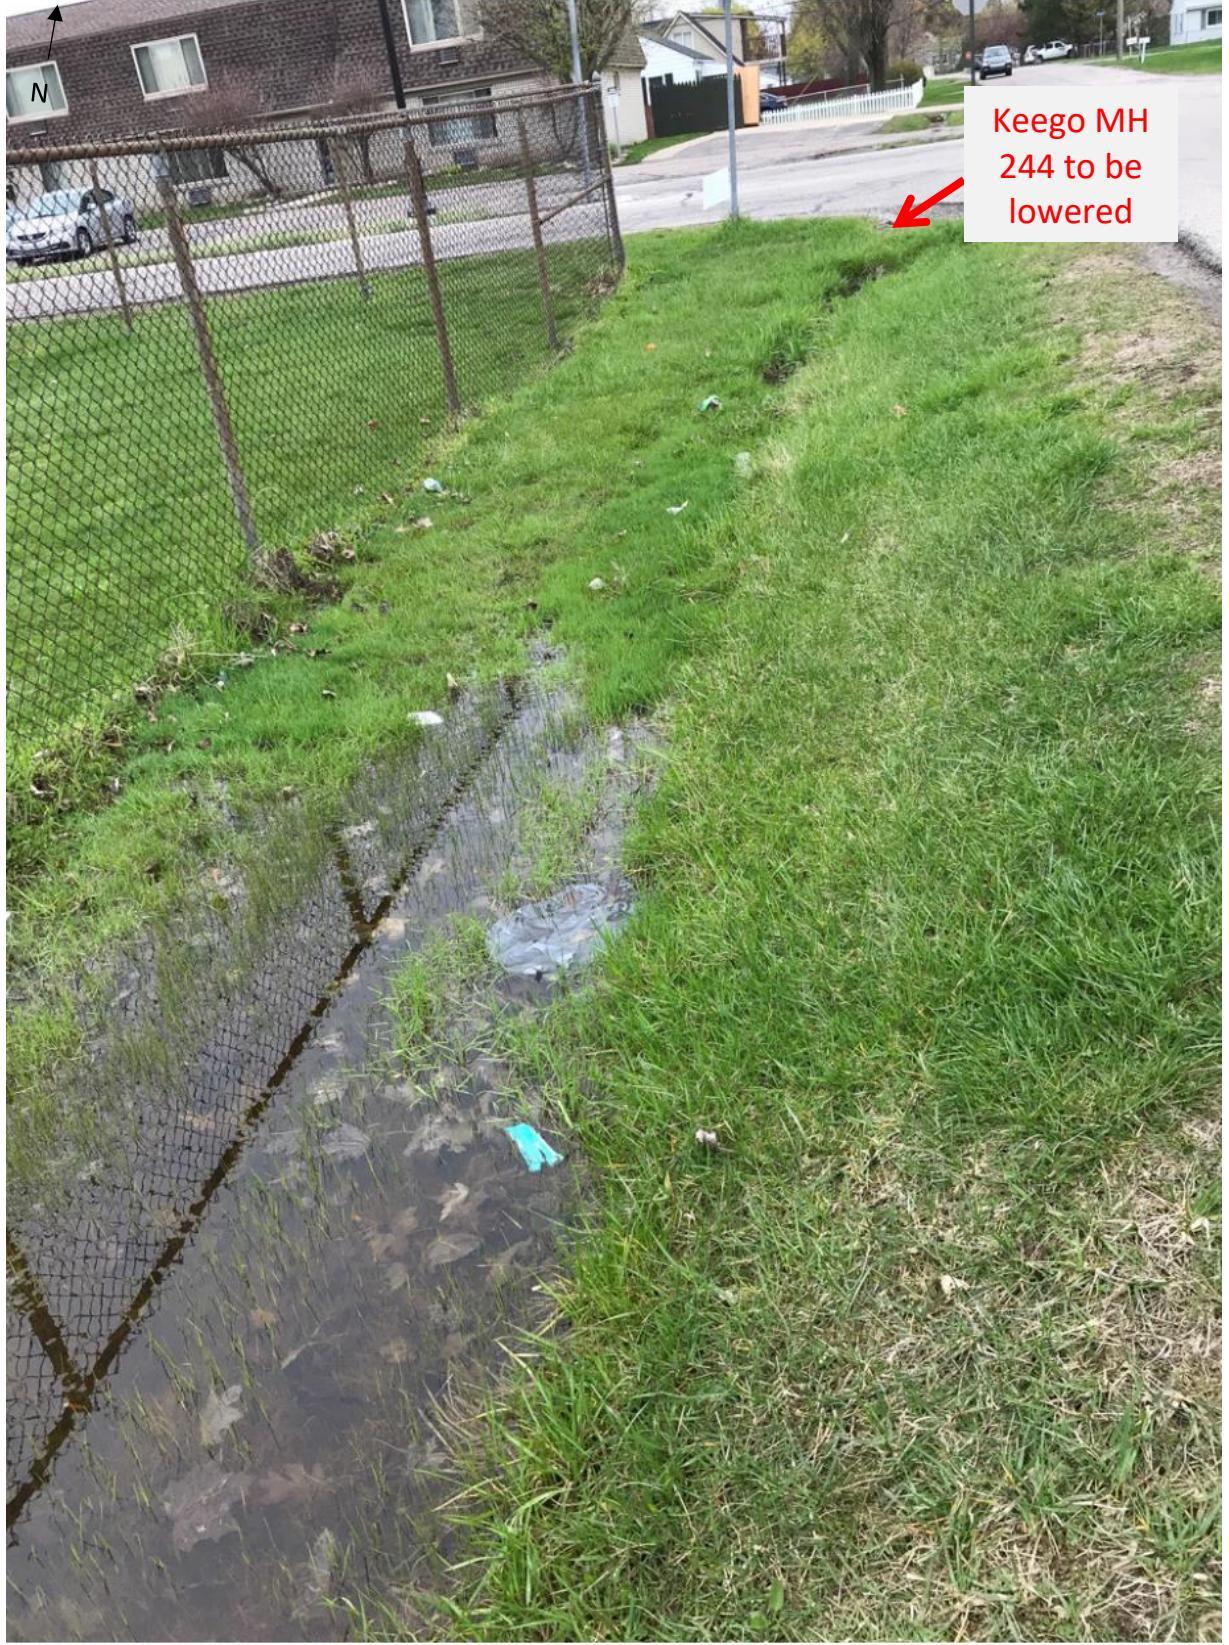
Photo taken by HRC staff on May 3, 2019 of stagnant water in the ditch along Beechmont, south of Schroeder, that's prevent flow from entering the manhole.

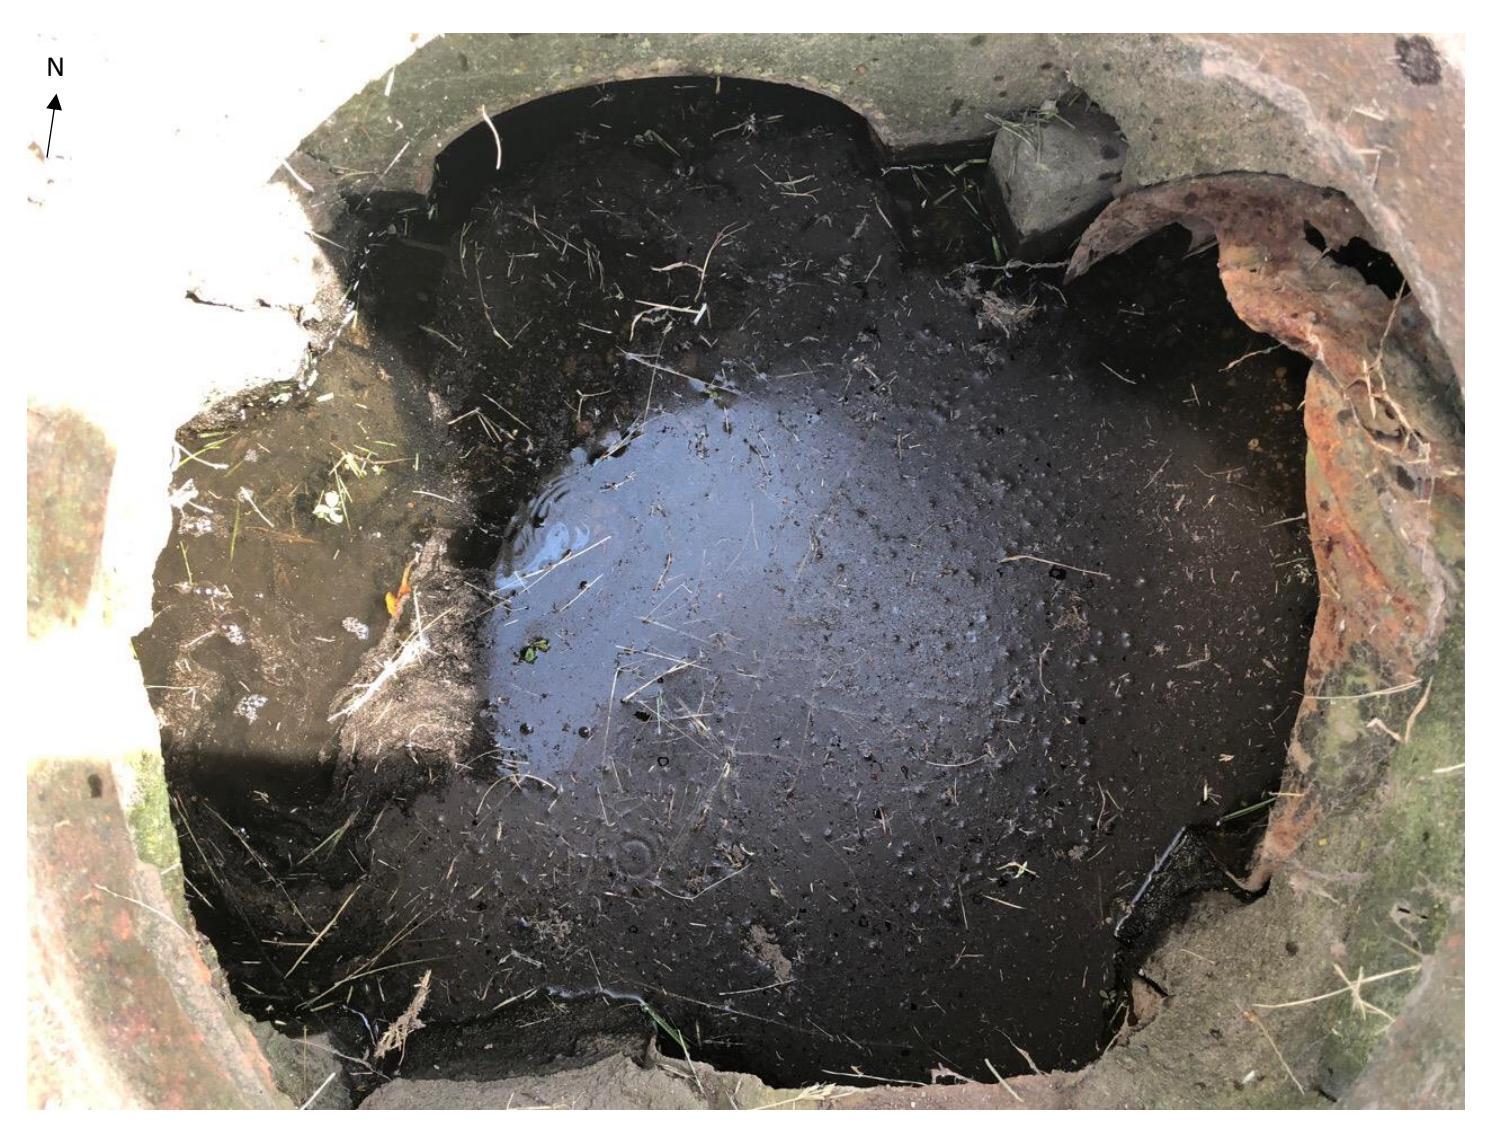
Photo taken by HRC staff on May 3, 2019 showing the inside of the manhole (MH244) at the corner of Beechmont and Schroeder.

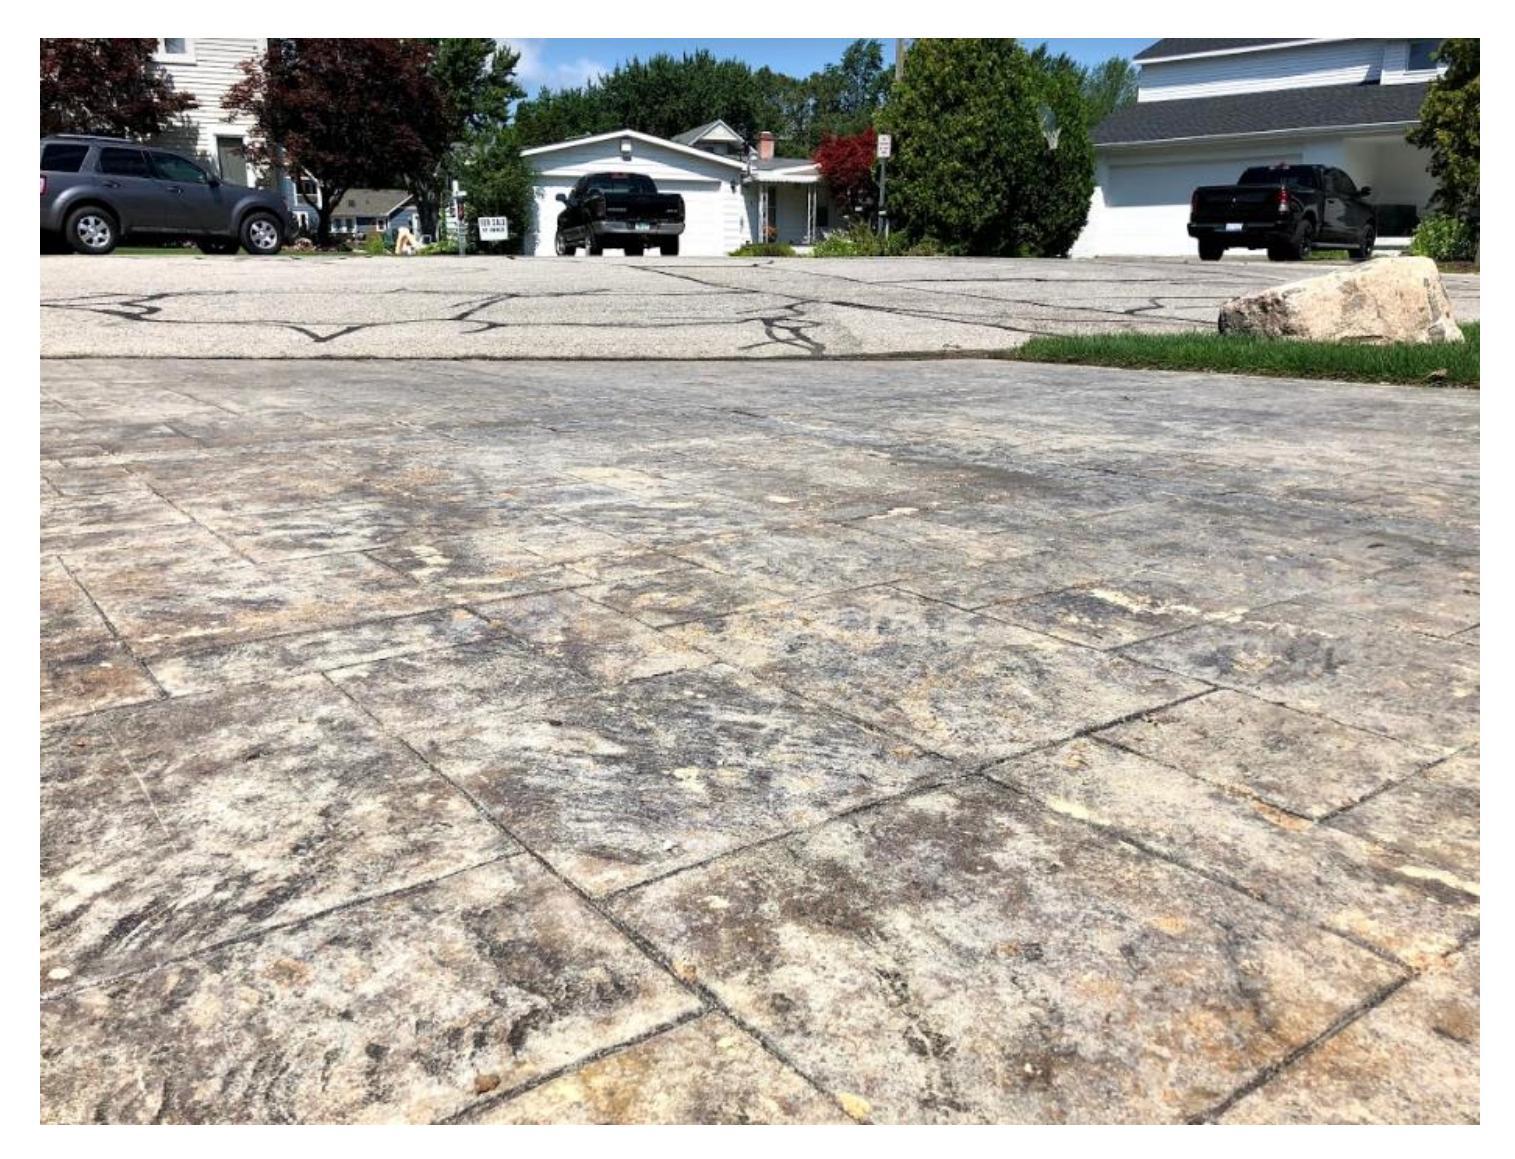
Elevation comparison of driveway compared to the road from July 30, 2019, taken by HRC staff.

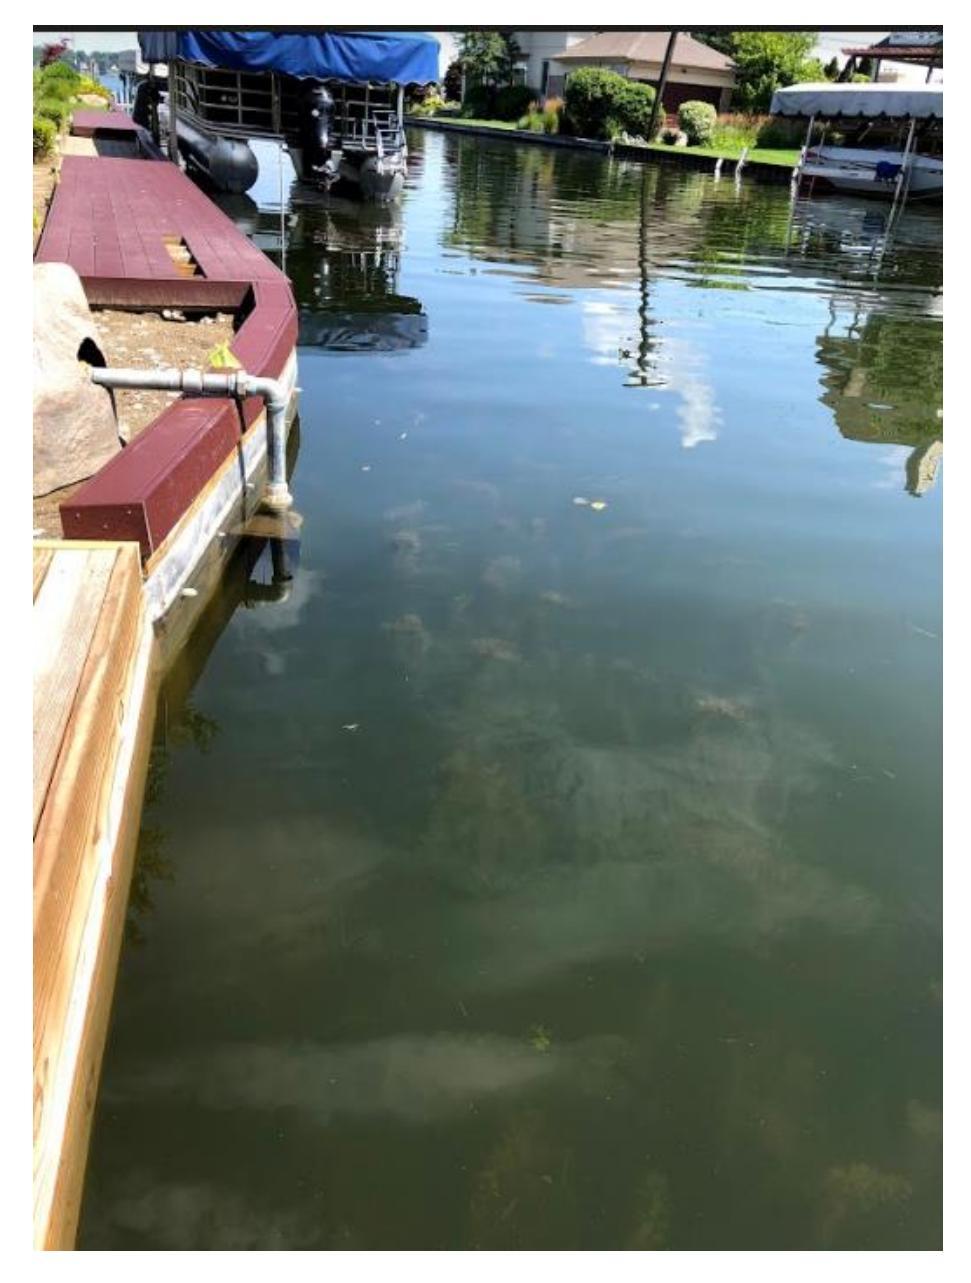
Sylvan Lake water-level at the seawall on July 30, 2019, taken by HRC staff.

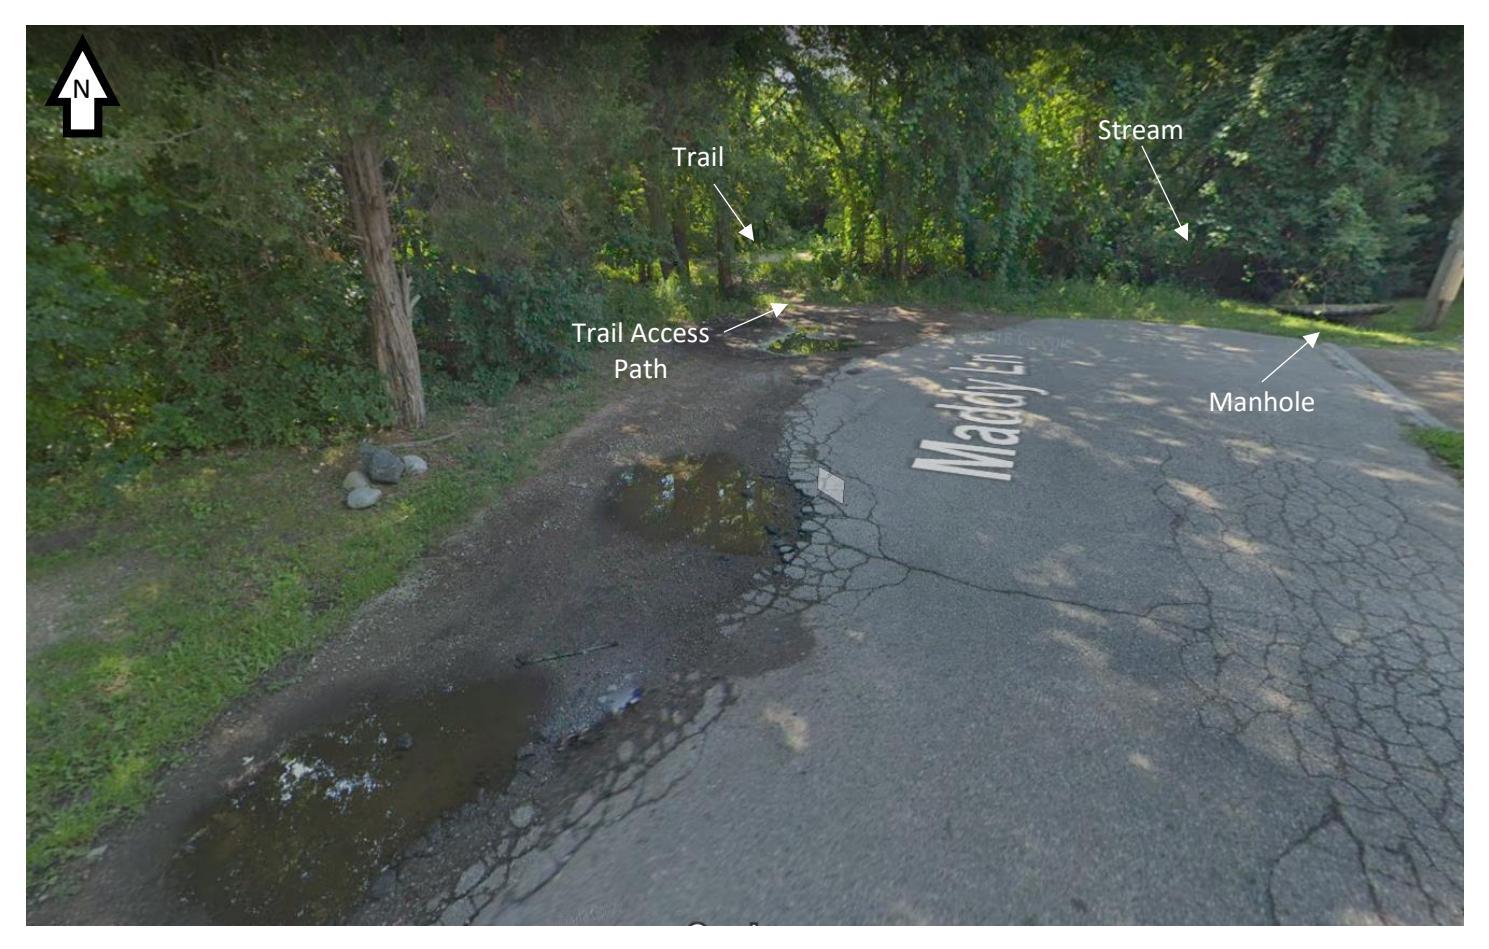
Google Street View of dead-end street where stormwater ponding occurs.
