STORMWATER SYSTEM ASSET MANAGEMENT PLAN

CITY OF KEEGO HARBOR OAKLAND COUNTY, MICHIGAN

EGLE SAW GRANT #1220-01

DECEMBER 2019

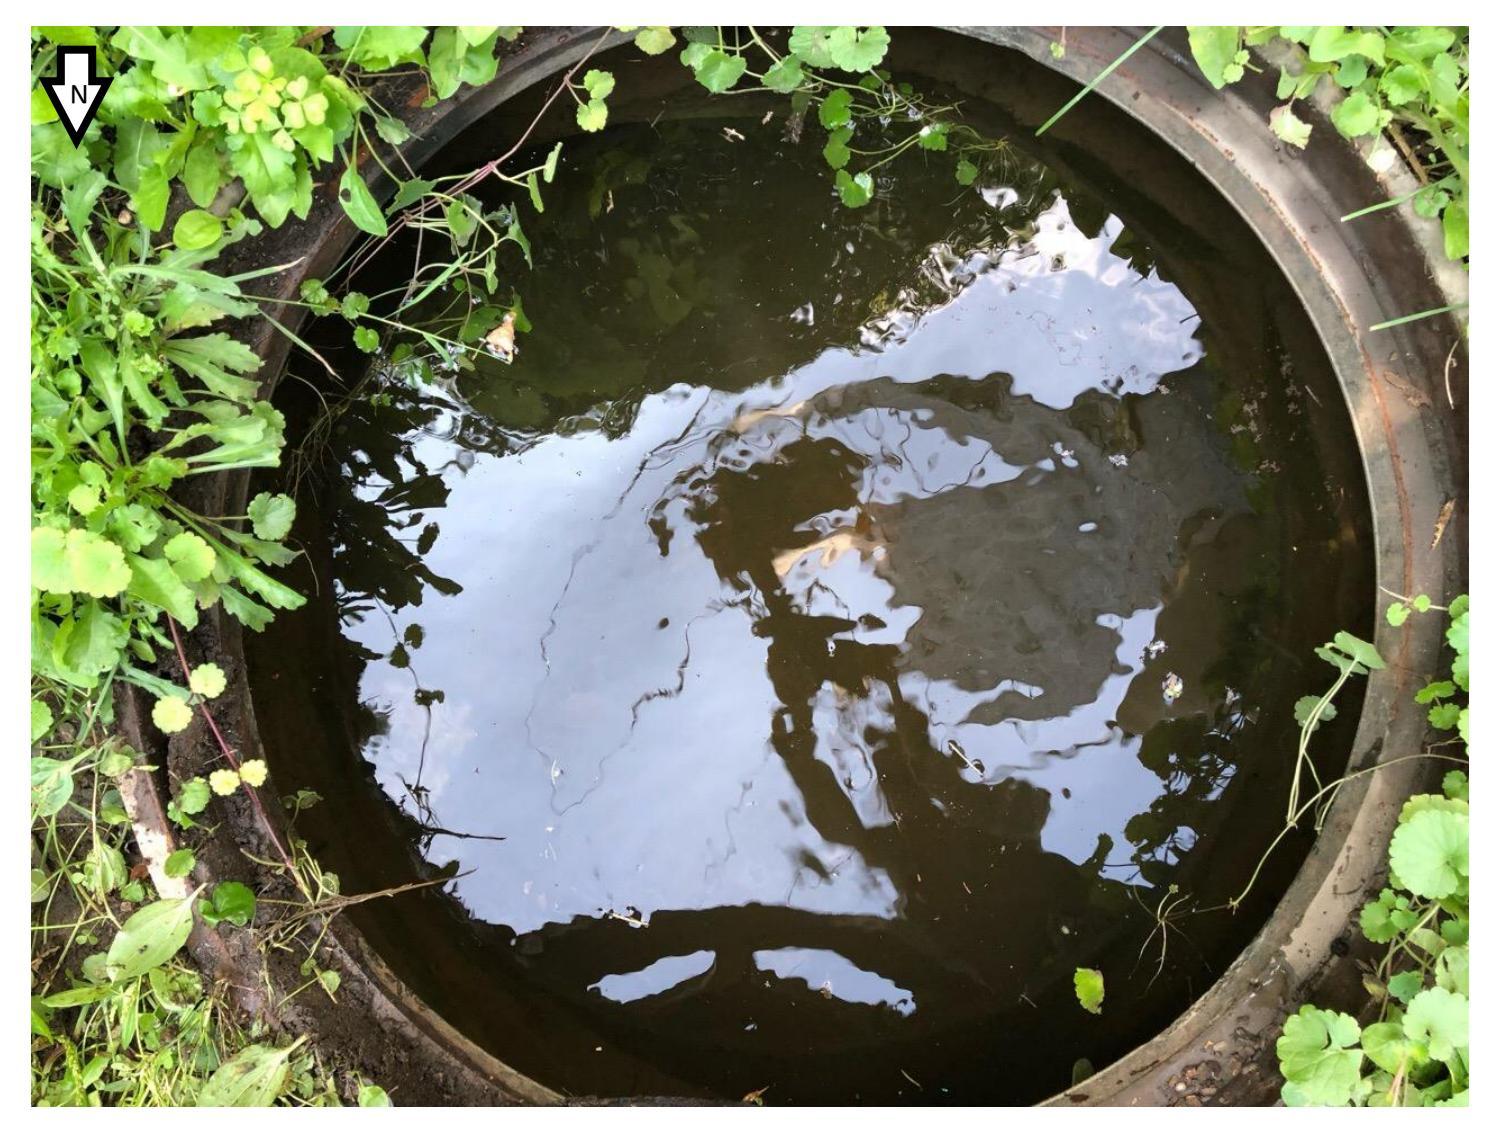
Inside image of the manhole at the end of Maddy Ln that is regularly filled with water as the outgoing pipe is below the water level in the stream.

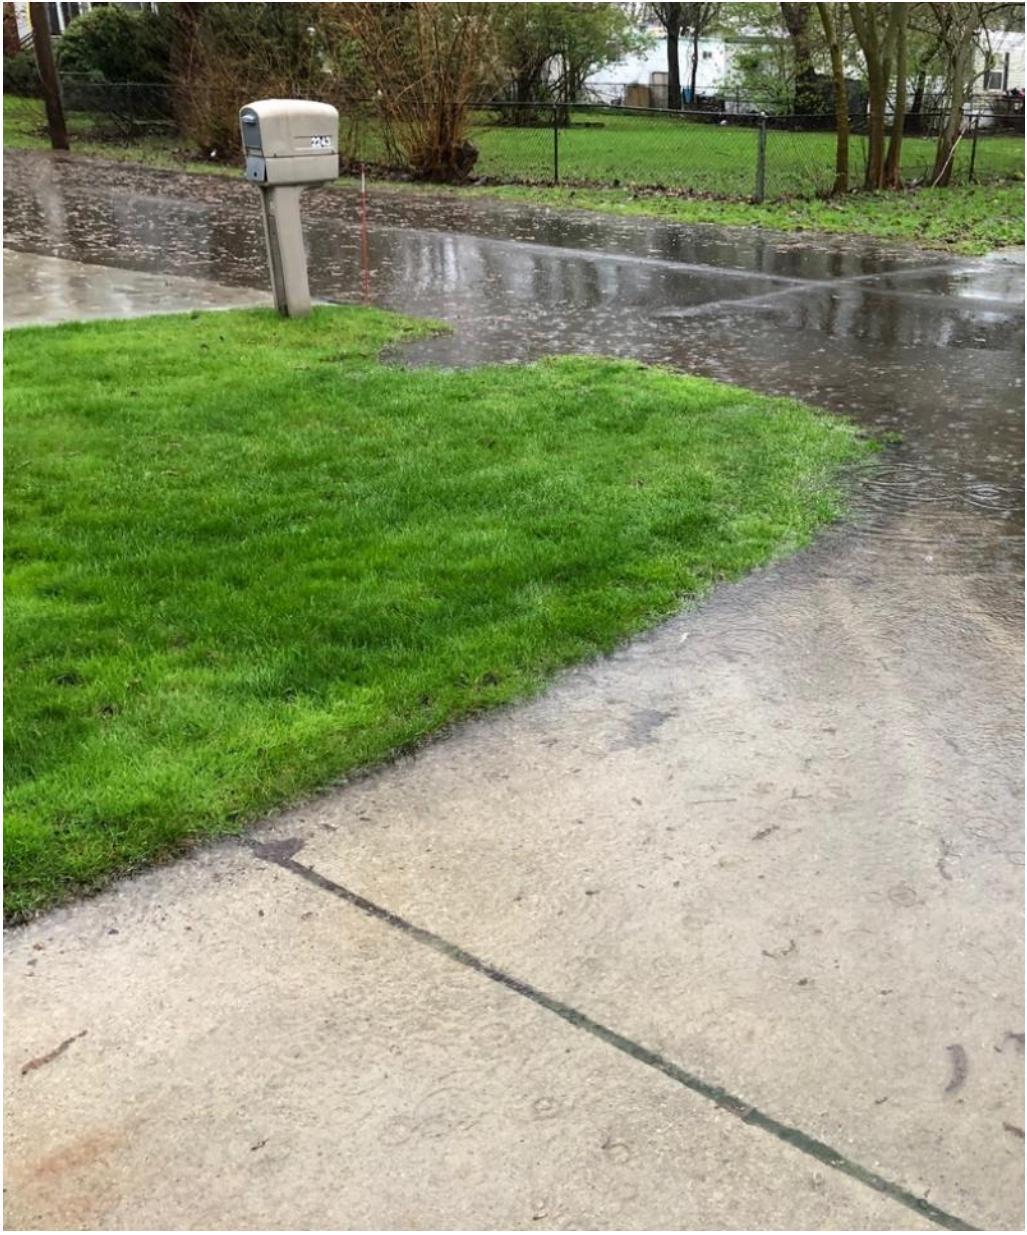
Photo from homeowner at 2229 Willow Beach St from May, 2019 of the flooded driveway and street.

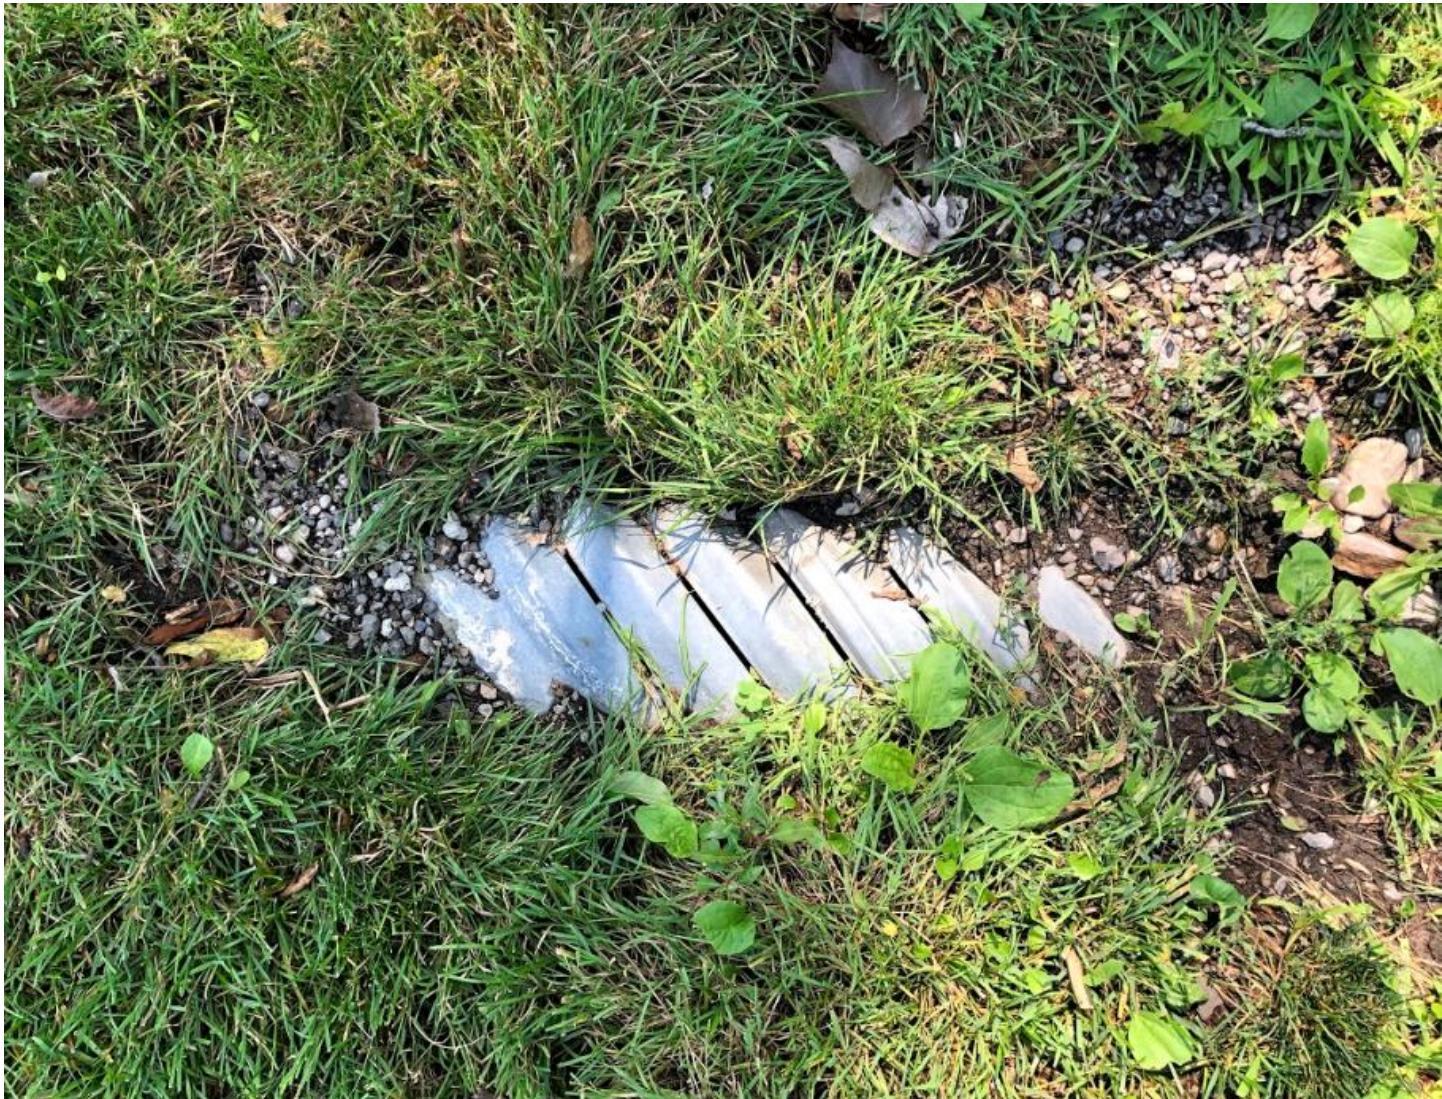
Photo taken by HRC staff the exposed drain and slit created to allow flow into the pipe from July 30, 2019. Location where field catch basin is recommended to be installed.
