**STORMWATER SYSTEM
ASSET MANAGEMENT PLAN**

**CITY OF KEEGO HARBOR
OAKLAND COUNTY, MICHIGAN**

EGLE SAW GRANT #1220-01

DECEMBER 2019

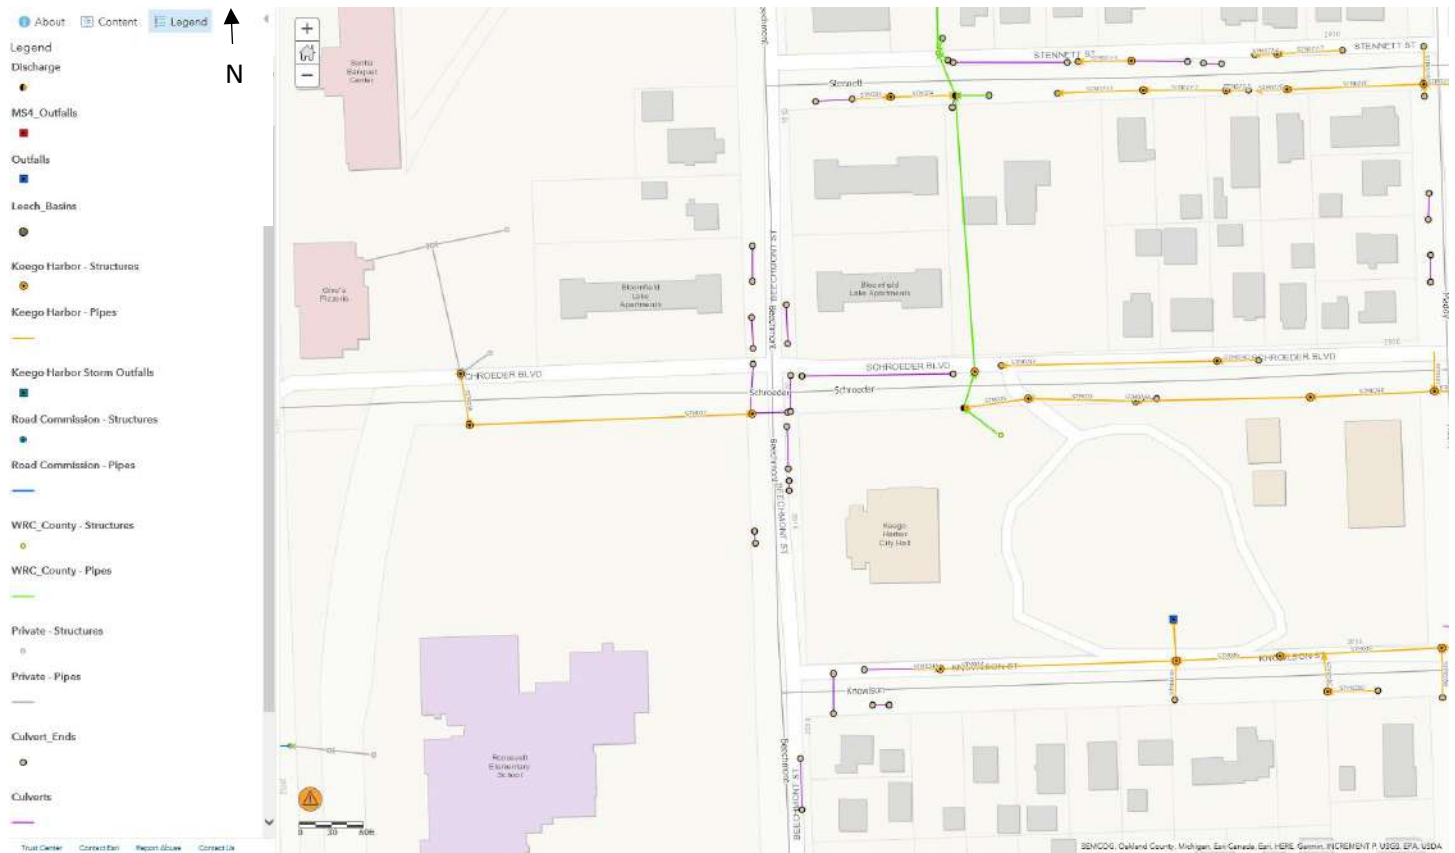
- The culverts that run on the southwest side of Schroeder and under Beechmont are defective and corroded
- The elevation of this area is relatively flat.

HRC's ArcGIS Map of the existing pipes at the intersection of Schroeder and Beechmont.

- In order to allow water to get to MH244 at the southwest corner of Beechmont and Schroeder, the manhole should be lowered, replaced with a beehive cover, and have a deeper sump.

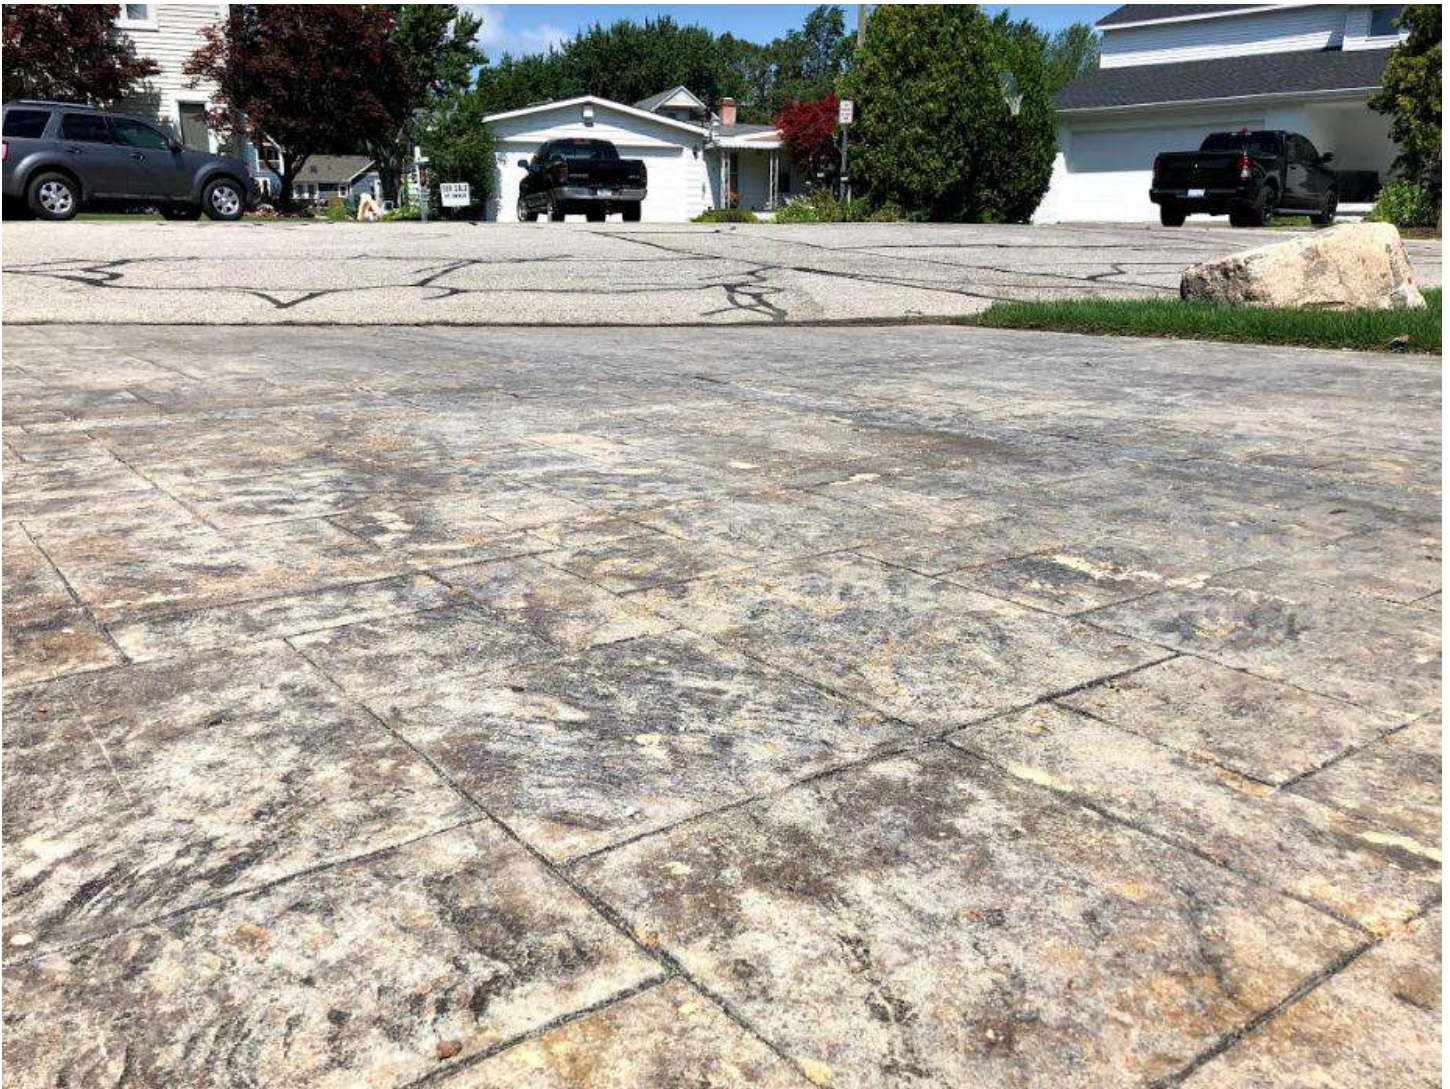
Elevation comparison of driveway compared to the road from July 30, 2019, taken by HRC staff.

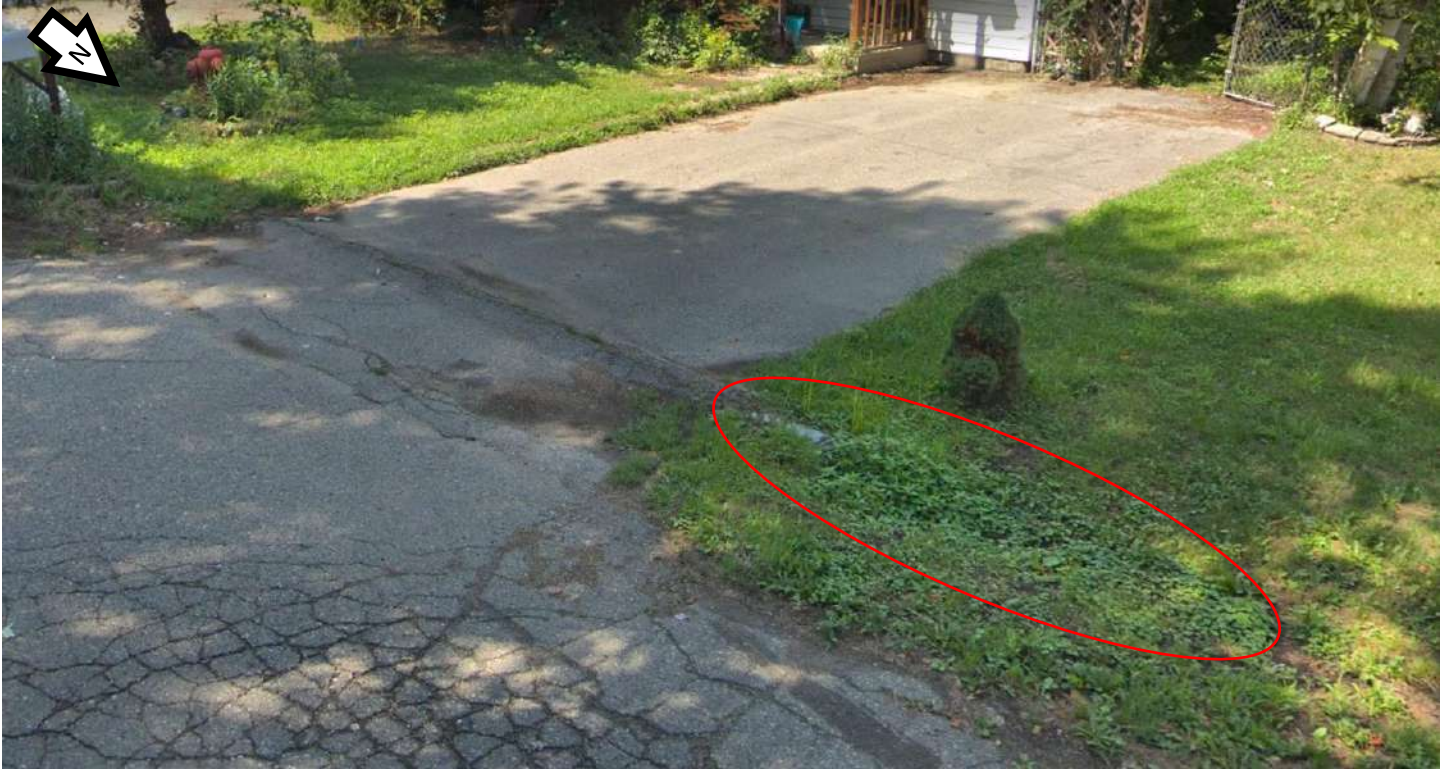
Buried culvert and ditches.

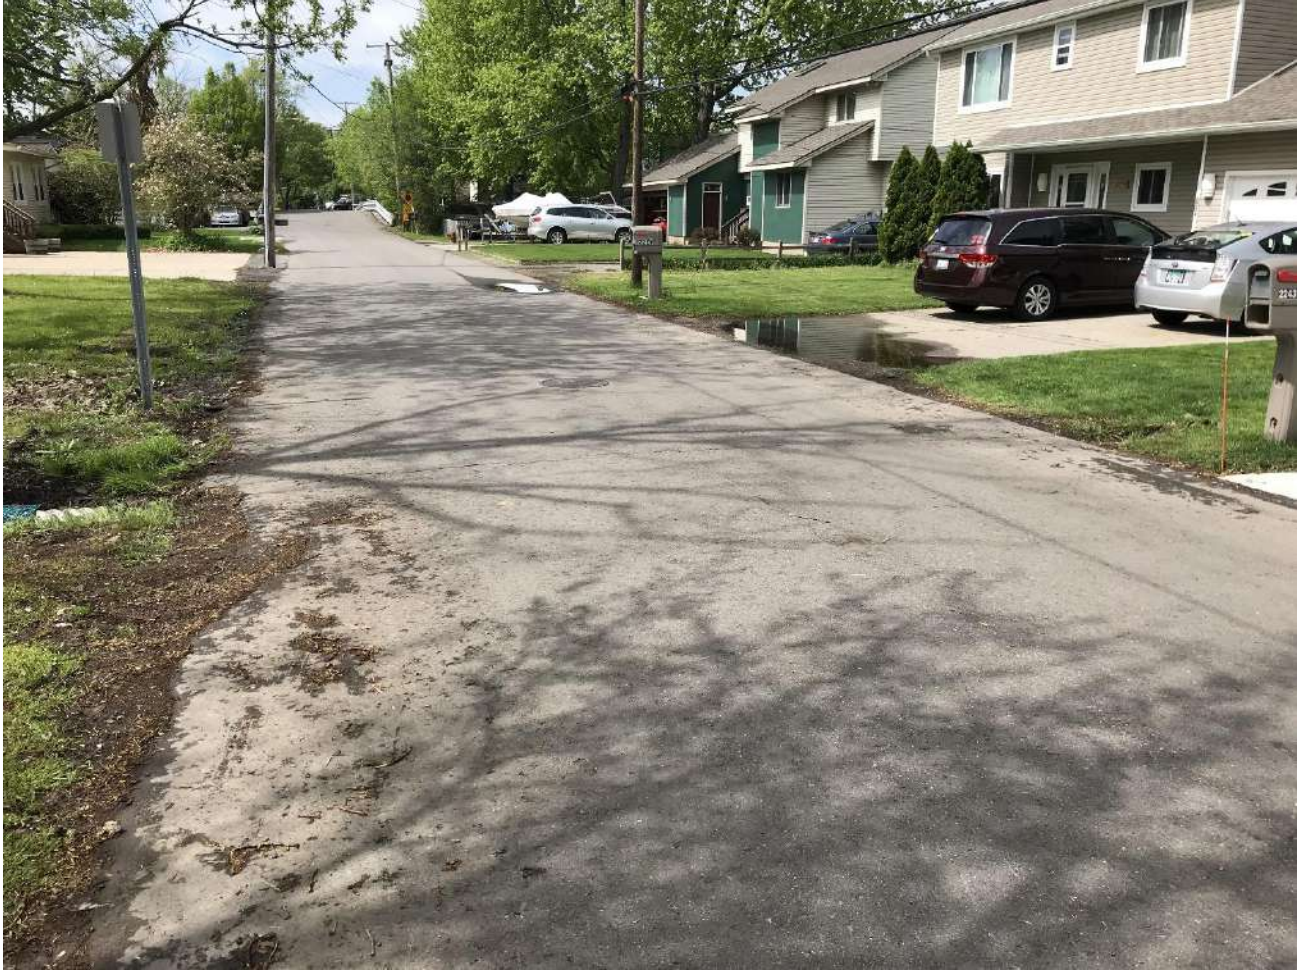
Taken by HRC staff on May 22, 2019 facing north showing Willow Beach with less flooding after rain event

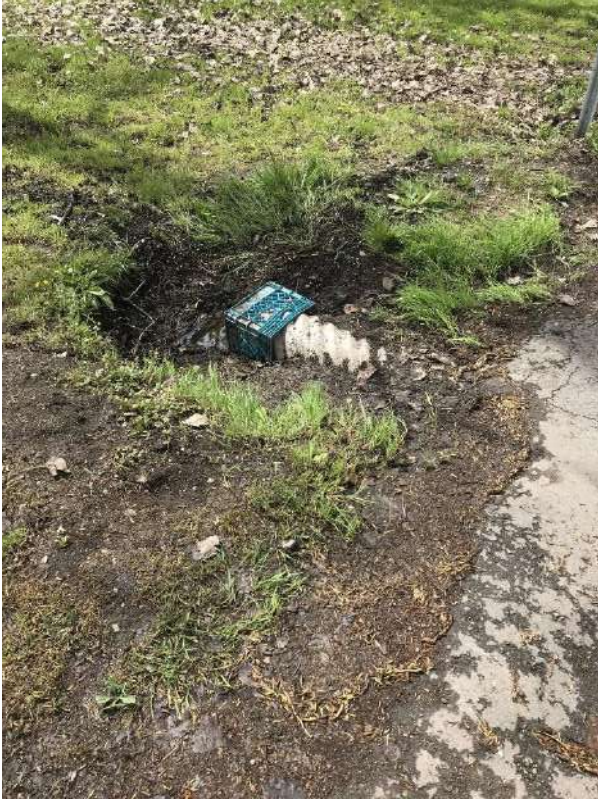
Taken by HRC staff on May 22, 2019 showing the inlet on the west side of Willow Beach.
