**STORMWATER SYSTEM
ASSET MANAGEMENT PLAN**

**CITY OF KEEGO HARBOR
OAKLAND COUNTY, MICHIGAN**

DECEMBER 2019

HRC JOB NO. 20130735

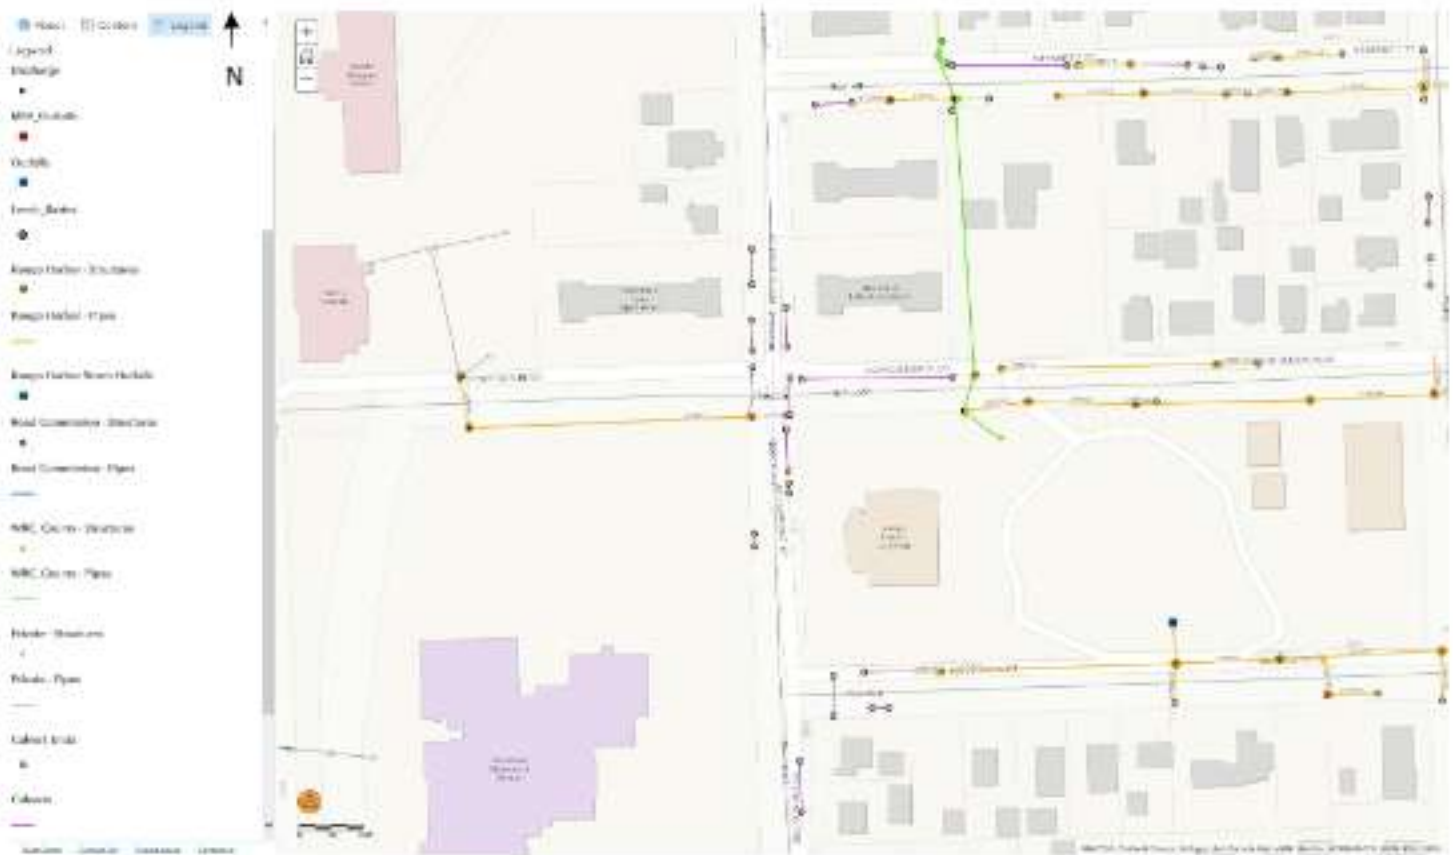
- The culverts that run on the southwest side of Schroeder and under Beechmont are defective and corroded
- The elevation of this area is relatively flat.

HRC's ArcGIS Map of the existing pipes at the intersection of Schroeder and Beechmont.

- In order to allow water to get to MH244 at the southwest corner of Beechmont and Schroeder, the manhole should be lowered, replaced with a beehive cover, and have a deeper sump.

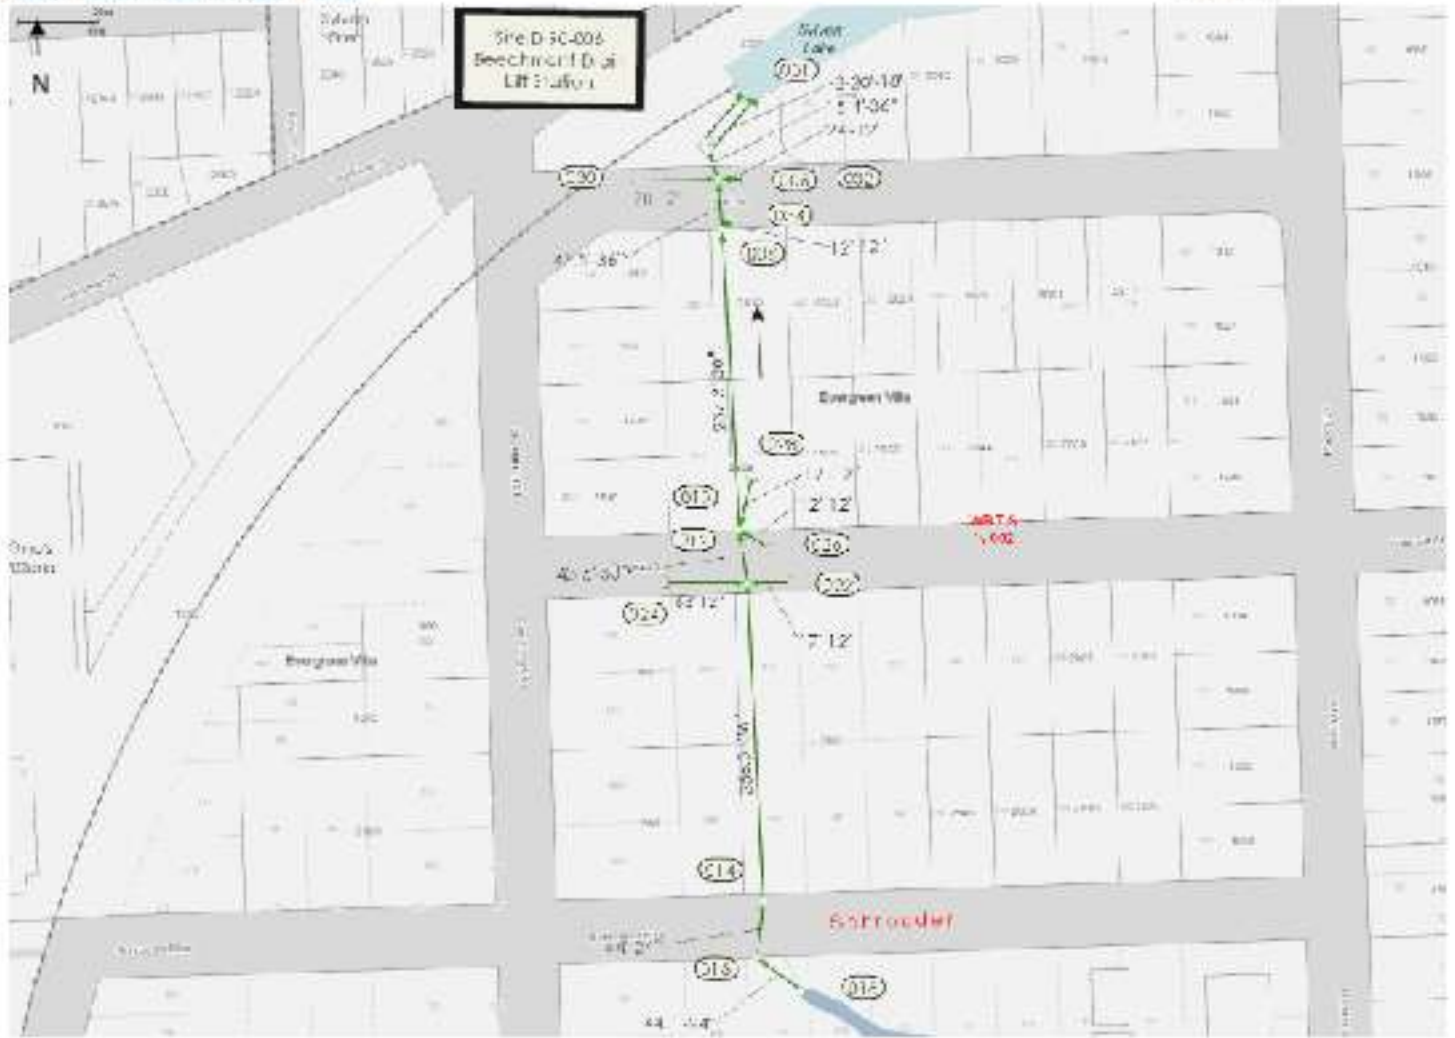
Oakland County's GIS Map of their Beechmont Drain, showing the storm drain taking the overflow from the pond and discharging to the Sylvan Lake lift station.

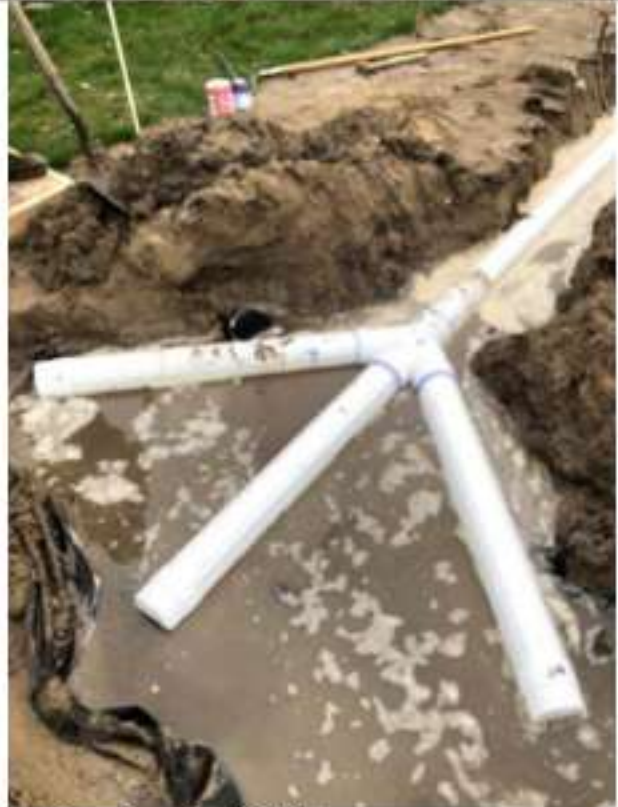
Homeowner's images of installing footing drainage from May 5, 2019.

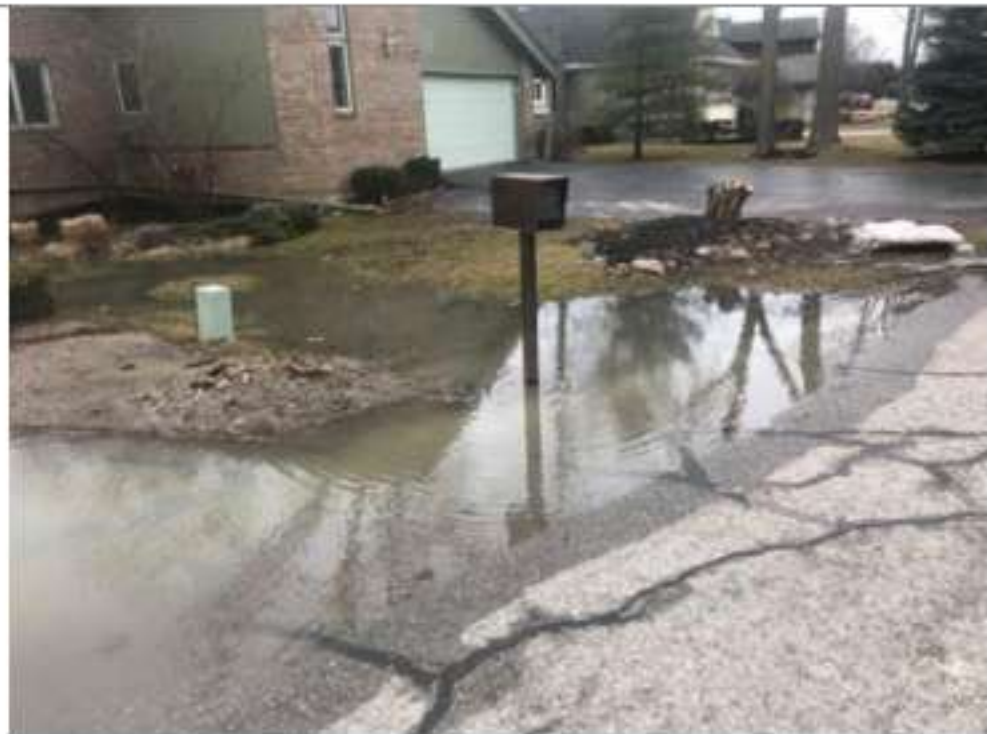
Homeowner's images of flooding in their driveway from May 7, 2019.
