**STORMWATER SYSTEM
ASSET MANAGEMENT PLAN**

**CITY OF KEEGO HARBOR
OAKLAND COUNTY, MICHIGAN**

EGLE SAW GRANT #1220-01

DECEMBER 2019

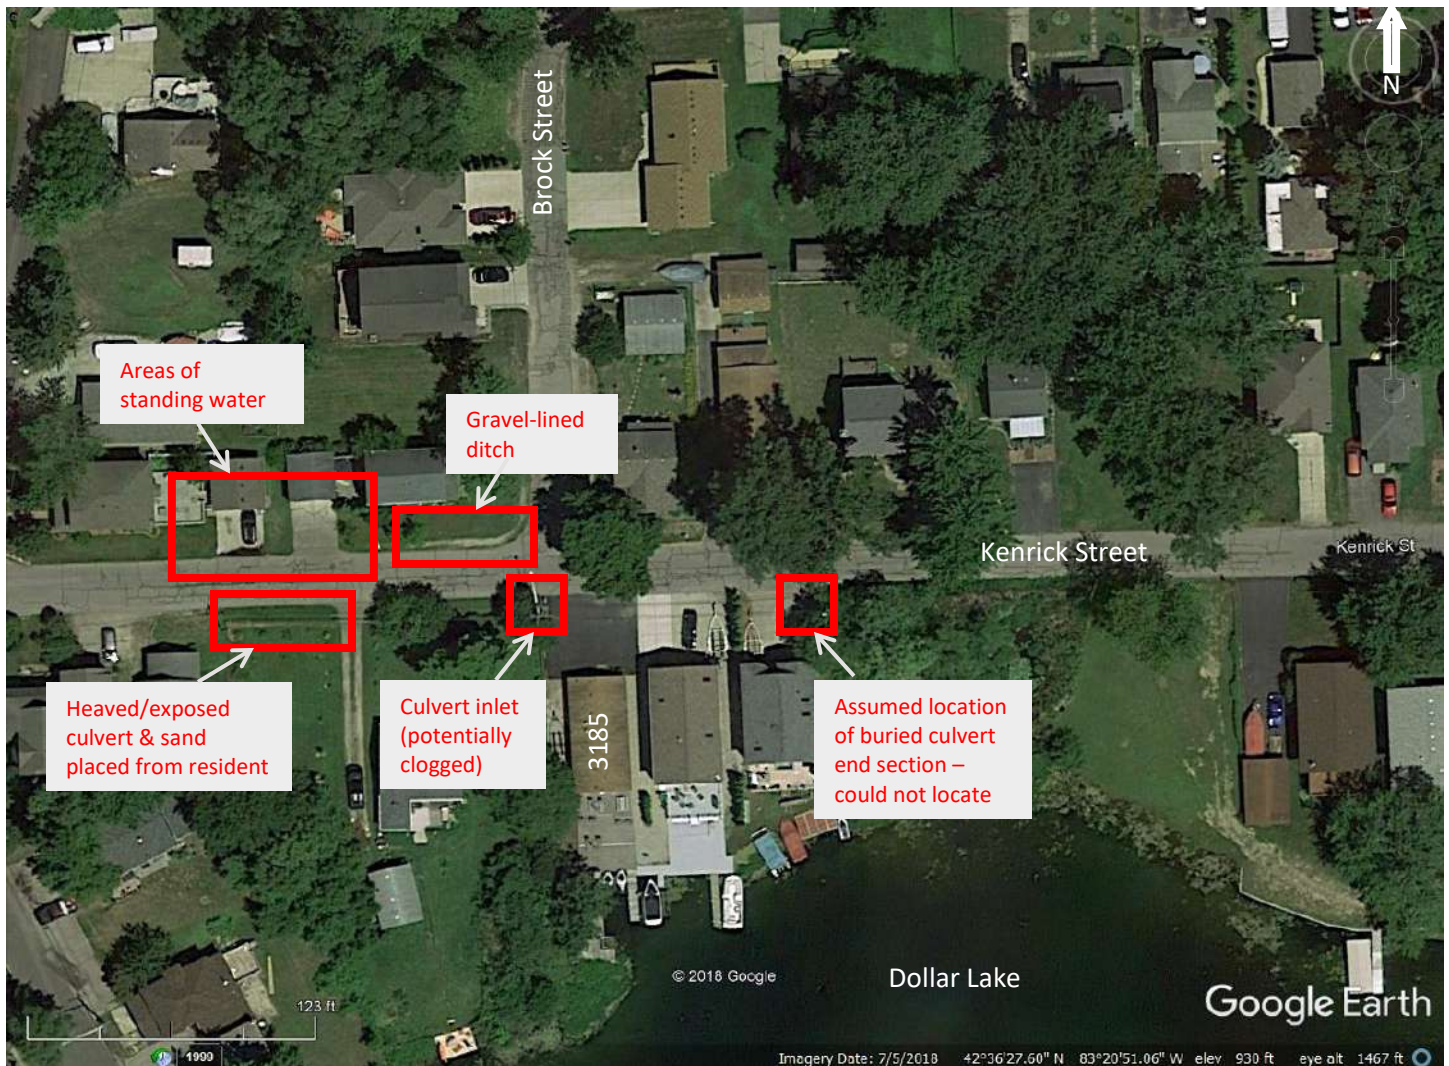
Google aerial view of Kenrick Street with markups of where complaints and drainage issues were passed along to the City.

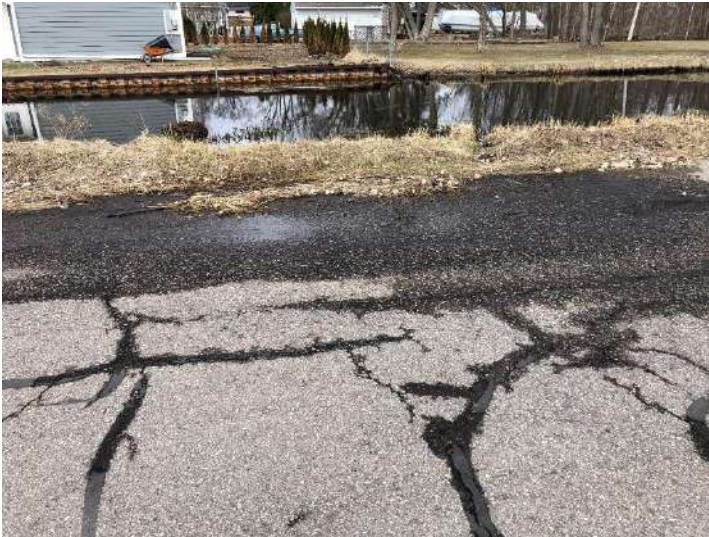
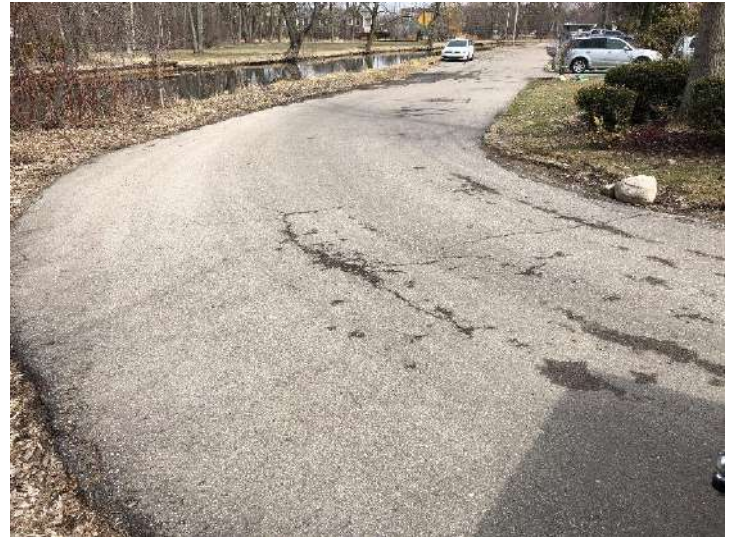
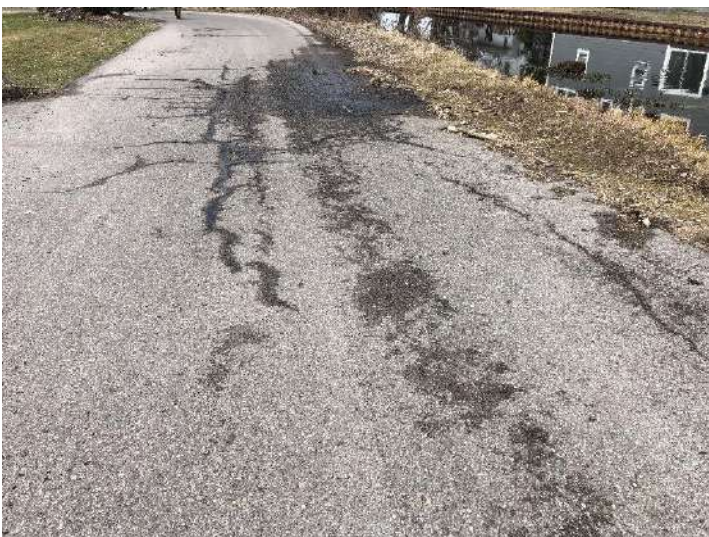
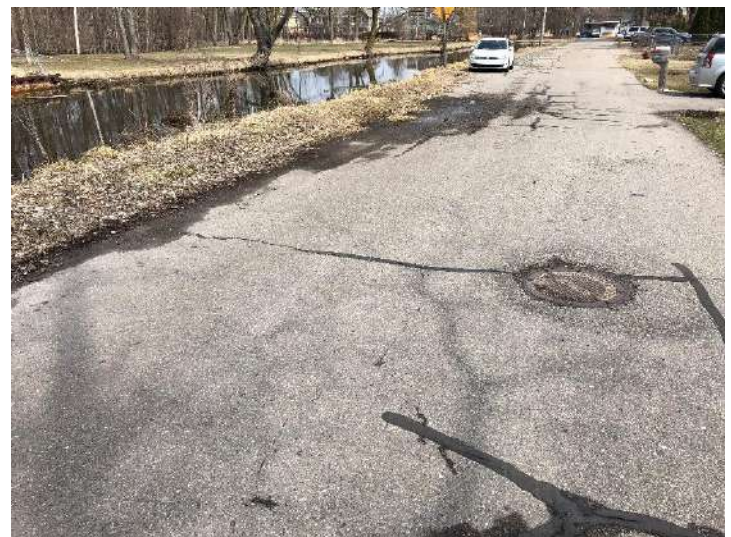
Site photos taken by HRC staff on April 5, 2019 of the wet road and shoreline erosion along Brock Street.

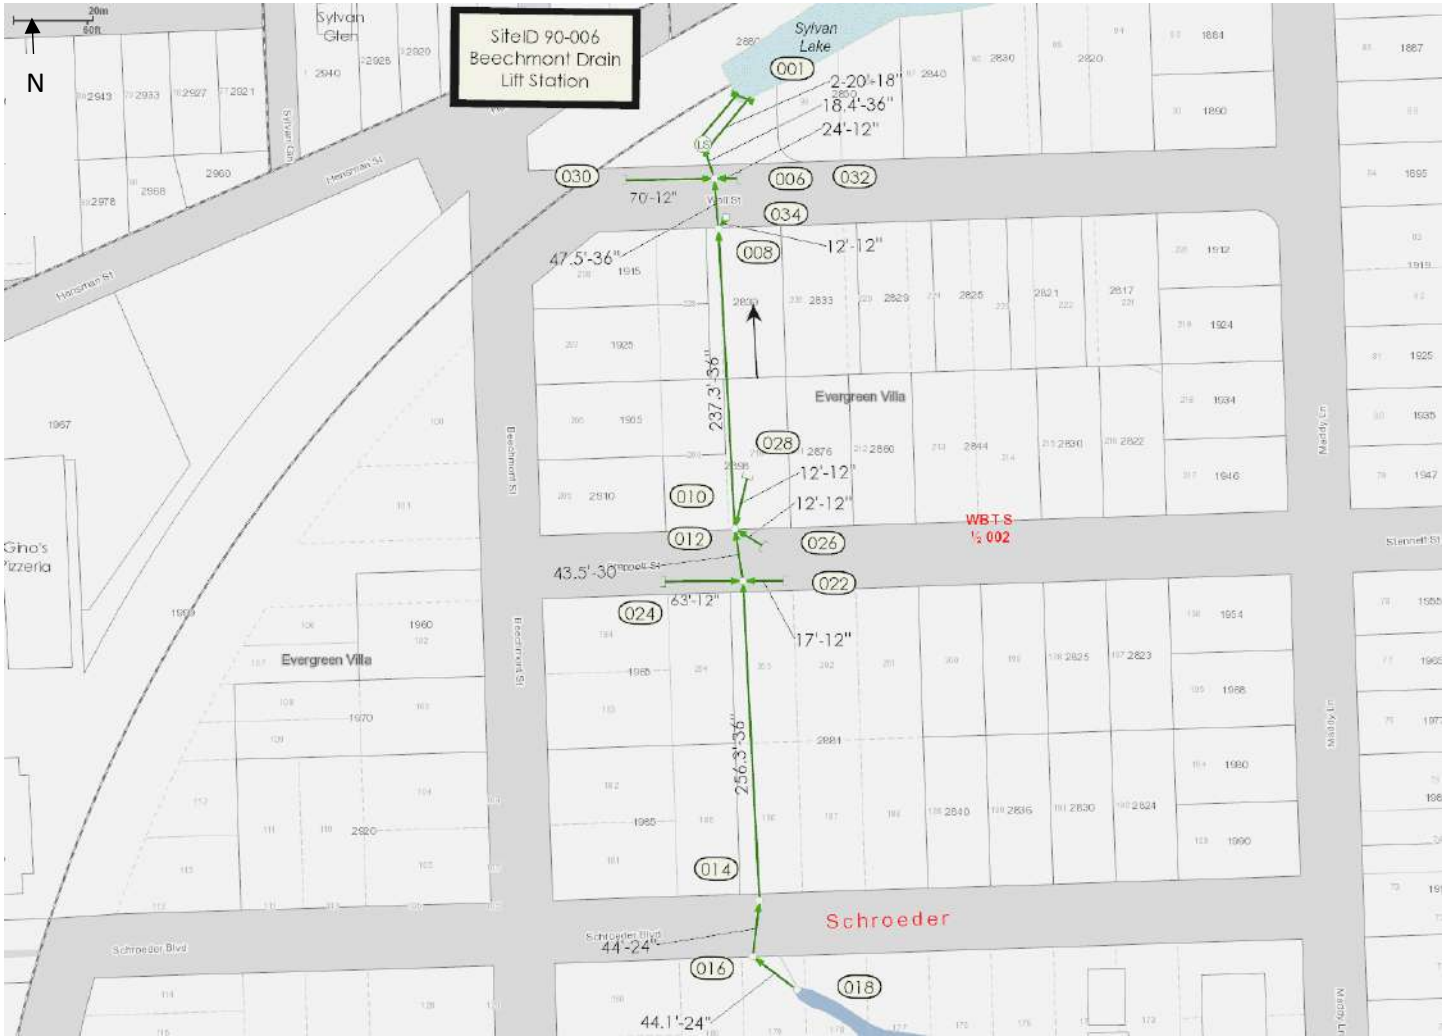
Oakland County's GIS Map of their Beechmont Drain, showing the storm drain taking the overflow from the pond and discharging to the Sylvan Lake lift station.

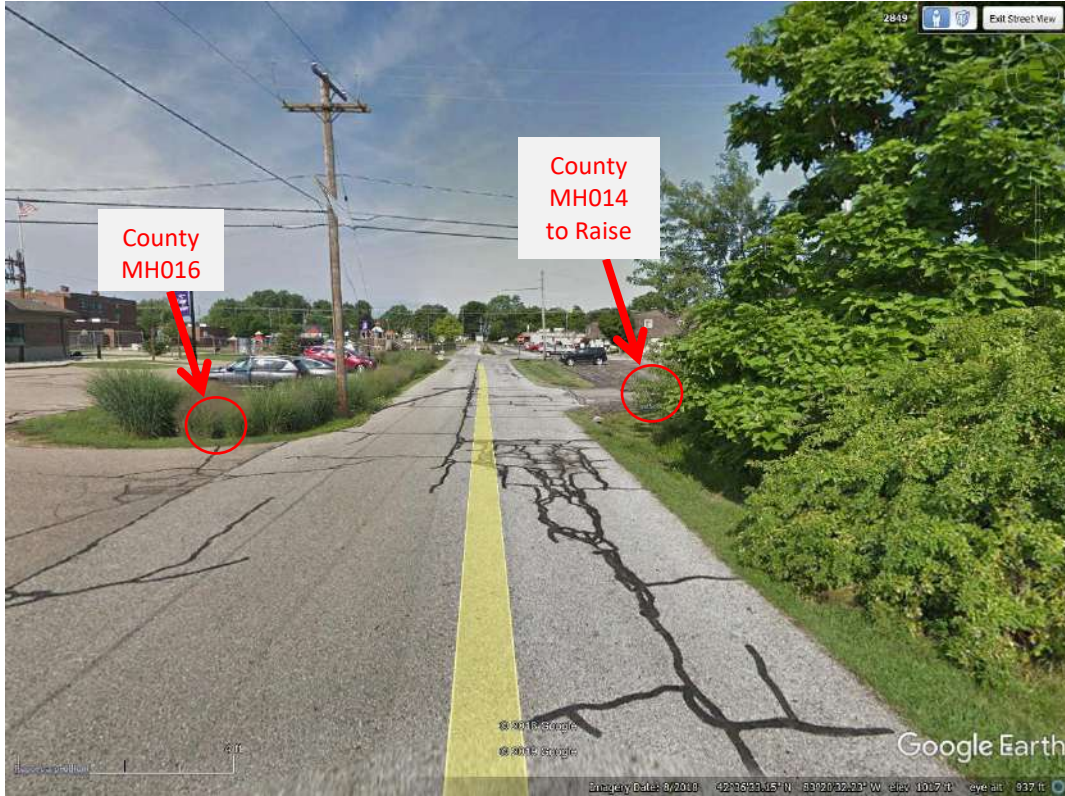
Google street view image taken in August 2018 of Schroeder Blvd., facing west and showing the location of the manhole recommended to repair.

- In order to allow water to get to MH244 at the southwest corner of Beechmont and Schroeder, the manhole should be lowered, replaced with a beehive cover, and have a deeper sump.

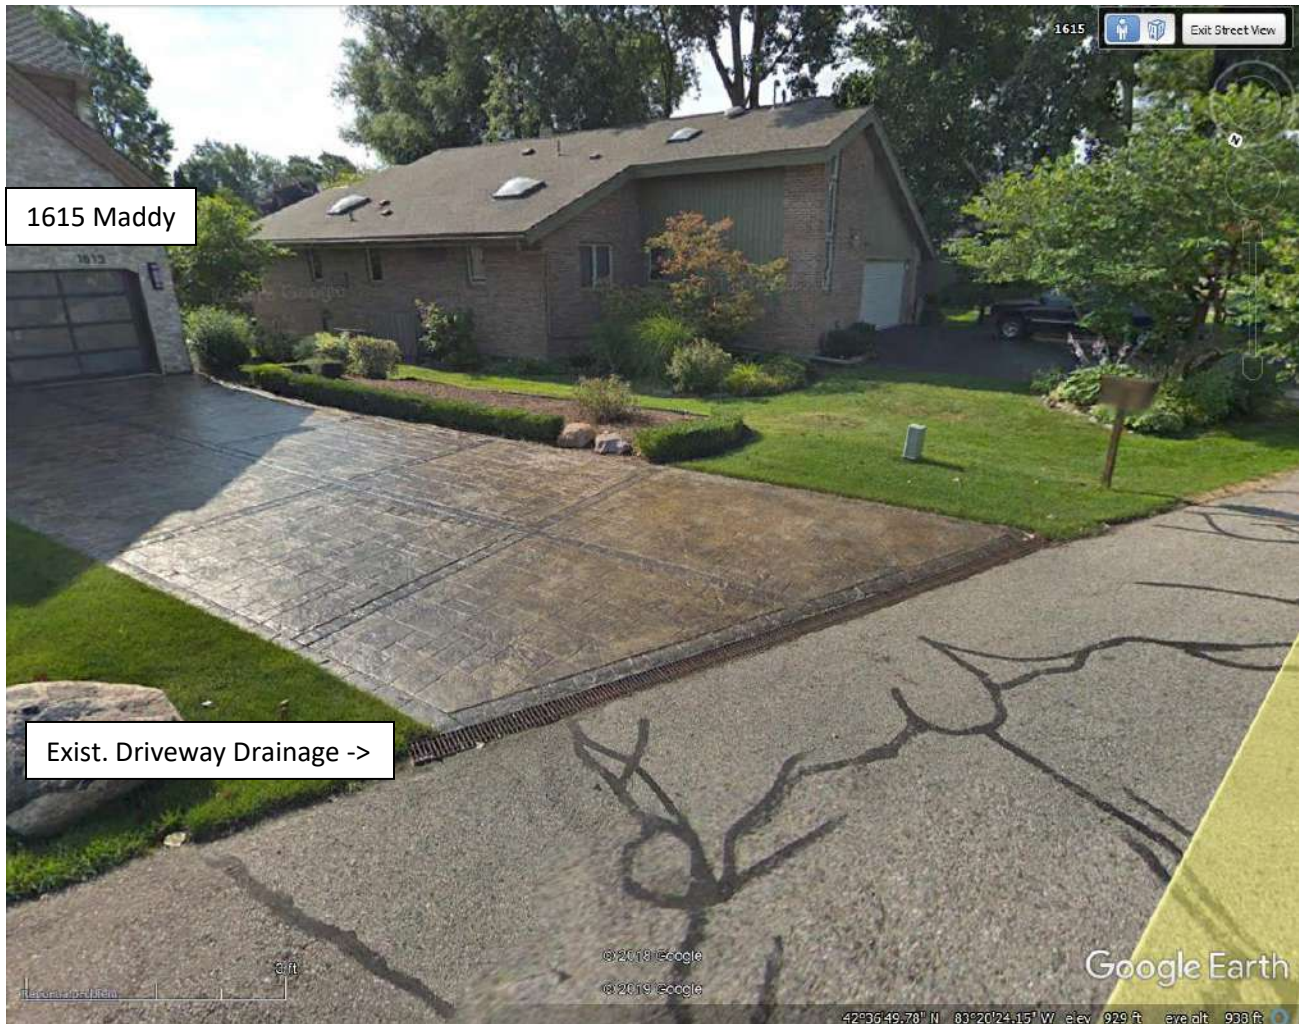
Google Earth Image from August 2018 of homeowner's house and driveway drainage.

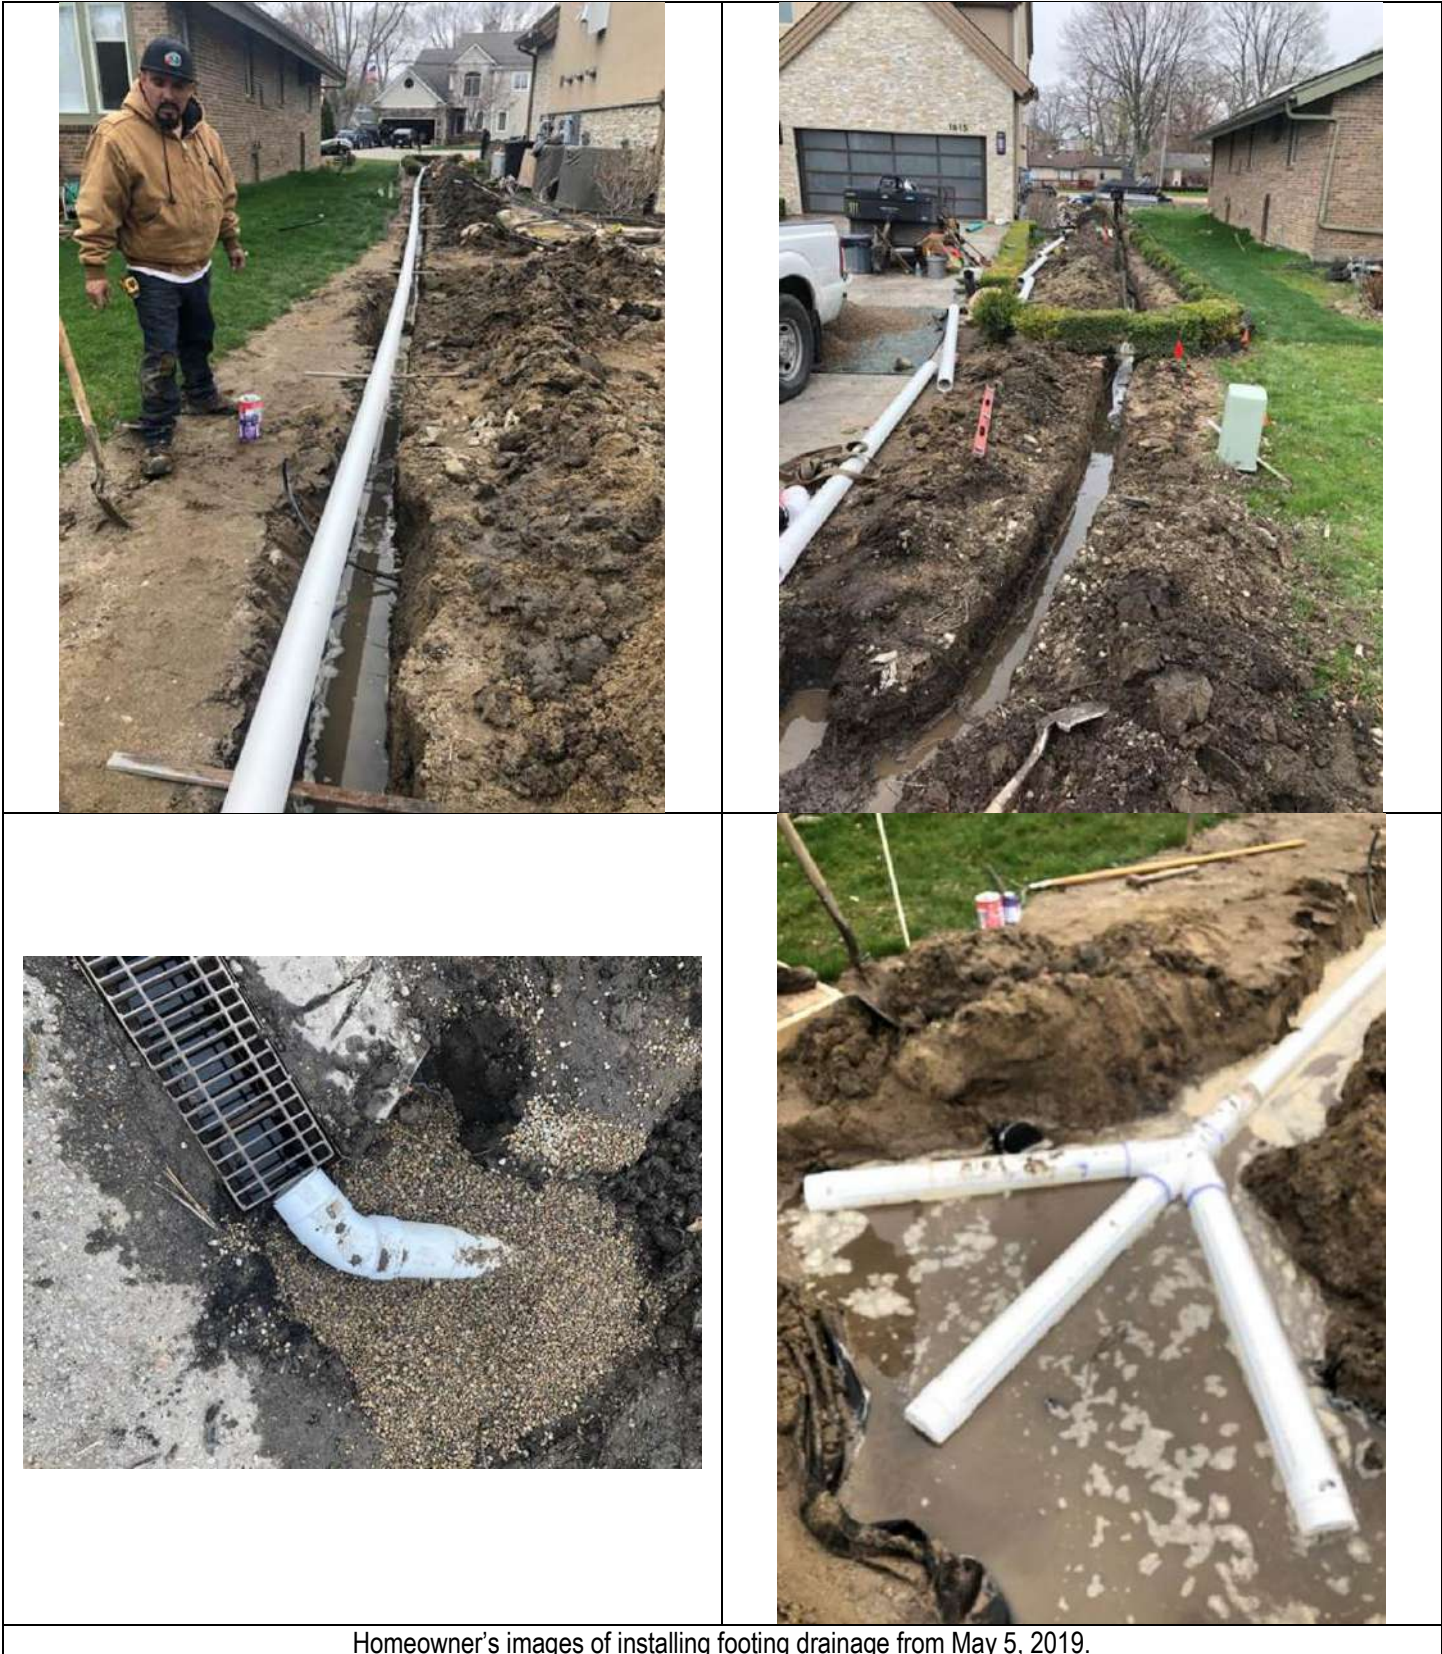
Homeowner's images of installing footing drainage from May 5, 2019.

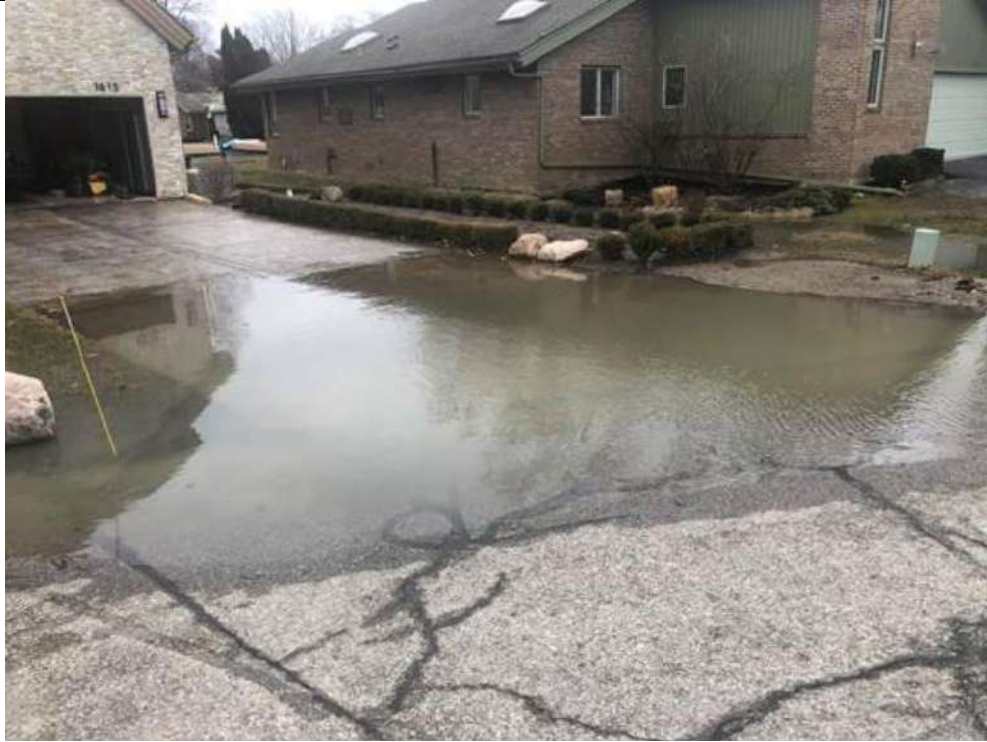
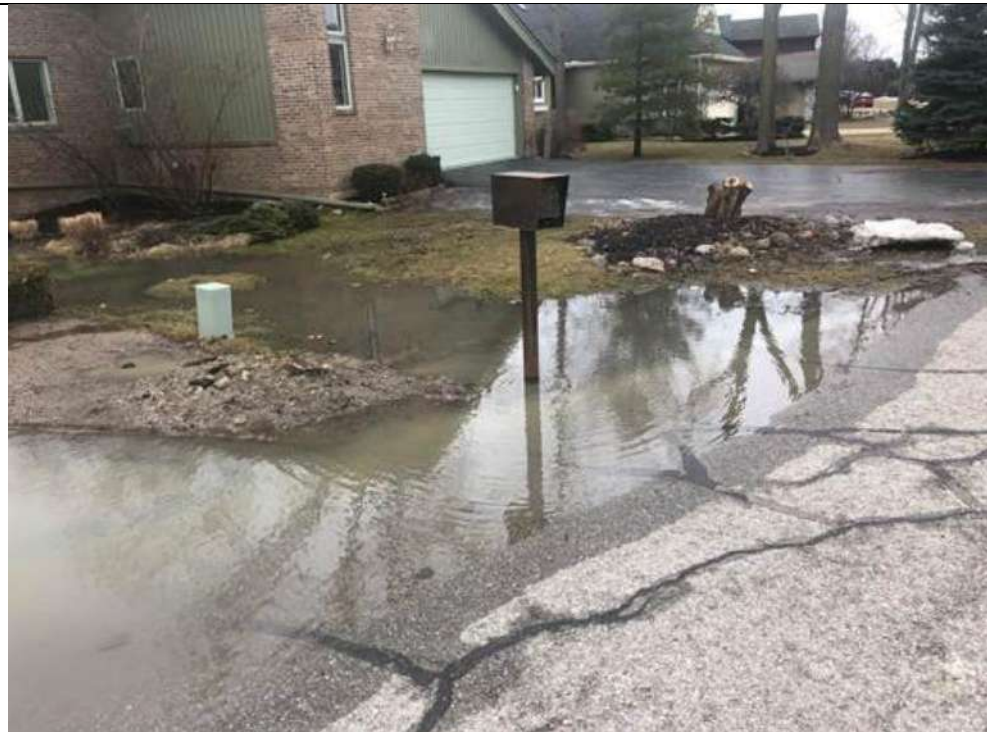
Homeowner's images of flooding in their driveway from May 7, 2019.

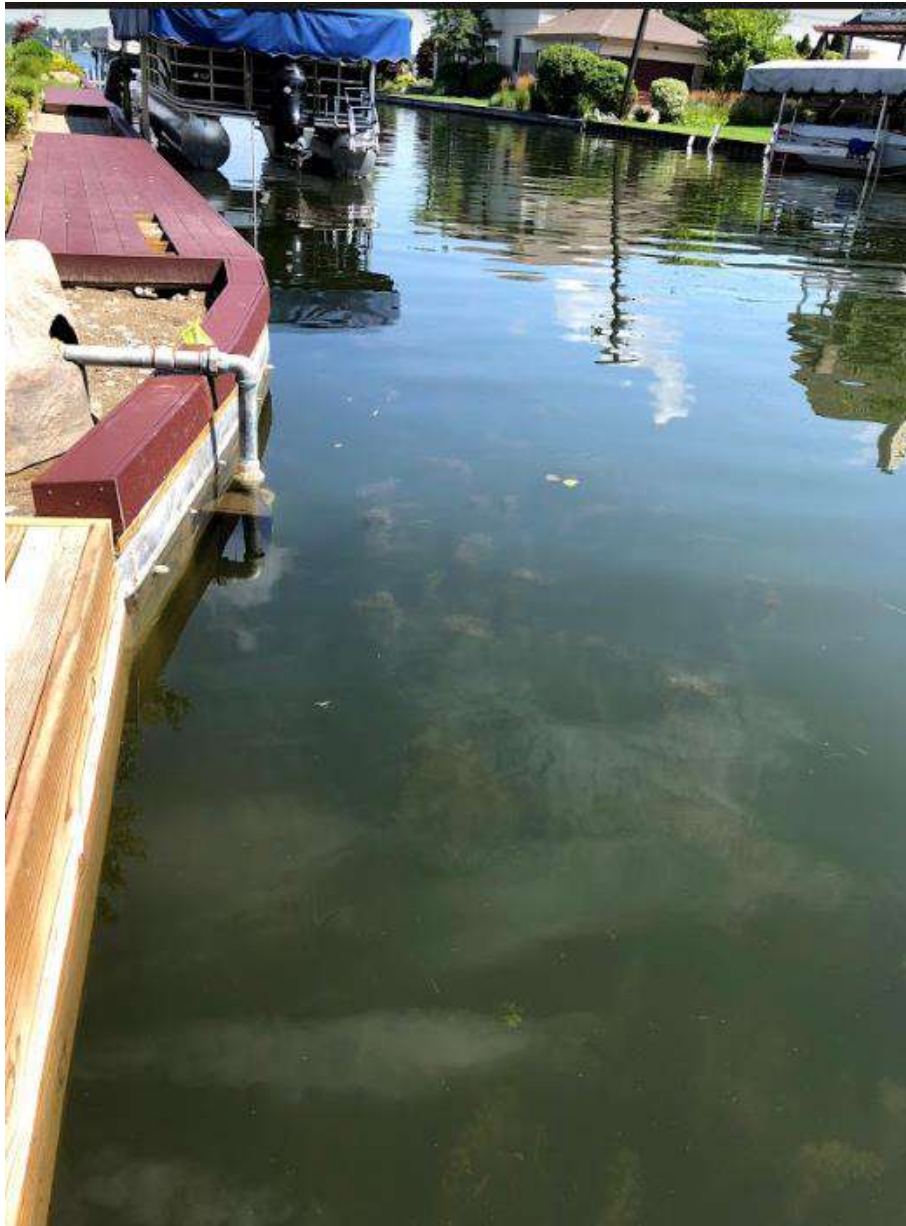
Sylvan Lake water-level at the seawall on July 30, 2019, taken by HRC staff.

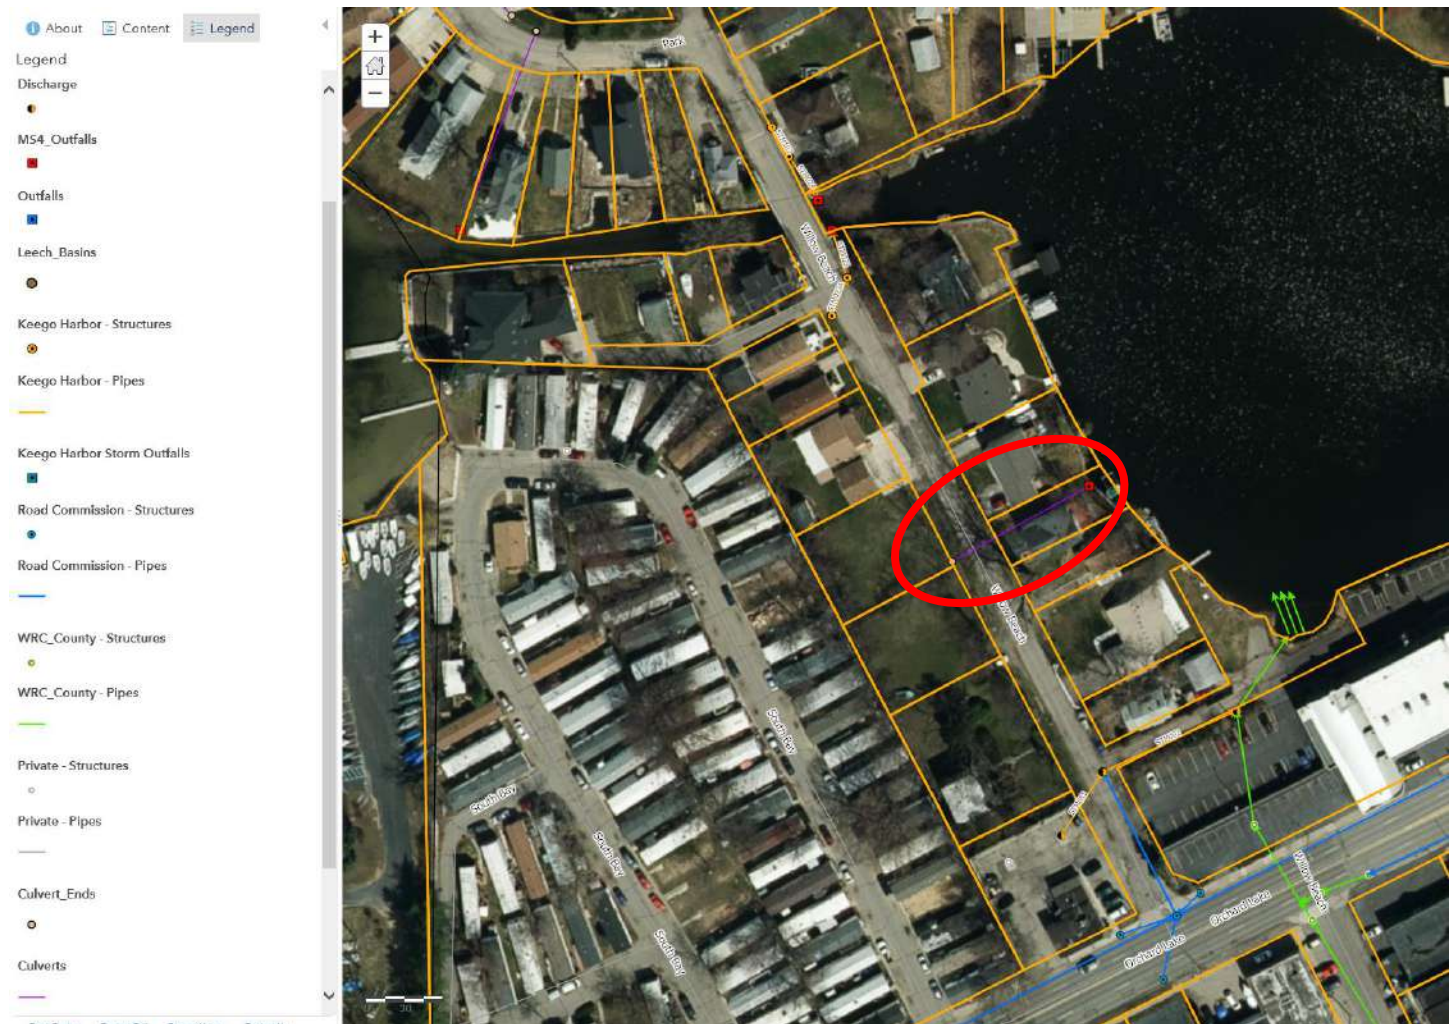
ArcGIS map overview of culvert location.

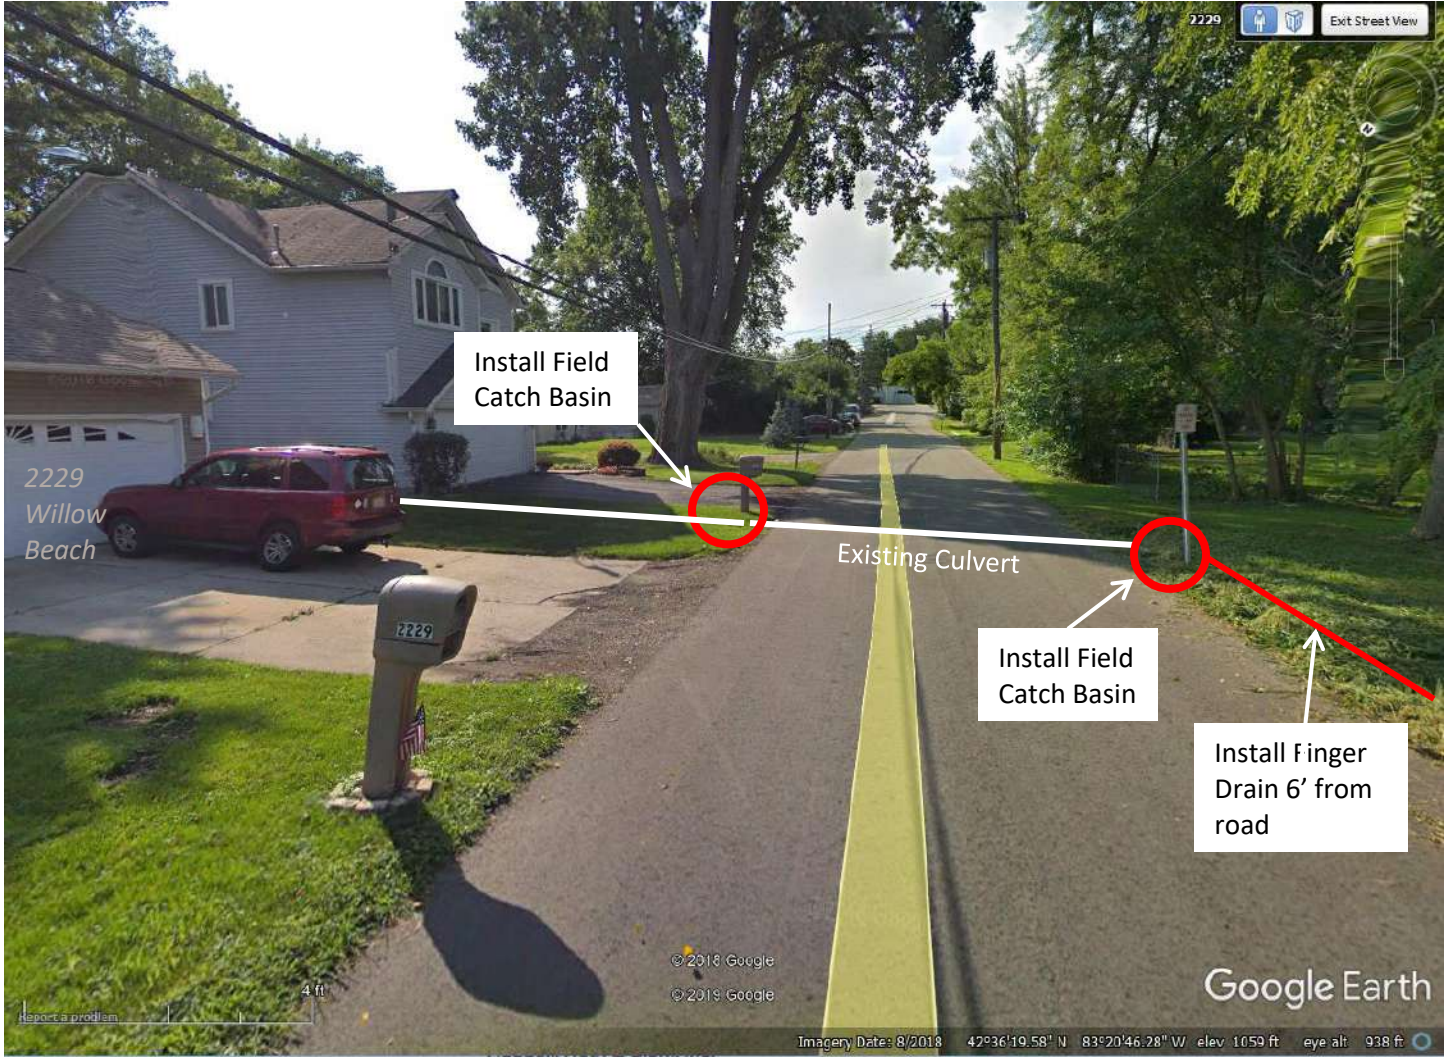
Google Earth Image from August 2018 with suggested improvements.

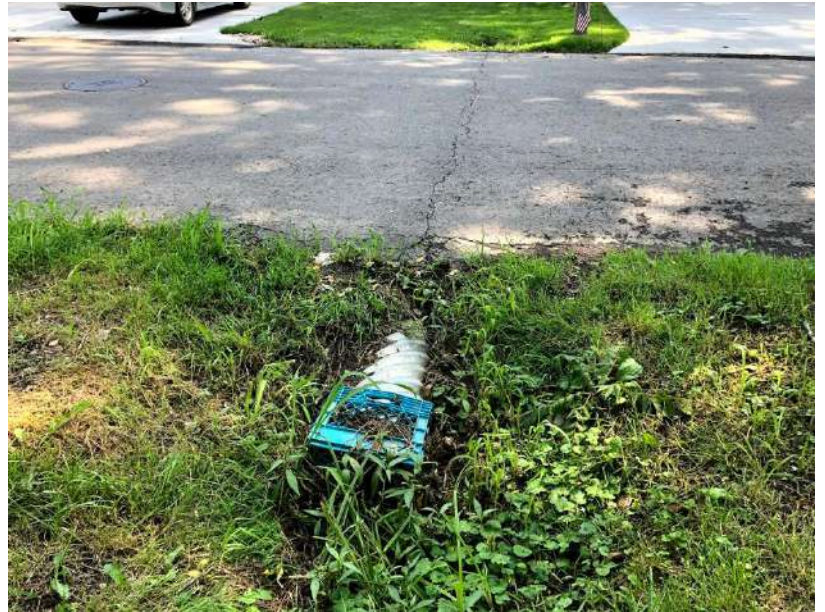
Taken by HRC staff on July 30, 2019 showing the inlet on the west side of Willow Beach.

- Add a field catch basin structure over the top of the existing culvert in the low-lying area in front of 2229 Willow Beach.
- A field catch basin structure should be placed over the culvert opening on the West side of Willow Beach
 - Finger drains should be extended North and South from this structure parallel to the road and approximately 6-feet from the edge of road
- The location of where the pipe changes sizes should be identified:
 - Pipe should be replaced with a 12" pipe from this point to Dollar Lake or
 - A structure should be placed in this location to improve maintenance.
- The projected cost for this is in the range of \$8,000 – \$10,000.
