**STORMWATER SYSTEM
ASSET MANAGEMENT PLAN**

**CITY OF KEEGO HARBOR
OAKLAND COUNTY, MICHIGAN**

DECEMBER 2019

HRC JOB NO. 20130735

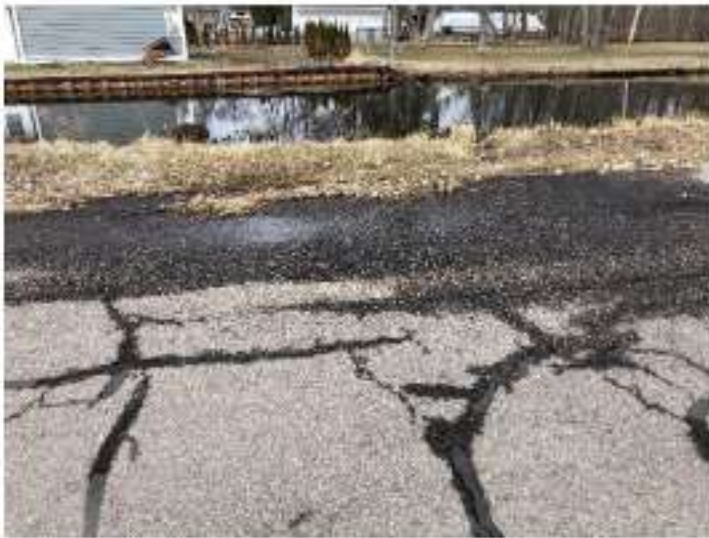
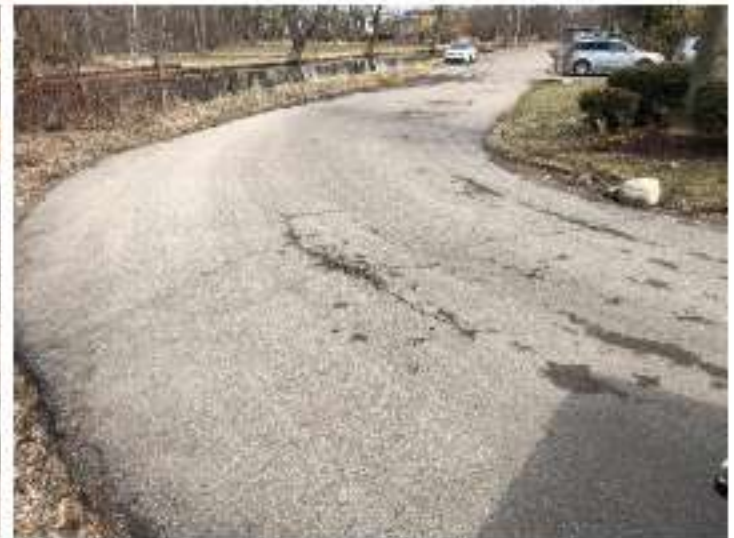
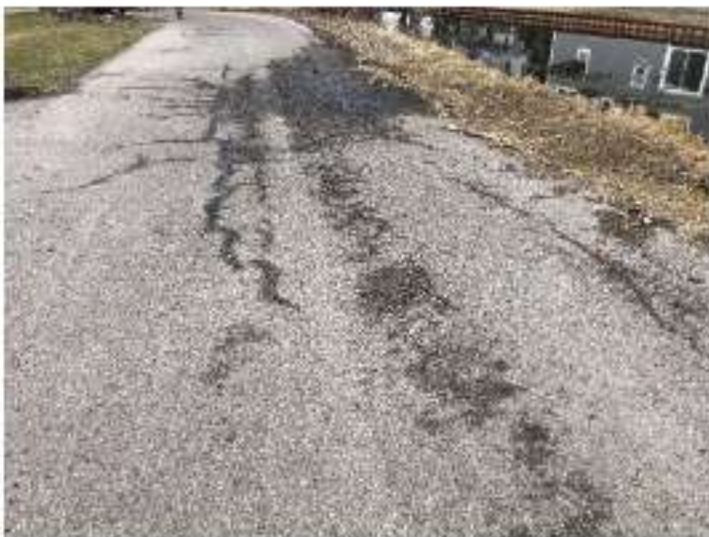
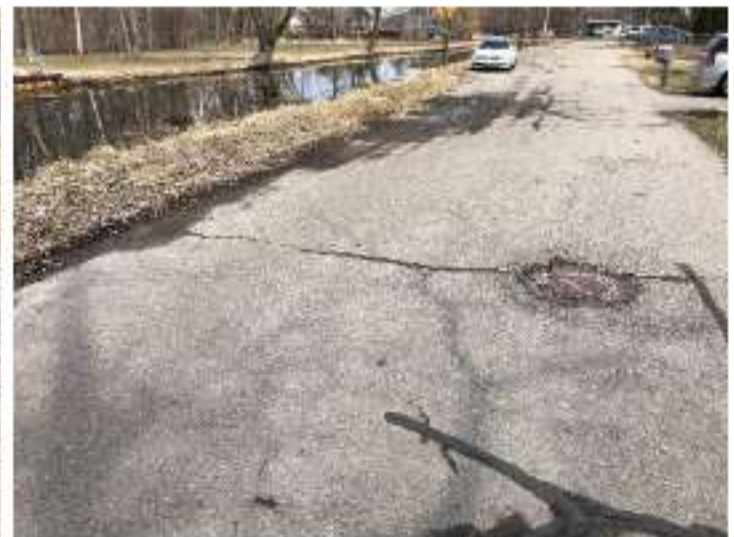
Site photos taken by HRC staff on April 5, 2019 of the wet road and shoreline erosion along Brock Street.

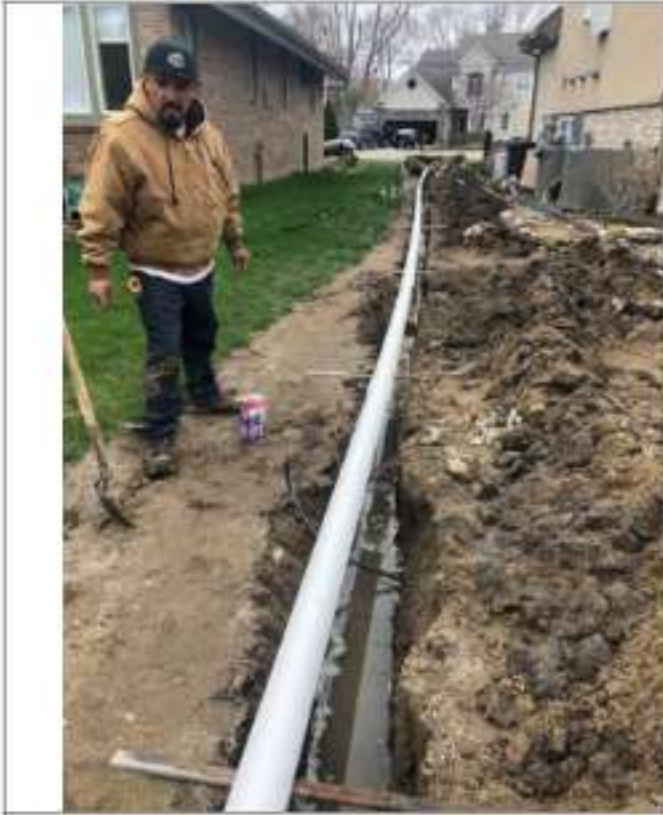
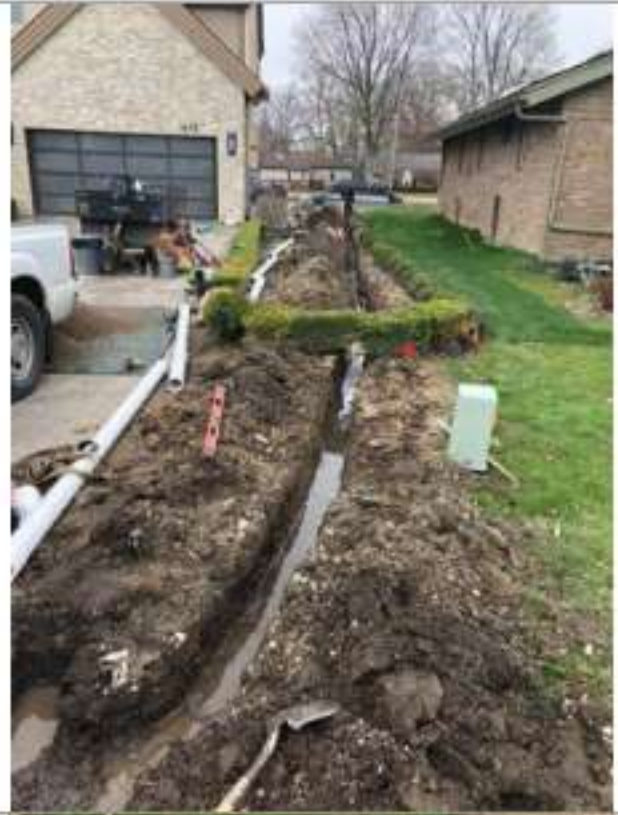
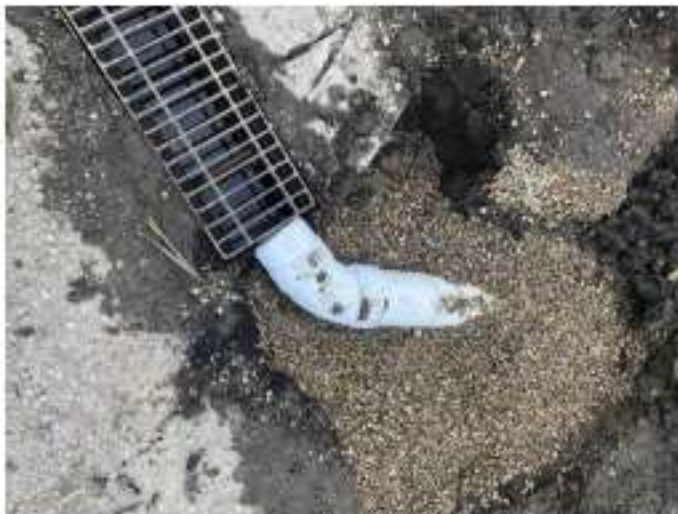
Homeowner's images of installing footing drainage from May 5, 2019.

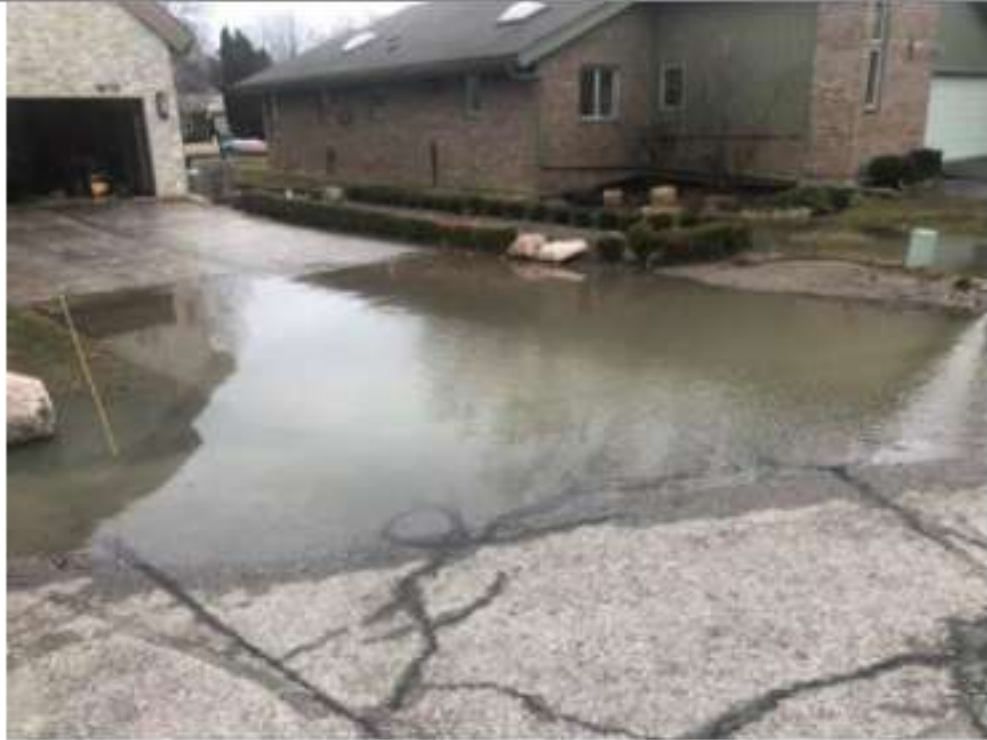
Homeowner's images of flooding in their driveway from May 7, 2019.

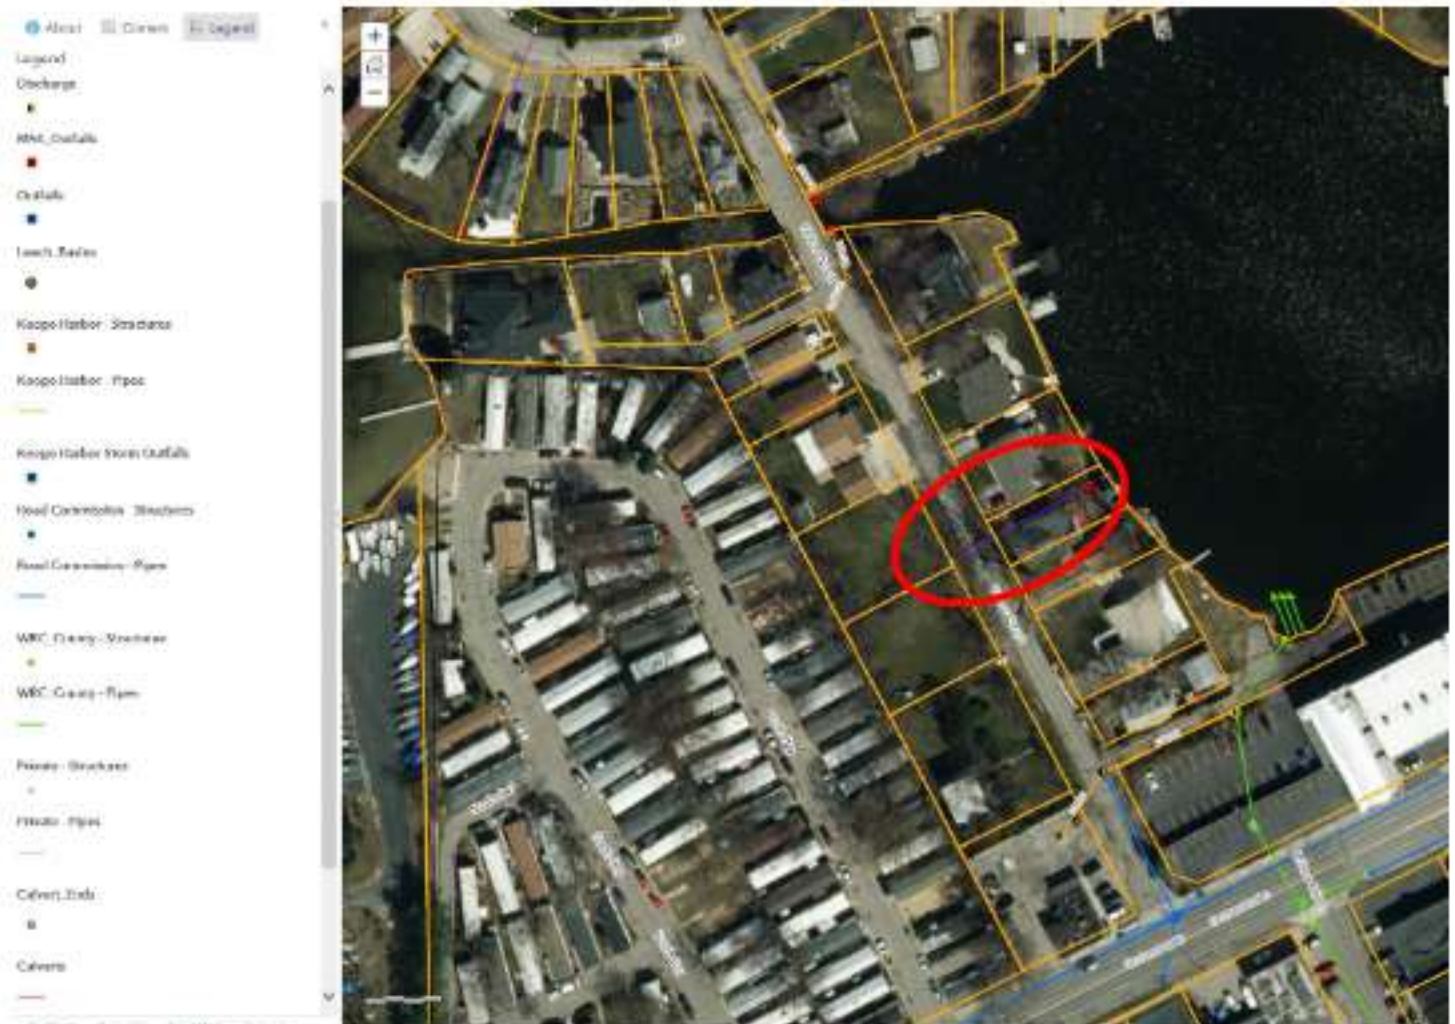
- The homeowner has complained of water ponding in their driveway, their yard, and in the road.
- Willow Beach Road was repaved in this area in 2017 (HRC job #20170705).
- A 12" CMP culvert was installed during the road repaving job in 2017 under Willow Beach in this area that outlets to Dollar Lake with an inlet on the west side of Willow Beach. Minutes from that project discussing the intention and further recommendations for this culvert are attached.
- Elevations of the City streets and structures were collected from a Lidar Scan in March of 2017.

ArcGIS map overview of culvert location.

- Add a field catch basin structure over the top of the existing culvert in the low-lying area in front of 2229 Willow Beach.
- A field catch basin structure should be placed over the culvert opening on the West side of Willow Beach
 - Finger drains should be extended North and South from this structure parallel to the road and approximately 6-feet from the edge of road
- The location of where the pipe changes sizes should be identified:
 - Pipe should be replaced with a 12" pipe from this point to Dollar Lake or
 - A structure should be placed in this location to improve maintenance.
- The projected cost for this is in the range of \$8,000 – \$10,000.

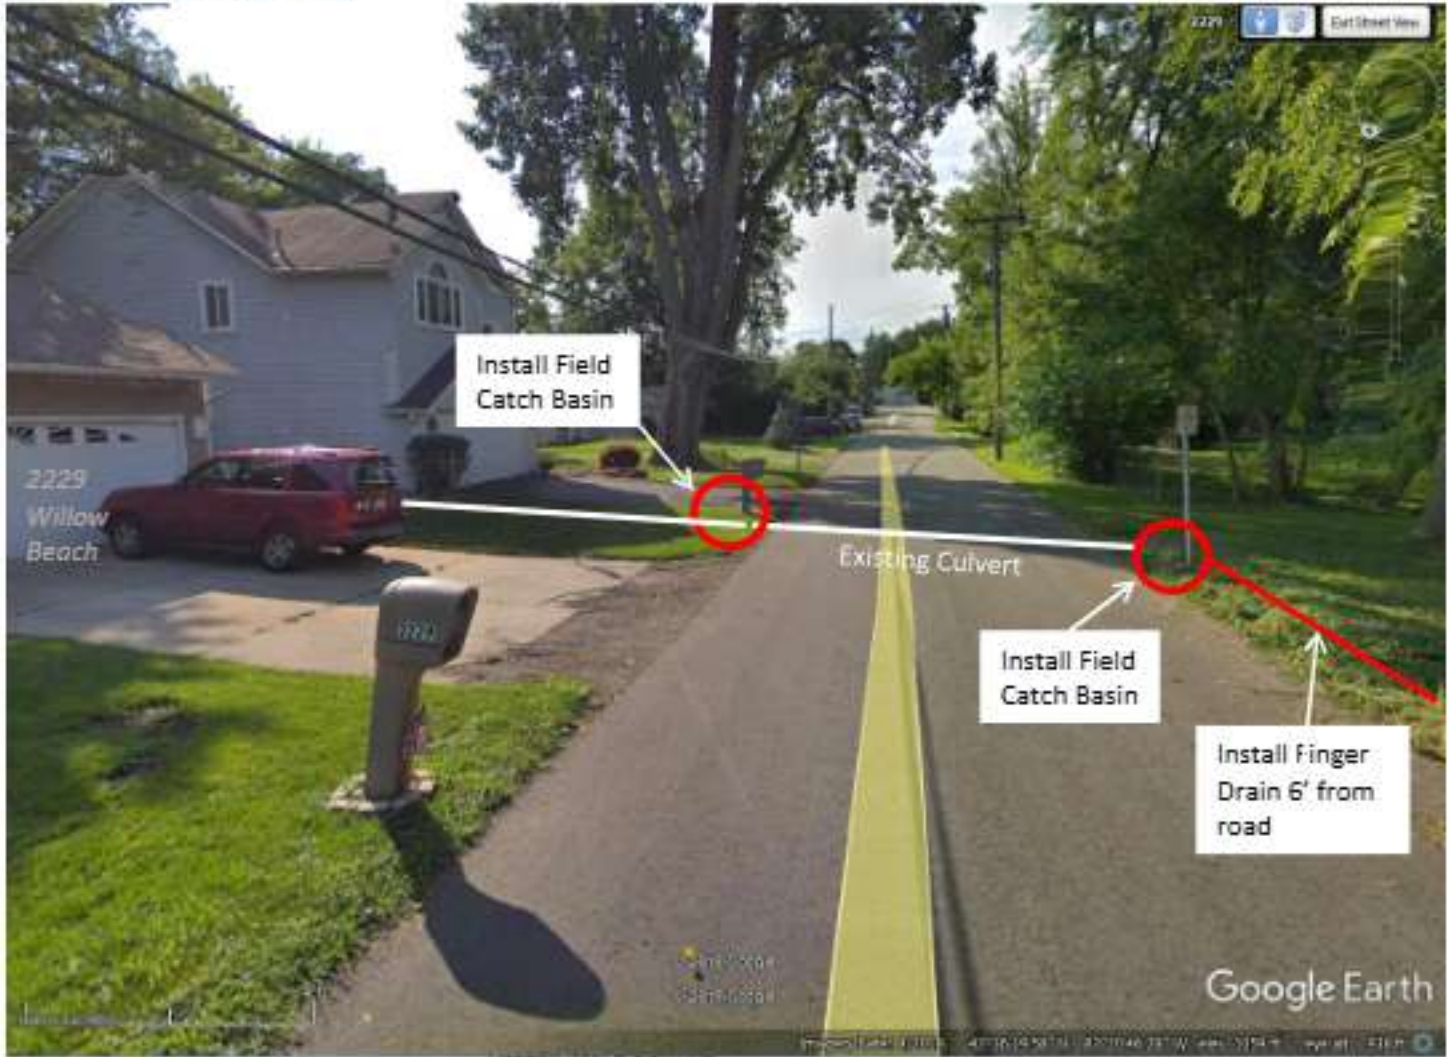
Google Earth Image from August 2018 with suggested improvements.

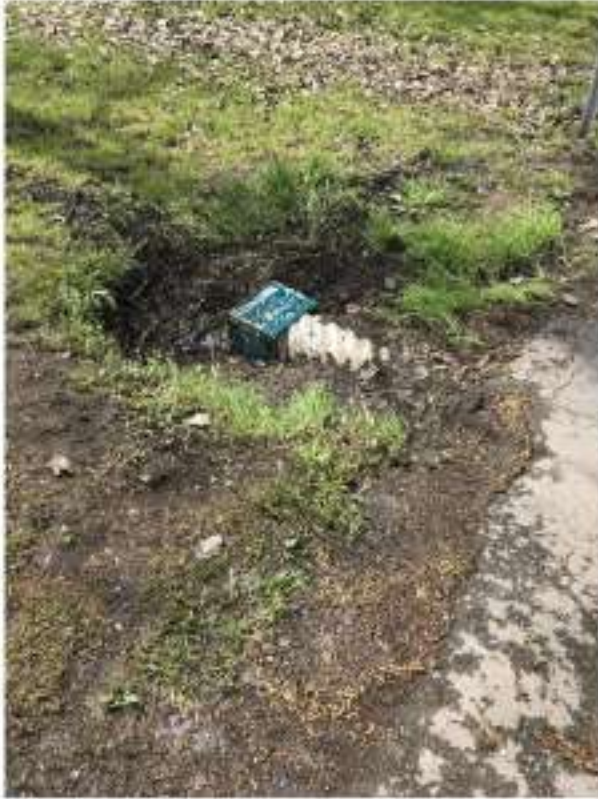
Taken by HRC staff on May 22, 2019 showing the inlet on the west side of Willow Beach.

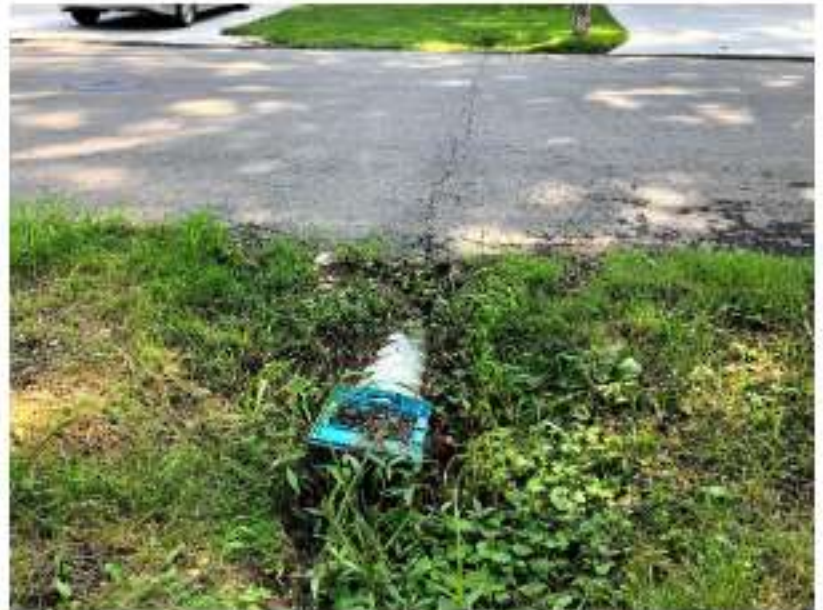
Taken by HRC staff on July 30, 2019 showing the inlet on the west side of Willow Beach.

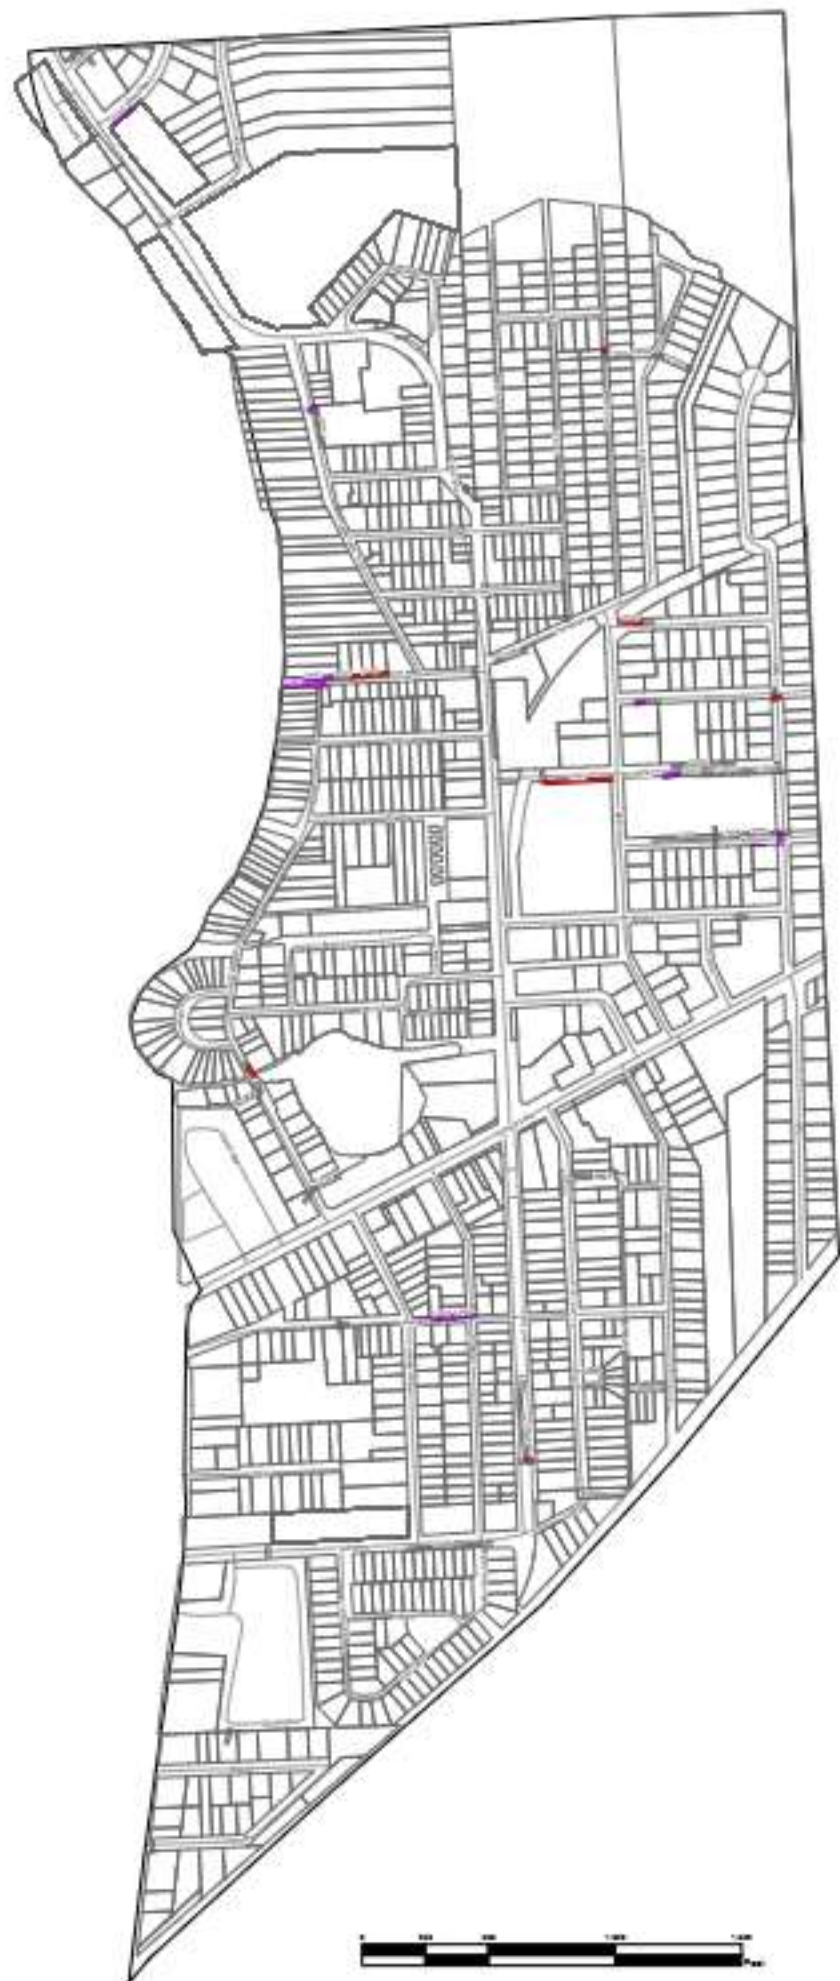
CIP

- Pipes Years 0-5
- Pipes Years 5-20

**KEEGO HARBOR STORM SYSTEM
0-20-YEAR CAPITAL IMPROVEMENT PROJECTS
PROPOSED PIPE REPAIRS**

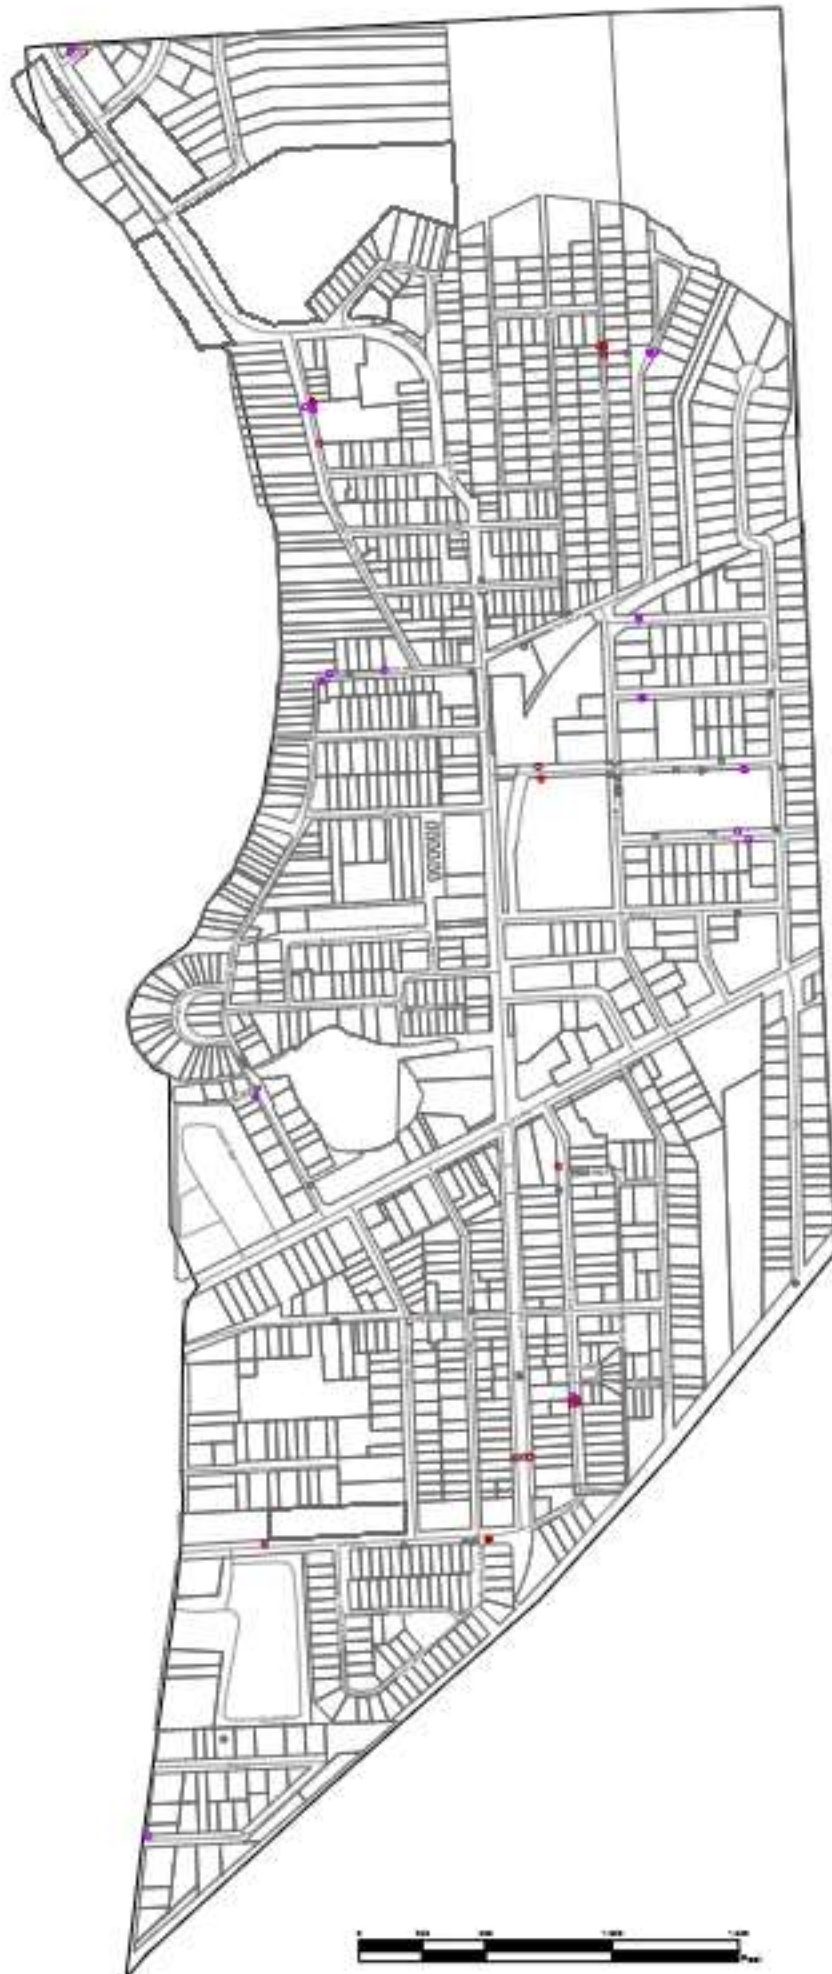
CIP

- MHs Years 0-5
- MHs Years 5-20

**KEEGO HARBOR STORM SYSTEM
0-20-YEAR CAPITAL IMPROVEMENT PROJECTS
PROPOSED MANHOLE REPAIRS**
