STORMWATER SYSTEM ASSET MANAGEMENT PLAN

CITY OF KEEGO HARBOR OAKLAND COUNTY, MICHIGAN

EGLE SAW GRANT #1220-01

DECEMBER 2019

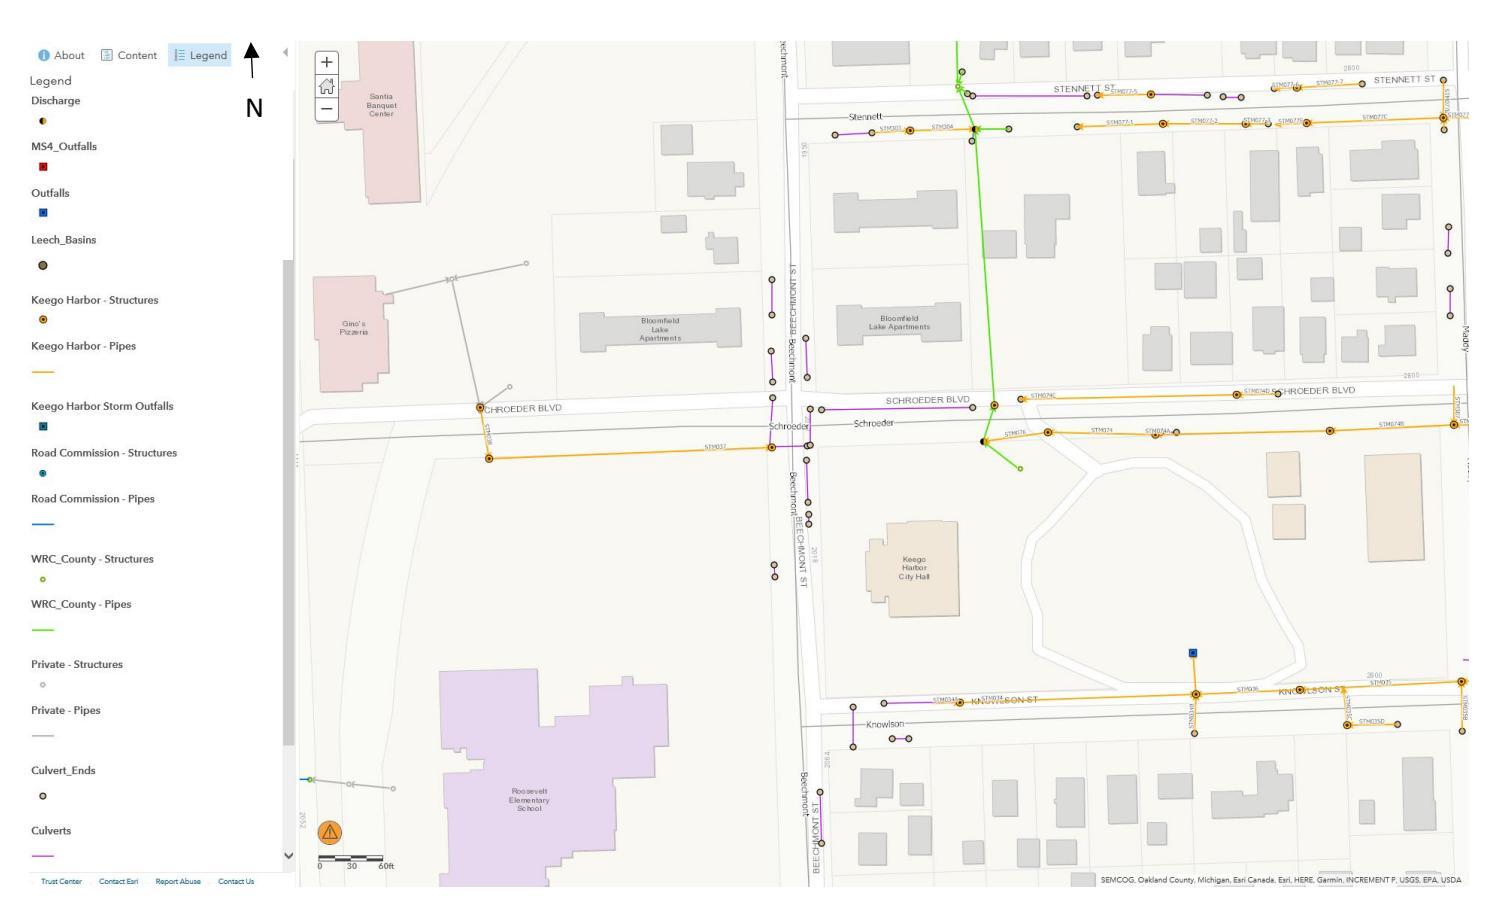
HRC's ArcGIS Map of the existing pipes at the intersection of Schroeder and Beechmont.

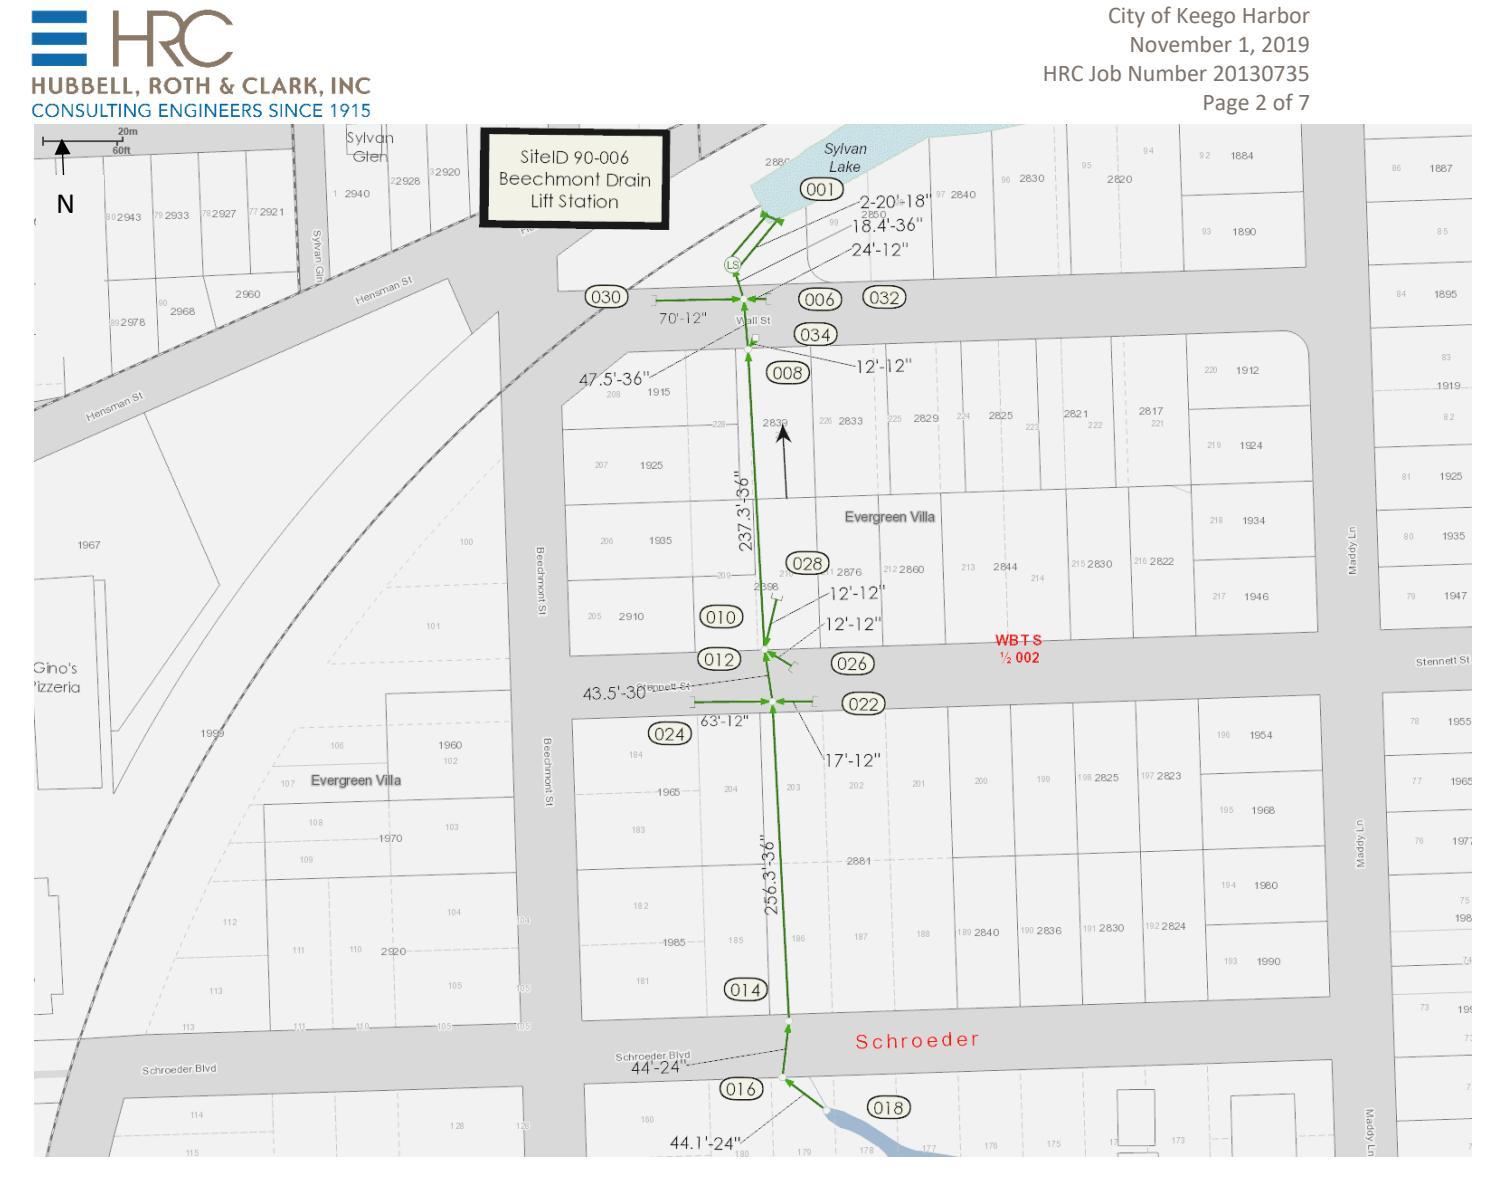
Oakland County's GIS Map of their Beechmont Drain, showing the storm drain taking the overflow from the pond and discharging to the Sylvan Lake lift station.

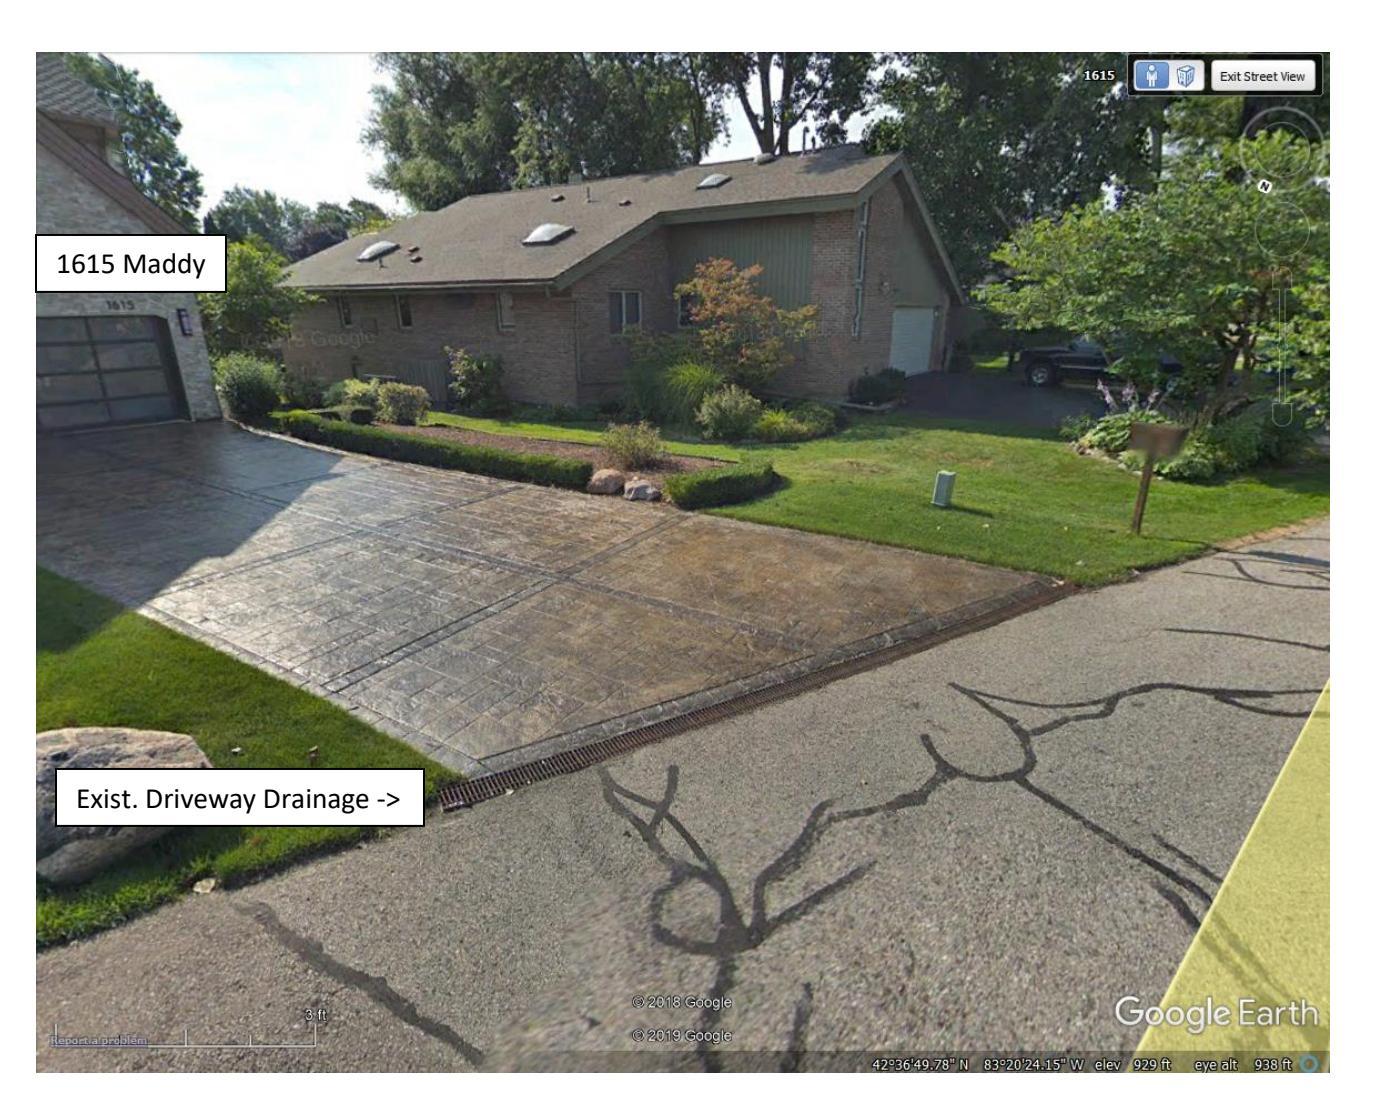
Google Earth Image from August 2018 of homeowner's house and driveway drainage.

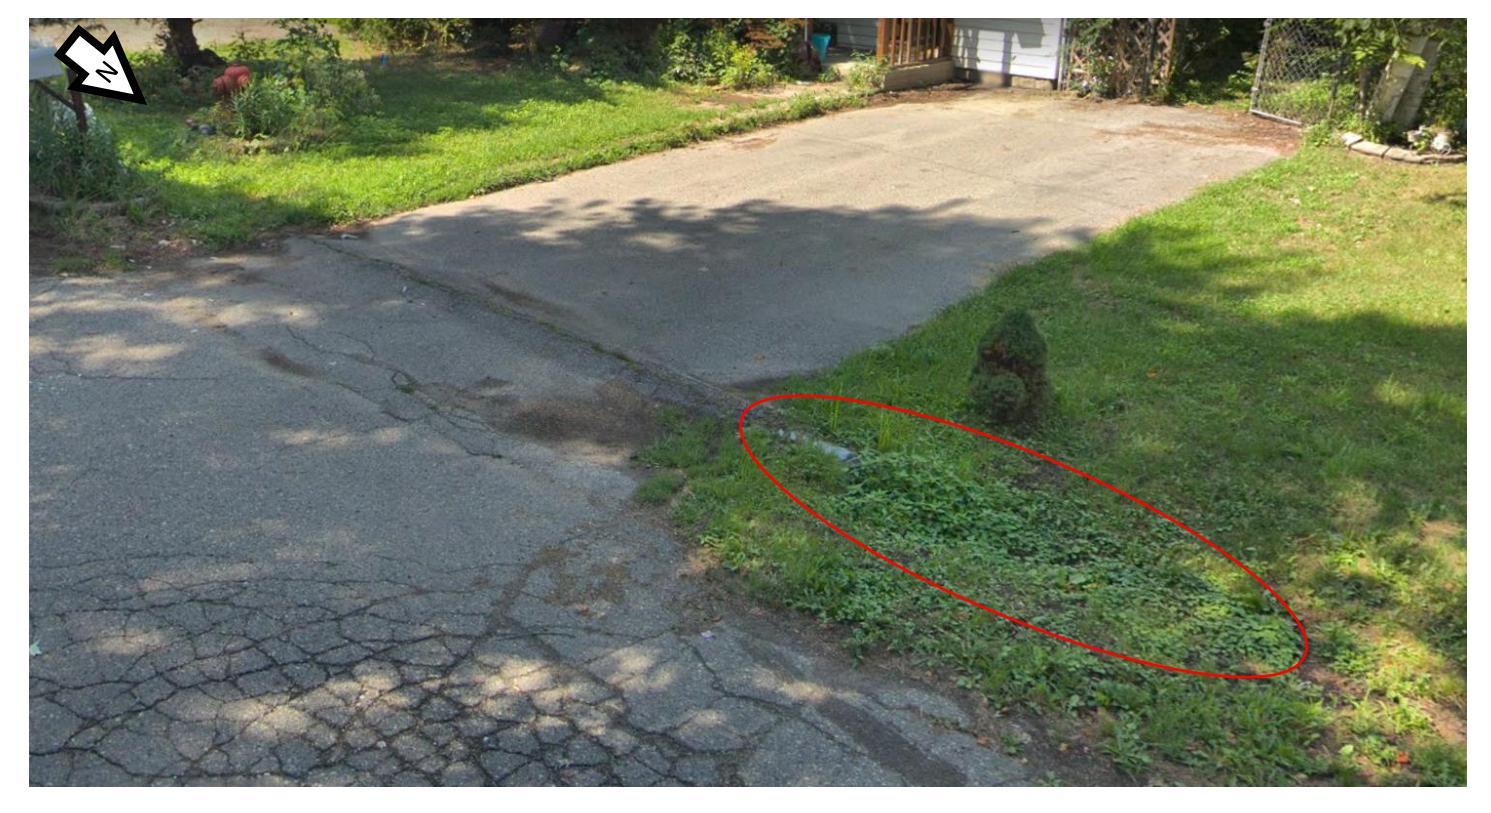
Buried culvert and ditches.

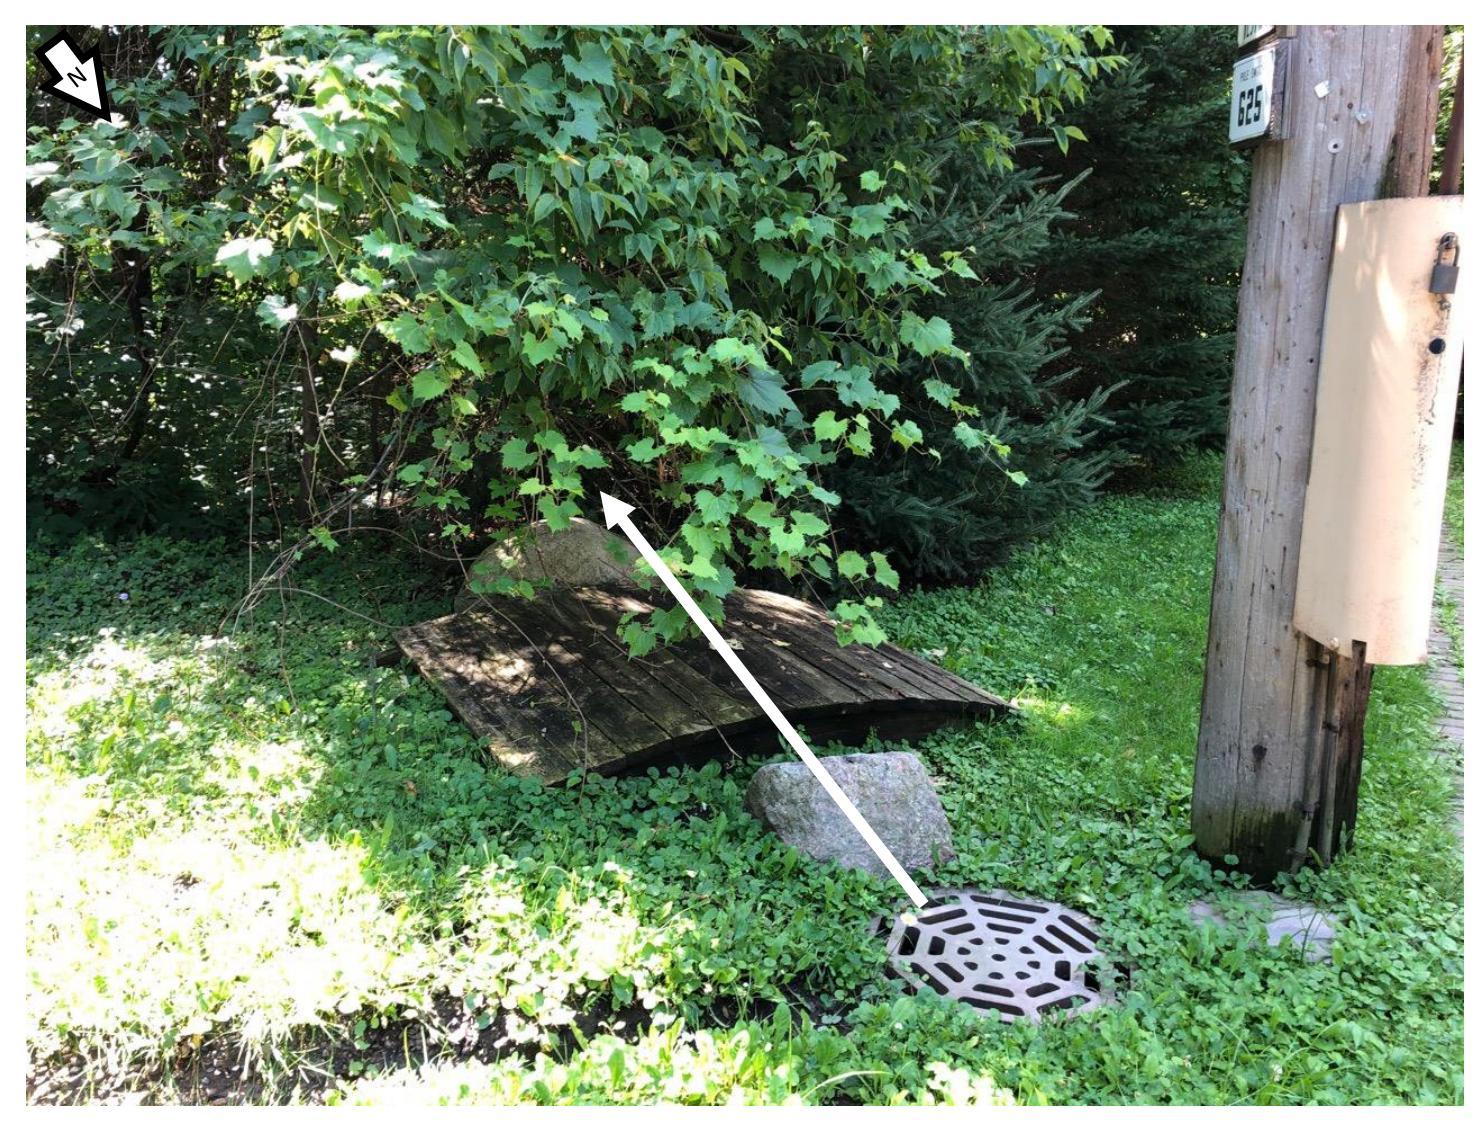
Location of the manhole at the end of Maddy Ln that discharges to the stream.

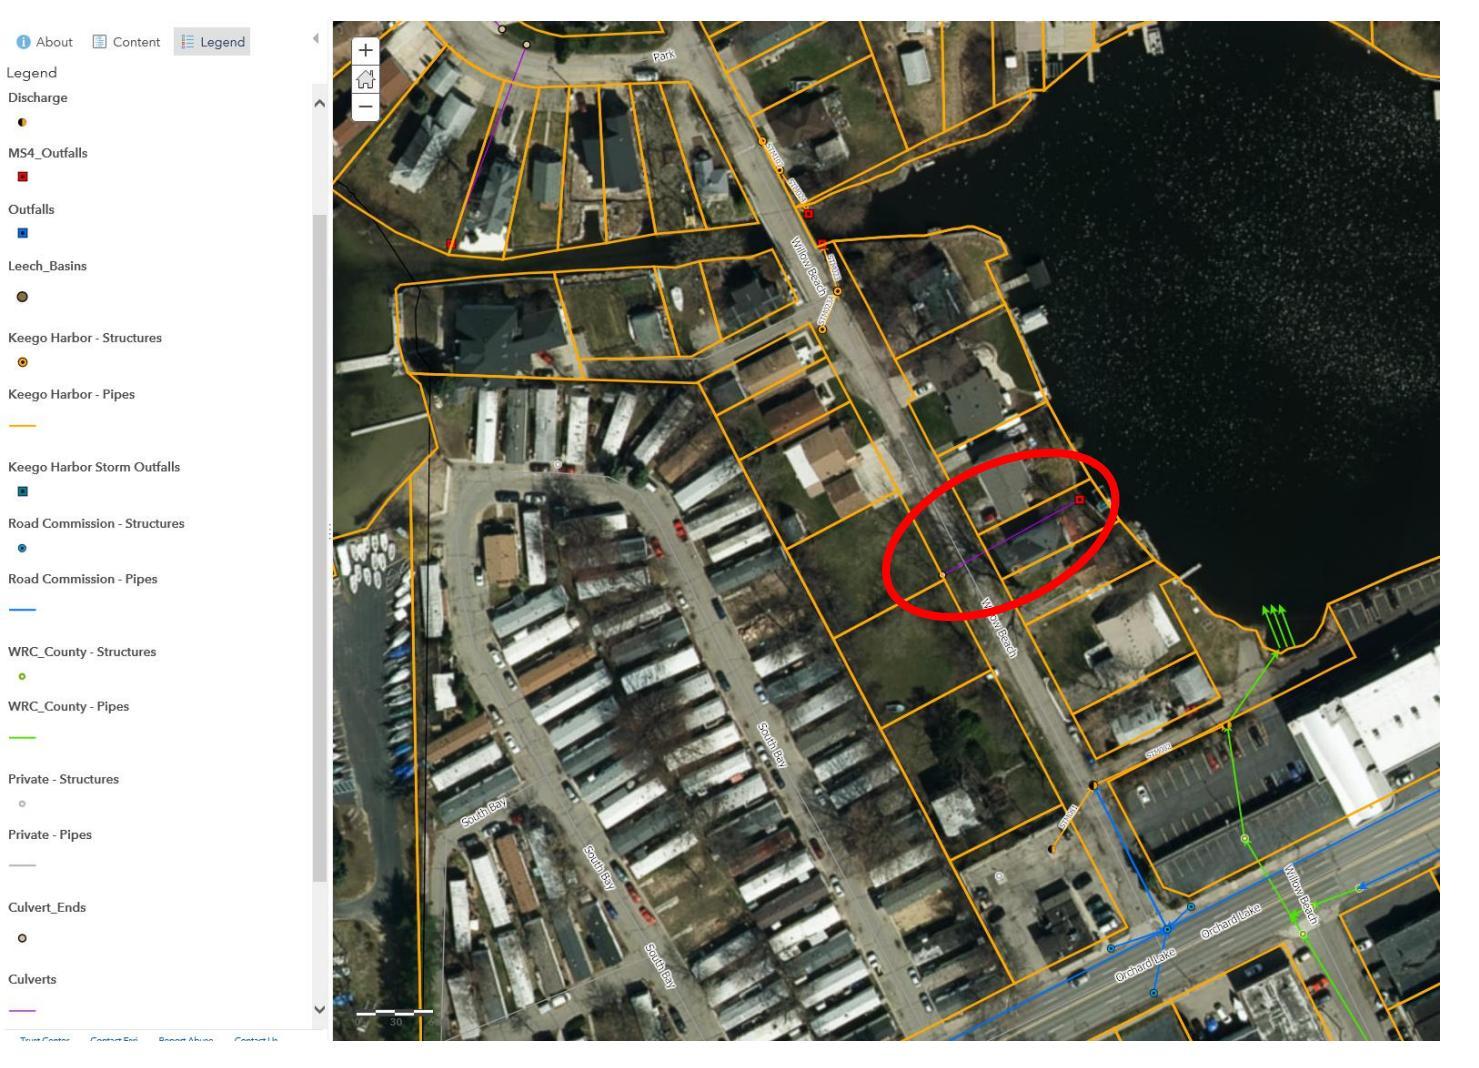
ArcGIS map overview of culvert location.

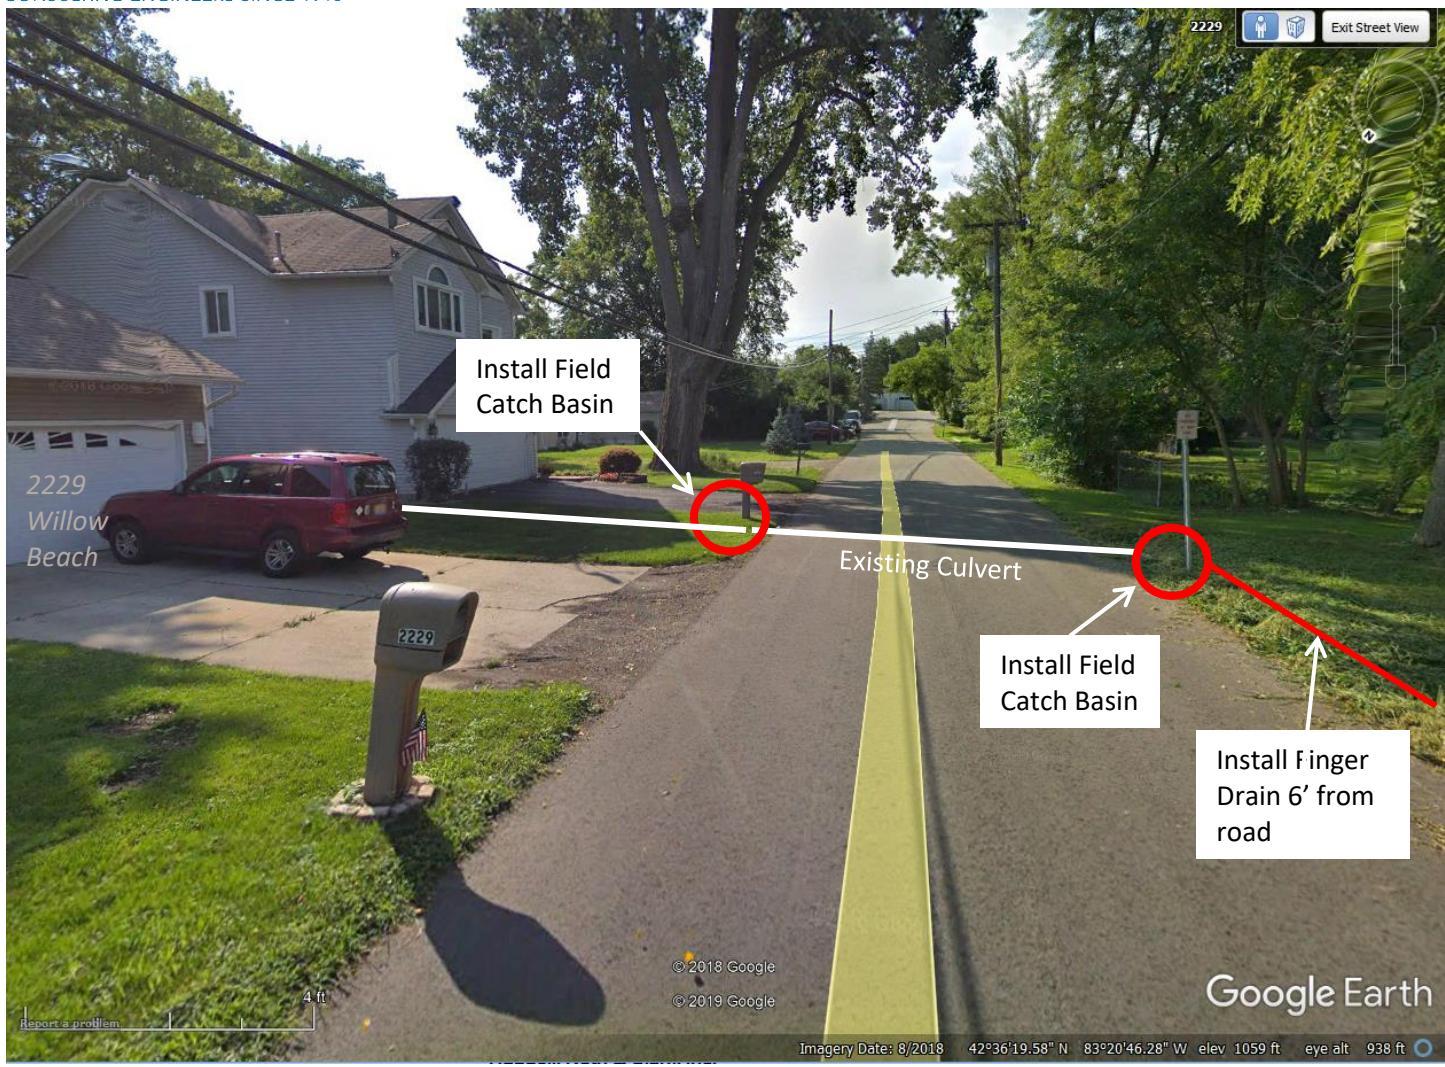
Google Earth Image from August 2018 with suggested improvements.

- Add a field catch basin structure over the top of the existing culvert in the low-lying area in front of 2229 Willow Beach.
- A field catch basin structure should be placed over the culvert opening on the West side of Willow Beach
 - Finger drains should be extended North and South from this structure parallel to the road and approximately 6-feet from the edge of road
- The location of where the pipe changes sizes should be identified:
 - Pipe should be replaced with a 12" pipe from this point to Dollar Lake or
 - A structure should be placed in this location to improve maintenance.
- The projected cost for this is in the range of \$8,000 \$10,000.

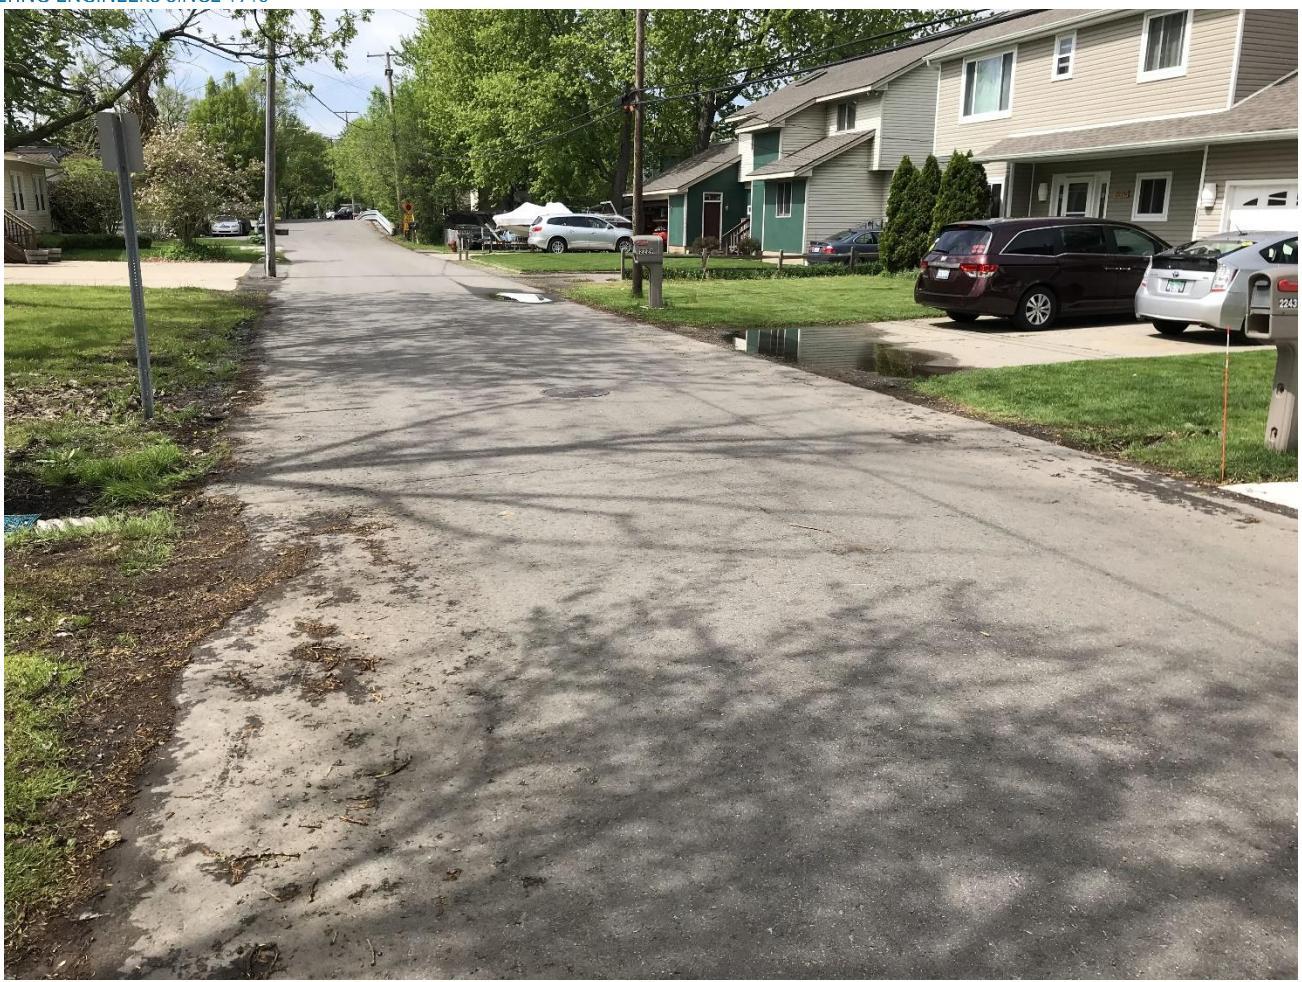
Taken by HRC staff on May 22, 2019 facing north showing Willow Beach with less flooding after rain event

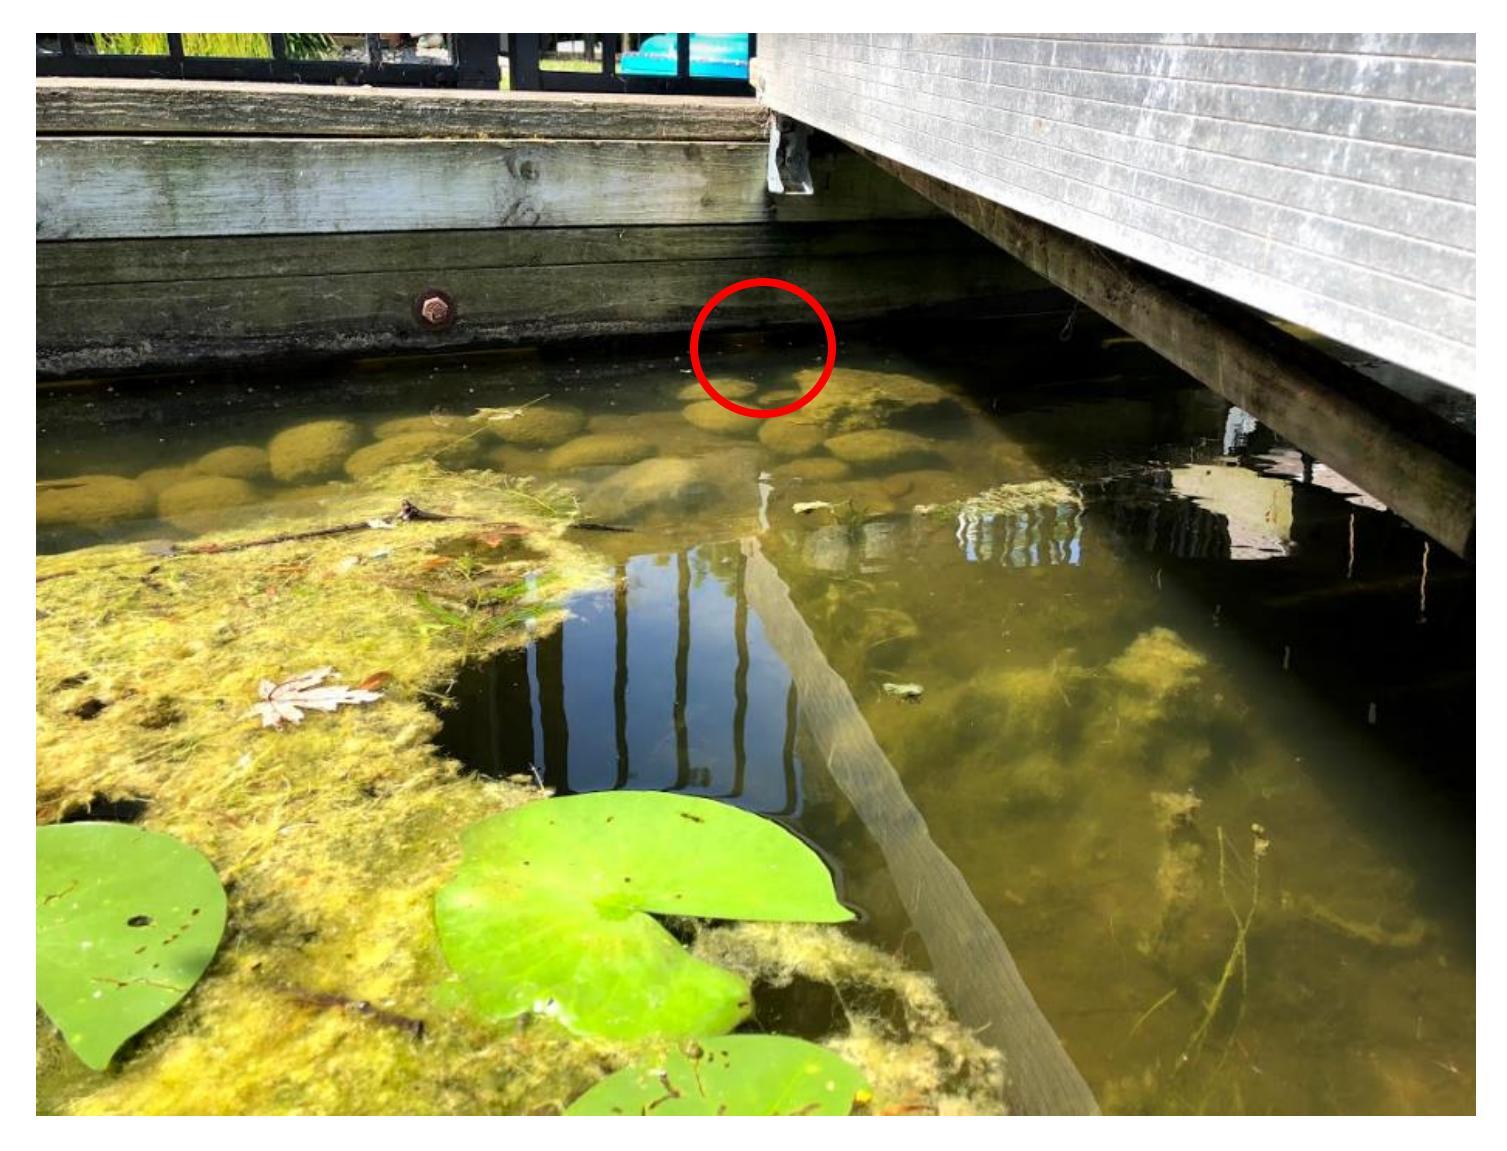
Photo taken by HRC staff of culvert outlet through the seawall into Sylvan Lake.
